# Conservation of a WWII Supermarine Spitfire section wing

This study focuses on a WWII Supermarine Spitfire aircraft section wing conservation, salvaged from the seabed in 1988 and stored in a private garden. The object was in poor condition so decisions on the conservation, preservation or removal of parts of the original elements were needed. Firstly, the wing fragment was studied to determine its heritage interest and to assess its historical, industrial, technical and scientific values. This object will become a memorial to the pilot who died during the mission, in his hometown. The conservation project aims to find the best solution to both conservation priorities and exhibition needs. Based on cleaning tests on corroded, painted aluminium alloys carried out within the PROCRAFT Project, a treatment was determined. This case serves as an example of how the results of a European project can be implemented in a conservation-restoration process and how industrial conservation theory can be applied to archaeological artefacts.

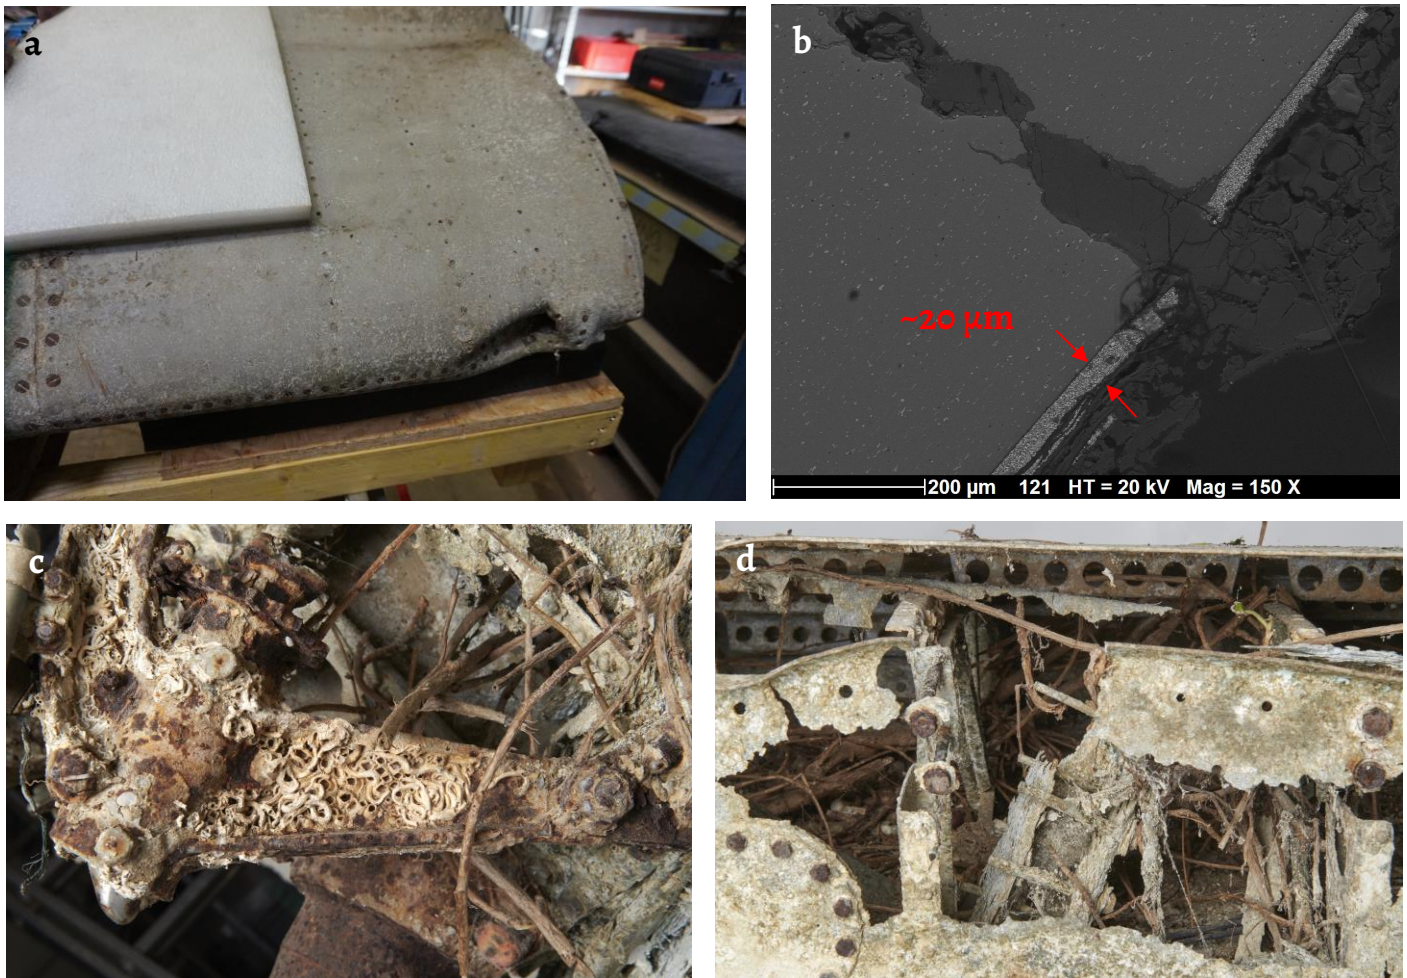
**Figure 4.** Examples of deterioration observed on the wing fragment of the Spitfire Mk VII: *a*) bullet impact; *b*) SEM photo of a sample (cross-section) from the wing showing generalized corrosion with inter- and intragranular corrosion in relation to micrometric intermetallic precipitates; *c*) development of marine microorganisms, called “concretions”; *d*) presence of undergrowth inside the wing.

Duralumin is highly sensitive [4] when in contact with chlorides, developing pitting and intergranular corrosion aggravated by the presence of intermetallic precipitates (Figure 4b).

Records [3] show that Duralumin parts of the Spitfire were usually protected by Al cladding (pure Al hot-rolled on both sides of the alloy, to provide more resistance to corrosion) and painting. However, SEM analysis of samples taken from different areas of the wing did not reveal any cladding. During the period of storage in the garden, the wing fragment was under a plastic tarp, surrounded by vegetation which generated humid conditions resulting in increased Al alloy corrosion. Localized corrosion had become generalized in some areas, especially at the level of the internal structure. Al alloys are highly sensitive to variations in relative humidity which produces mechanical stress and enhanced mechanical deterioration. The disappearance of the rivets due to corrosion had worsened the mechanical condition of various elements which were no longer physically held together.

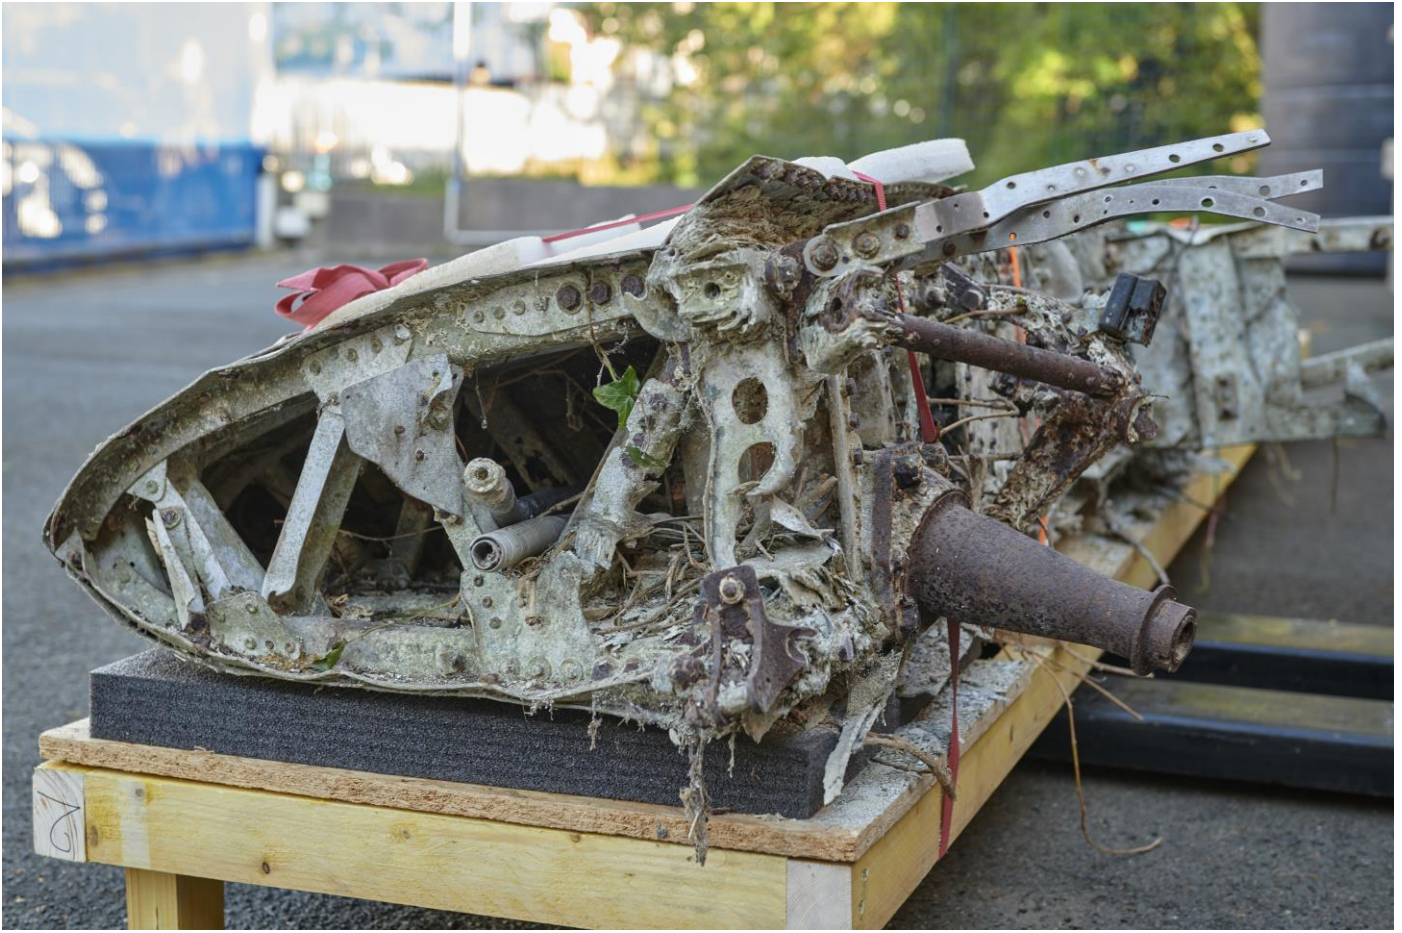
**Figure 5.** Exfoliation of the spar which caused the Al sheet to buckle.

The wing skin was in relatively good condition but required cleaning. Due to corrosion of the Duralumin, internal structure parts were in really poor condition, particularly the front spar and stringers (Figure 2). The front spar is the major structural element and this required urgent remedial conservation treatment (Figure 4d) as it had developed extensive exfoliation. Stringers needed consolidation, while some ribs that were too severely degraded had to be removed (about 10 %).

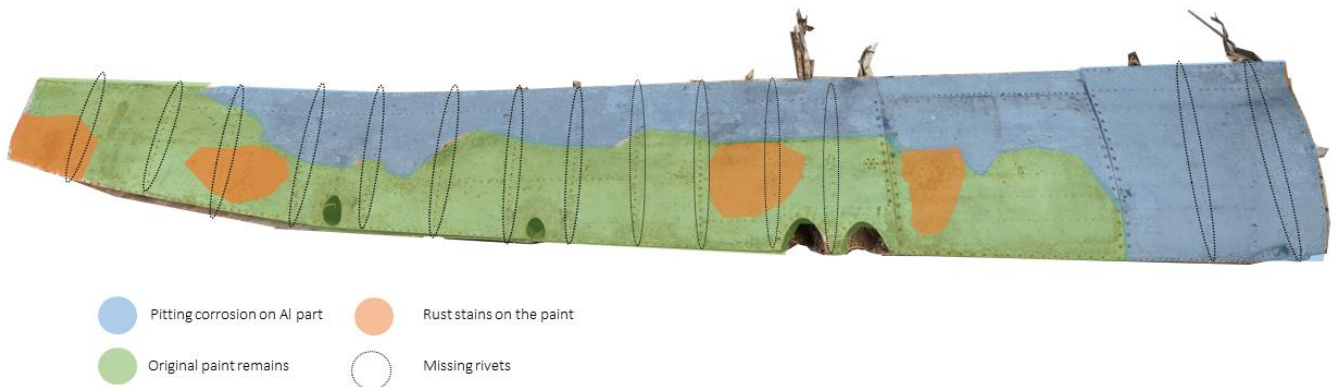
**Figure 6.** Location of various degradations on the wing fragment of the Spitfire Mk VII.

Mechanical damage due to bullet holes was visible on the side of the location of the machine guns. Most of the rivets that attached the ribs to the wing skin were missing. These Al-Cu alloy rivets are richer in Mg than Duralumin and are more susceptible to corrosion. The tank and elastomer parts do not seem to have deteriorated. The Fe bolts had resisted better and were still present. On the other hand, the presence of Fe elements had caused galvanic corrosion by accelerating the degradation of the Al alloys. The Fe elements were slightly corroded, and Fe corrosion products had caused rust stains on the surface of the wing.

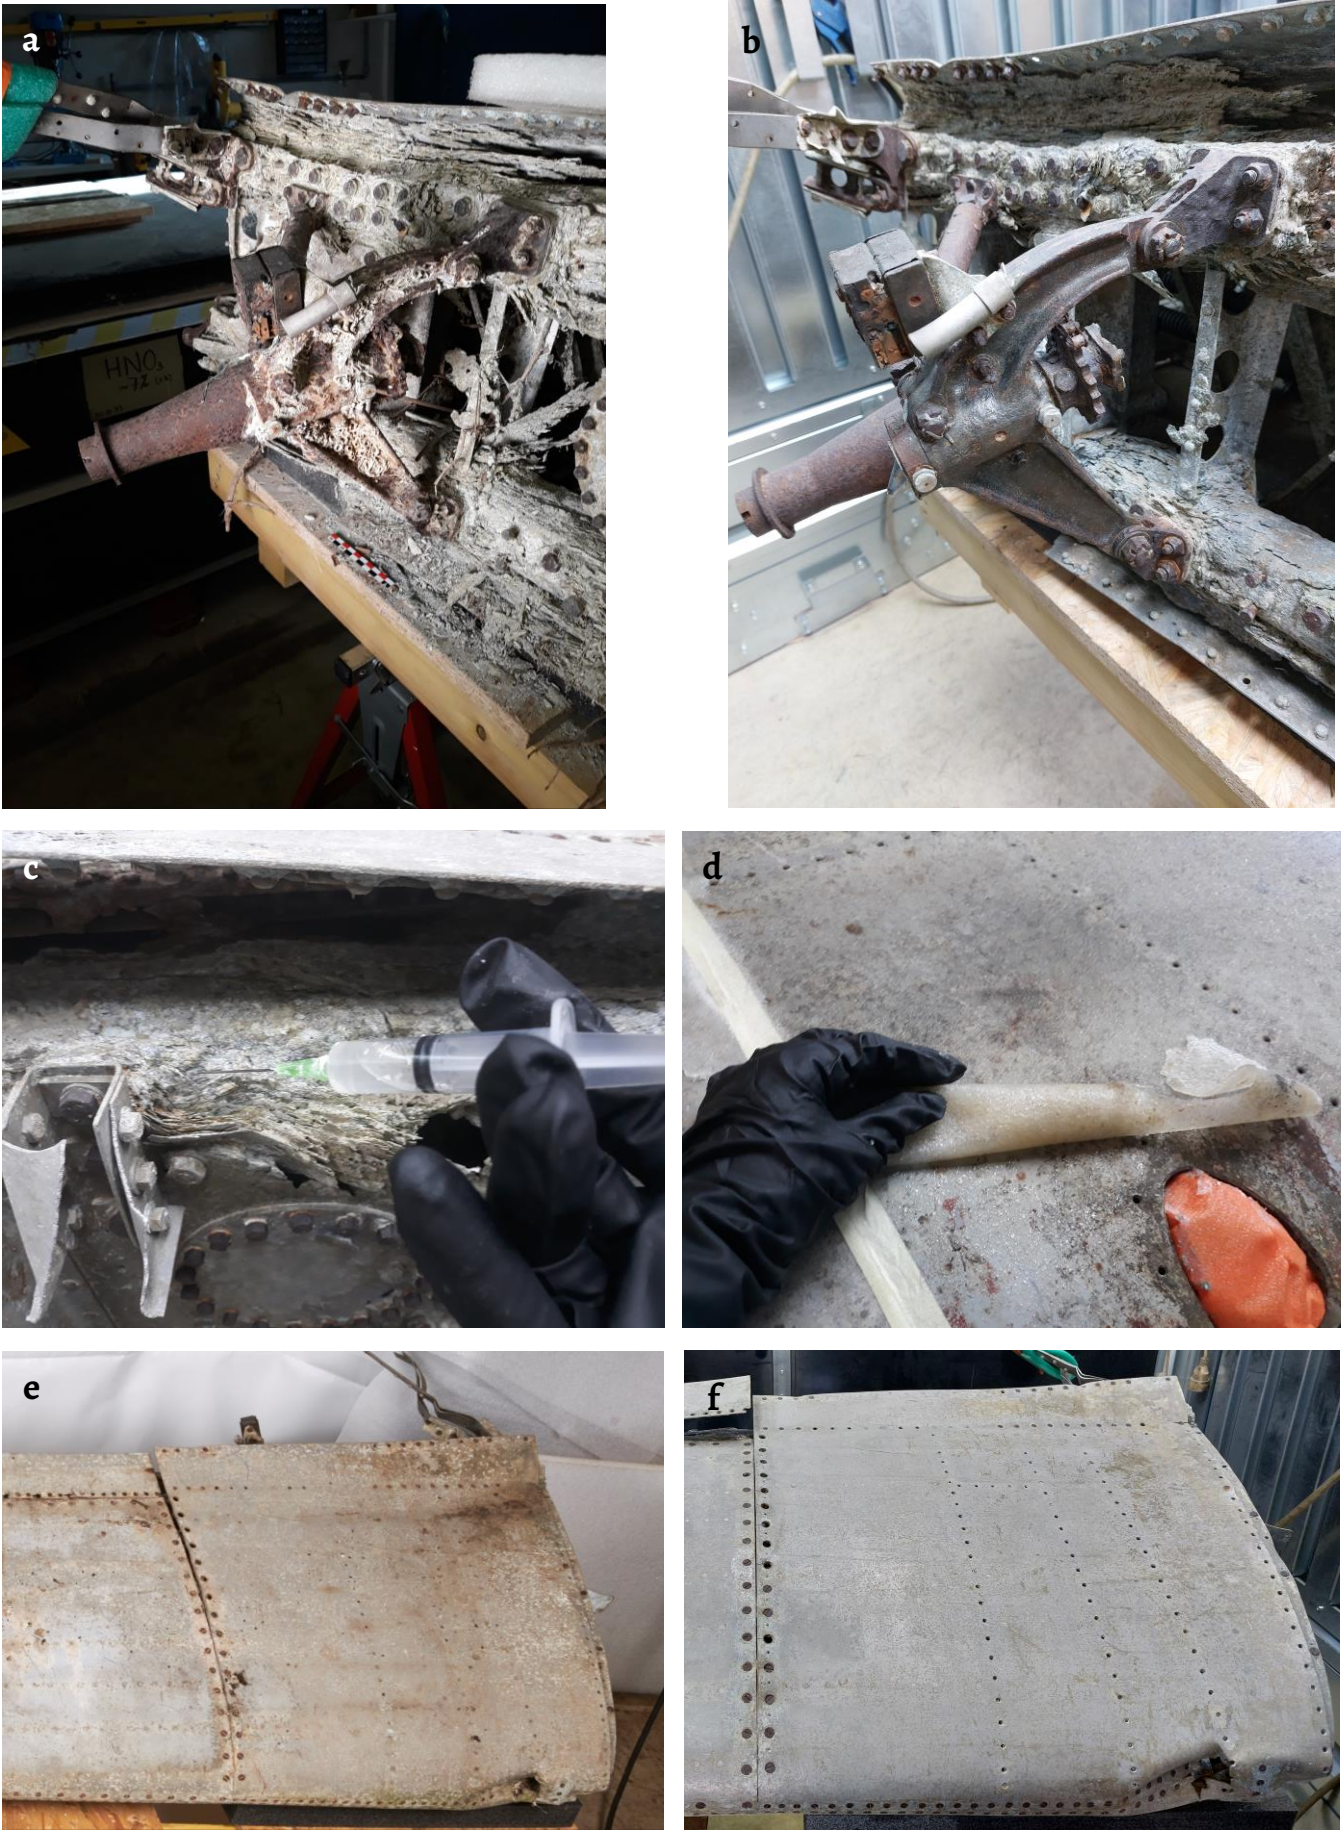
**Figure 7.** Mechanical cleaning: *a)* before; *b)* after treatment; *c)* consolidation; and chemical cleaning with TAC 5 % w/v applied with Agar gel to 3 % w/v by spray: *d)* removal of the gel; *e)* surface before cleaning; *f)* surface after cleaning.

The first step was to clean the internal area, removing any sediment, soil, sand, concretions and vegetation still present. Micro-suction enabled most of the various deposits to be extracted. After preliminary cleaning, the object gained considerably in terms of legibility. It was then necessary to consolidate the most severely damaged parts of the structure. For those parts that were exfoliating, an initial, in-depth consolidation was made with Paraloid B44 at 15 % w/v in acetone, then a second consolidation on the surface with Paraloid B44 at 30 % w/v in acetone. The front spar was lined with fiberglass using Paraloid B72 at 30 % or 60 % w/v in acetone. It was necessary to fill some of the internal parts to stabilize all the elements and restore the overall appearance of the object. Fills were made of Paraloid B72 (at 60 % or 70 % w/v in acetone) loaded with glass microspheres and pigments. Marine concretions were removed from ferrous parts by mechanical techniques, mainly with a rotation system, micro engraver or micro chisel. On structural Al alloy parts, mechanical techniques (sandblasting) were generally sufficient. The removal of concretions was finalized with a cotton compress impregnated with nitric acid at 10 % w (pH=1) for 30 seconds, then the surface was rinsed abundantly.

For the cleaning of the wing skin, which presented paint residue, aluminium corrosion products and rust stains, a first round of chemical cleaning was employed with a solution of TAC at 5 % w/v applied by Agar gel to 3 % w/v. Compared to other chemical agents, TAC was more efficient in removing dirt and was less aggressive. The gel was sprayed hot, in line with a protocol determined for application to large surfaces [19]. Three 20-minute applications were necessary to remove dirt and reduce rust stains (Figure 7). Cleaning of the wing skin was followed by blasting with vegetal abrasive to homogenize the surface.
