Return of the space hoppers: more measures on dH Comet G-BDIX

THILO BÜRCEL

National Museum of Flight, East
Fortune Airfield, Haddington,
East Lothian EH39 5LF, United
Kingdom

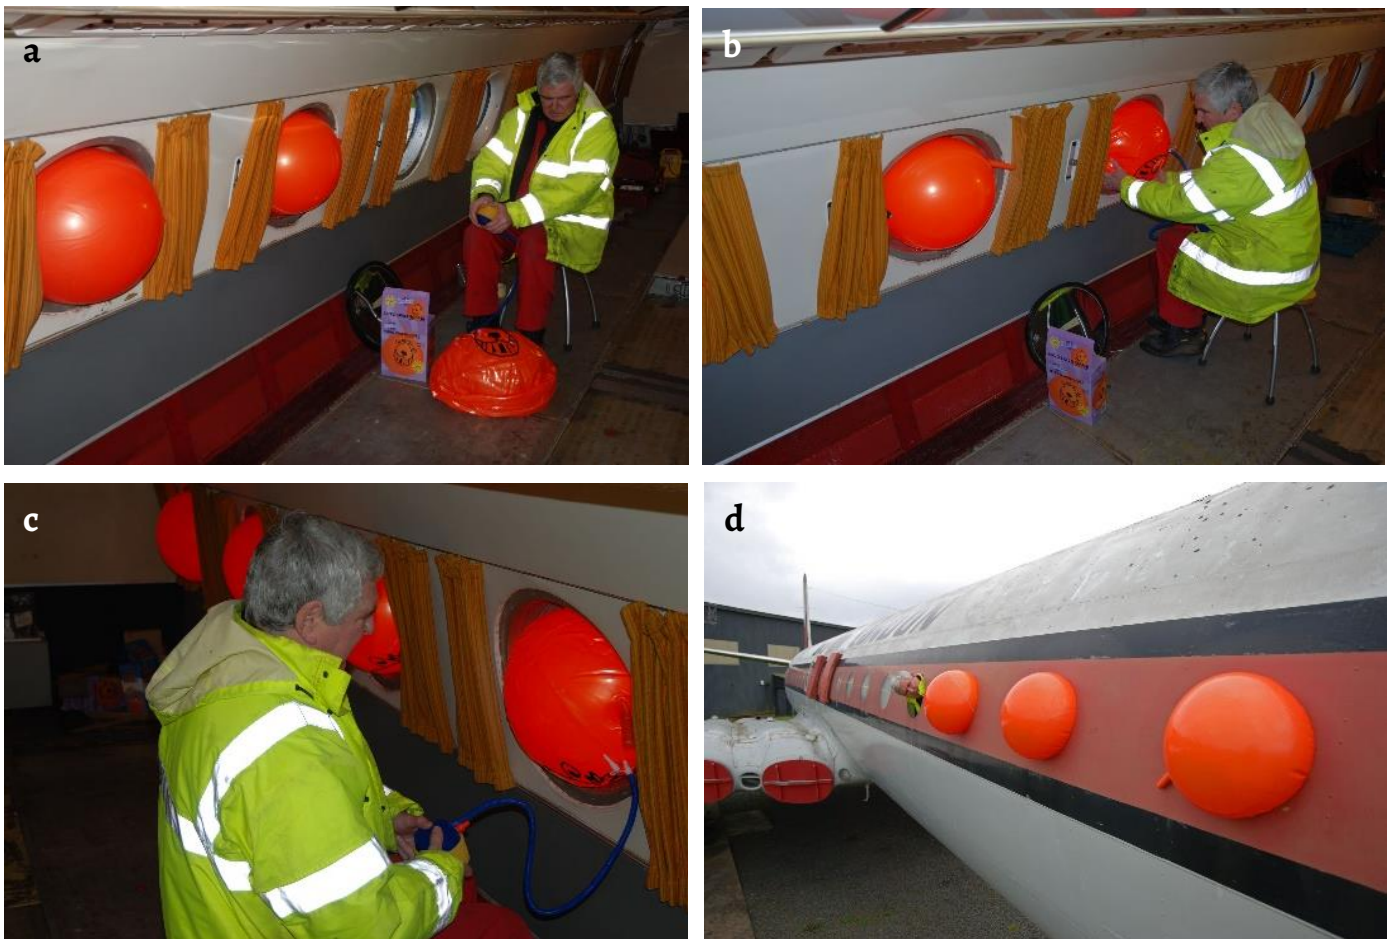
Figure 2. John and the Retro Space Hoppers: *a)* partly inflate; *b)* insert; *c)* completely inflate; *d)* check.

While exit hatches and windows were treated in the workshop, the apertures in the fuselage needed to be protected. The over-wing emergency exits were covered with blanks out of wooden frames, covered with Irish linen, cellulose nitrate dope and Plastazote foam padding. These blanks formed a good seal, even in high winds and heavy rain. For unknown reasons, that same system did not work for the passenger windows. Instead, our volunteer John suggested retro space hoppers to fill the window apertures. Ten adult-sized retro space hoppers were purchased and inserted into the open window apertures, which kept most of the rain out of the passenger cabin. As most of the interior has been removed during the project, a small leakage was acceptable. When sufficiently inflated, the space hoppers took on the shape of the oval windows, and bulges formed on the in- and outside, which prevented the space hoppers from falling out (Figure 2). Only occasionally, a space hopper was dislodged by very high winds.

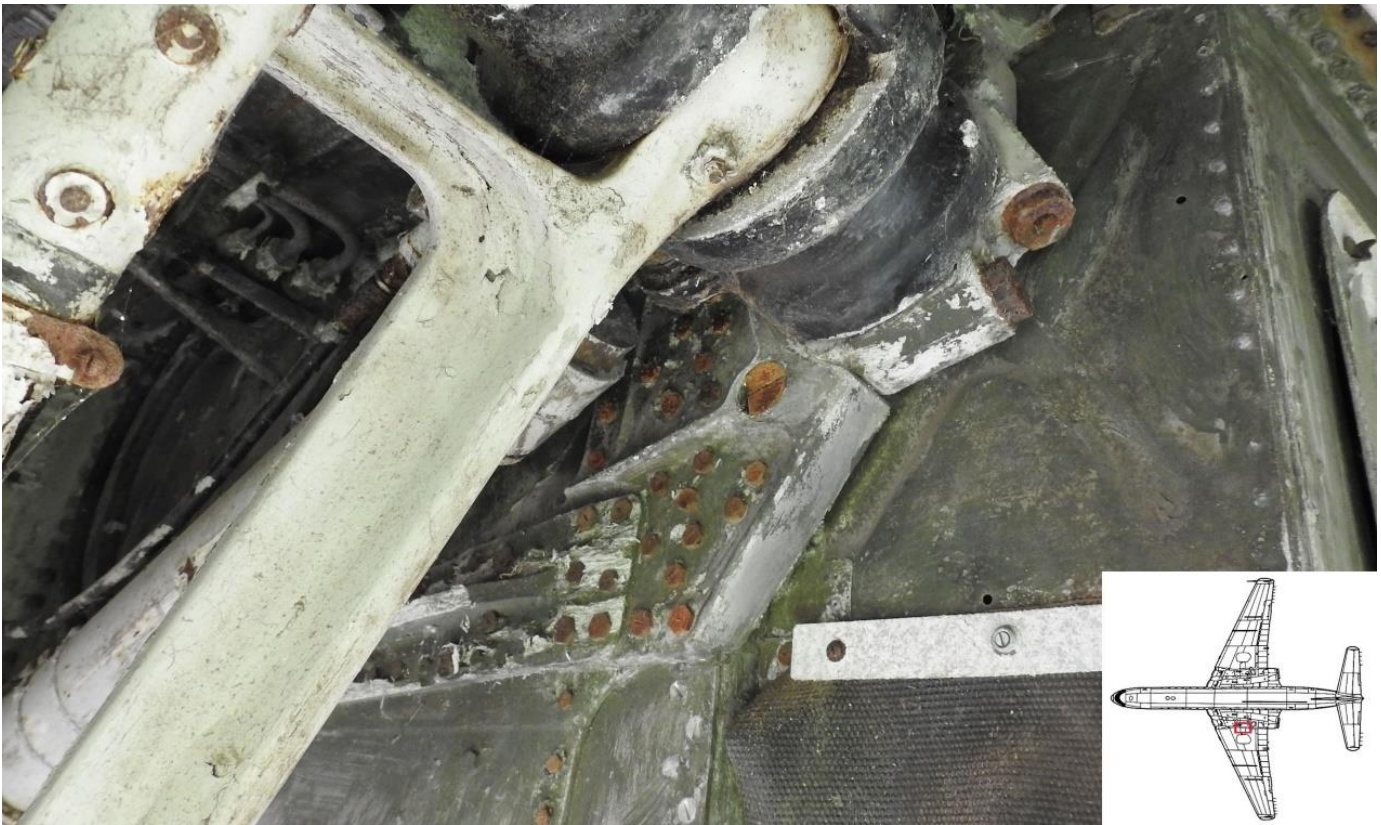
- Determining the condition of the more inaccessible but structurally important areas of the aircraft.
- Making the wings watertight.
- Treating corrosion in areas of the upper wing surfaces, on the undercarriages and undercarriage attachment points (Figure 3).
- Revisiting the measures undertaken in 2012/13 on the outside of the fuselage.

Figure 3. Corroded main undercarriage attachment point.

Areas of corrosion on the main undercarriage legs were treated by reducing the corrosion with brass wire brushes, 3M Flap Discs 769F, a coat of LAS-656 barium chromate primer and one coat of Akzonobel Aerospace Eclipse Topcoat, a two-pack polyurethane paint. Brass wire brushes reduce the risk of galvanic corrosion, as the elements copper and zinc are already existing in aluminium alloys. For the same reason 3M 769F discs were chosen, with a grain made of aluminium oxide and ceramic [10]. The use of barium chromate is essential because of its inhibitive characteristics.

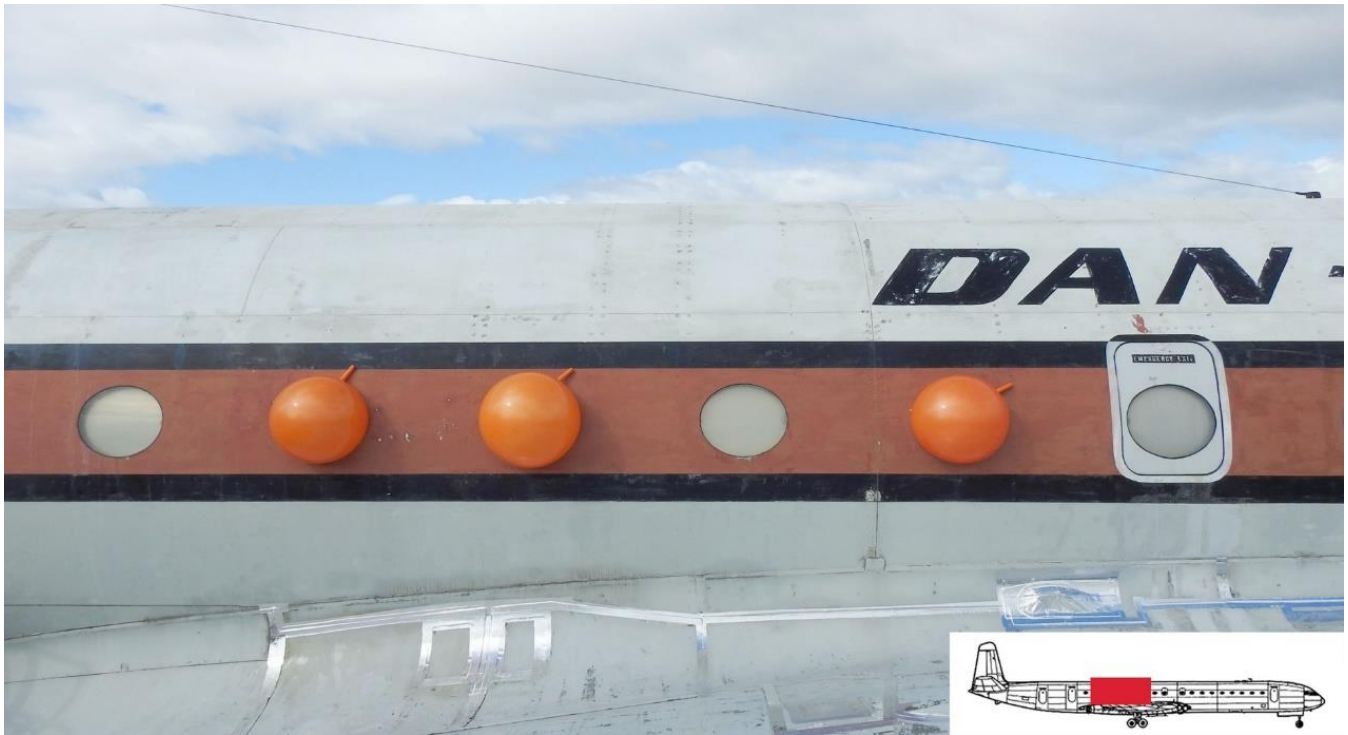
Furthermore, ten out of the 36 passenger cabin windows started to take in water again. Five of those were removed, dismantled, re-sealed and reinstalled. The acrylic sealant used during the 2012/13 project did not prove to be durable enough for this application and was therefore replaced with neutral silicone sealant Soudal Silirub LMN. Retro space hoppers were taken out of retirement to protect window apertures again while the windows were resealed (Figure 4). The procedure for the use of space hoppers, when used first time, was successful and has not been changed, please see previous section “Emergency measures”. As described, a small amount of water ingress into the passenger cabin was acceptable in 2012/13 because most of the cabin interior had been removed. Within the last two years, windows were only removed when the weather forecast did not predict any rain as the cabin interior remained in situ. Covering the openings was still essential to prevent birds, dust and direct sunlight entering the cabin, especially because of textile covered seats and carpets beneath the windows.

Figure 4. Retro Space Hoppers in window apertures.

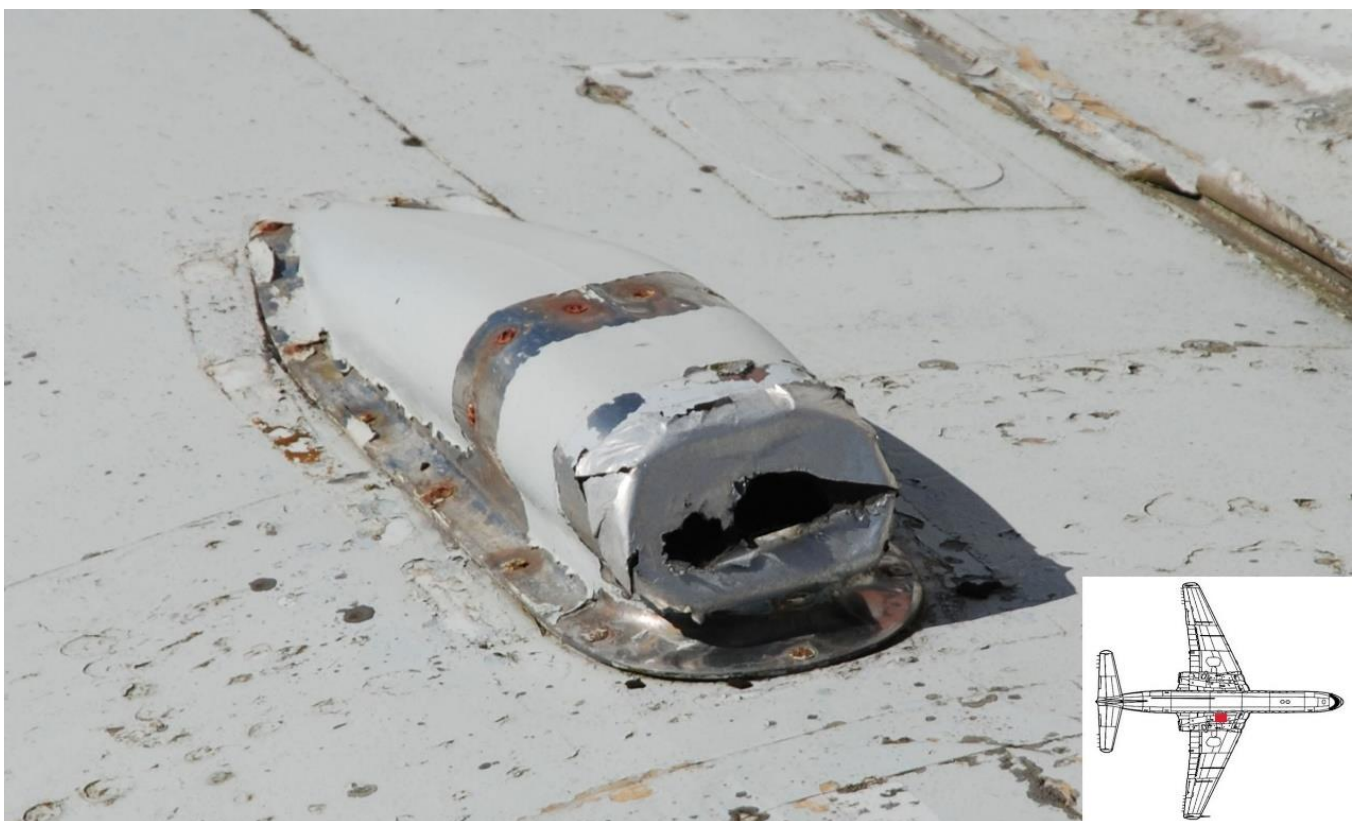
Figure 5. Failed bitumen based flashing tape from the 1990s.

Tape, which had been applied during the 1990s over gaps and openings on the wings, started to fail in many areas, partially by peeling off and partially by developing holes (Figure 5). The tape on the right-hand wing was replaced in most areas with new 3M Aluminium Foil Adhesive Tape 425. Tre Emme SPA Geko bitumen based flashing tape was applied where larger areas needed to be covered (Figure 6).

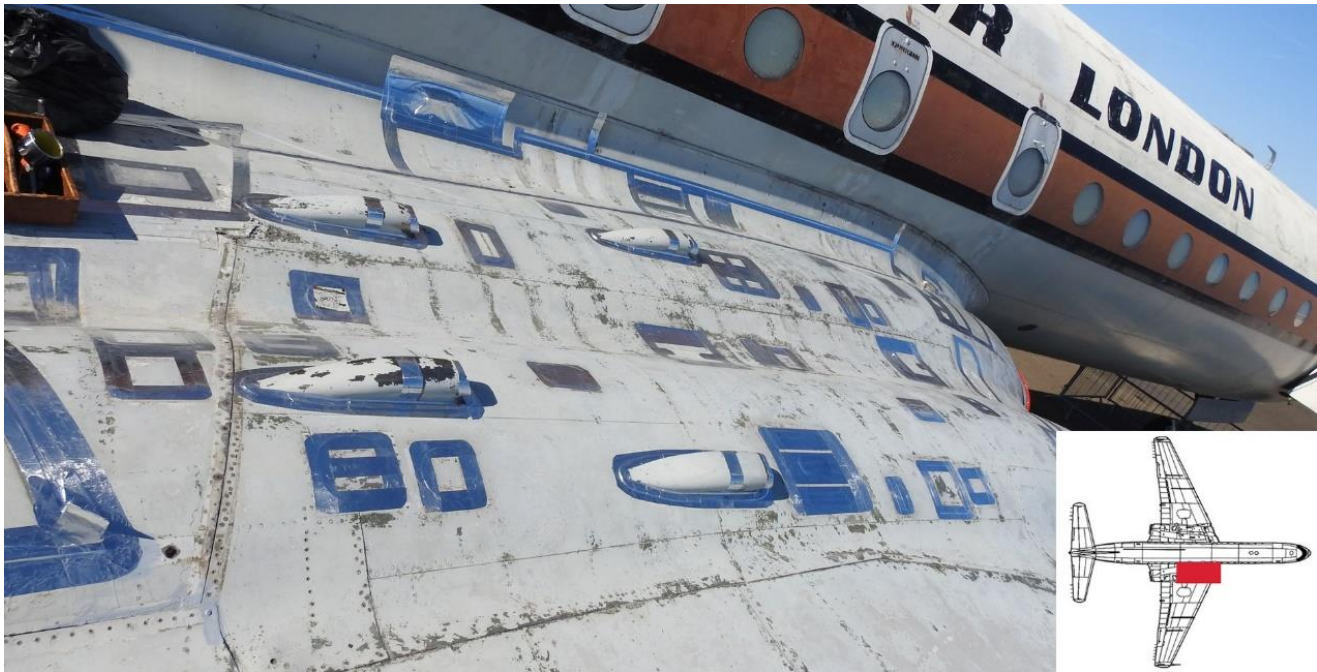
Figure 6. New bitumen based flashing and aluminium foil adhesive tape covering openings and gaps on top of the right wing.

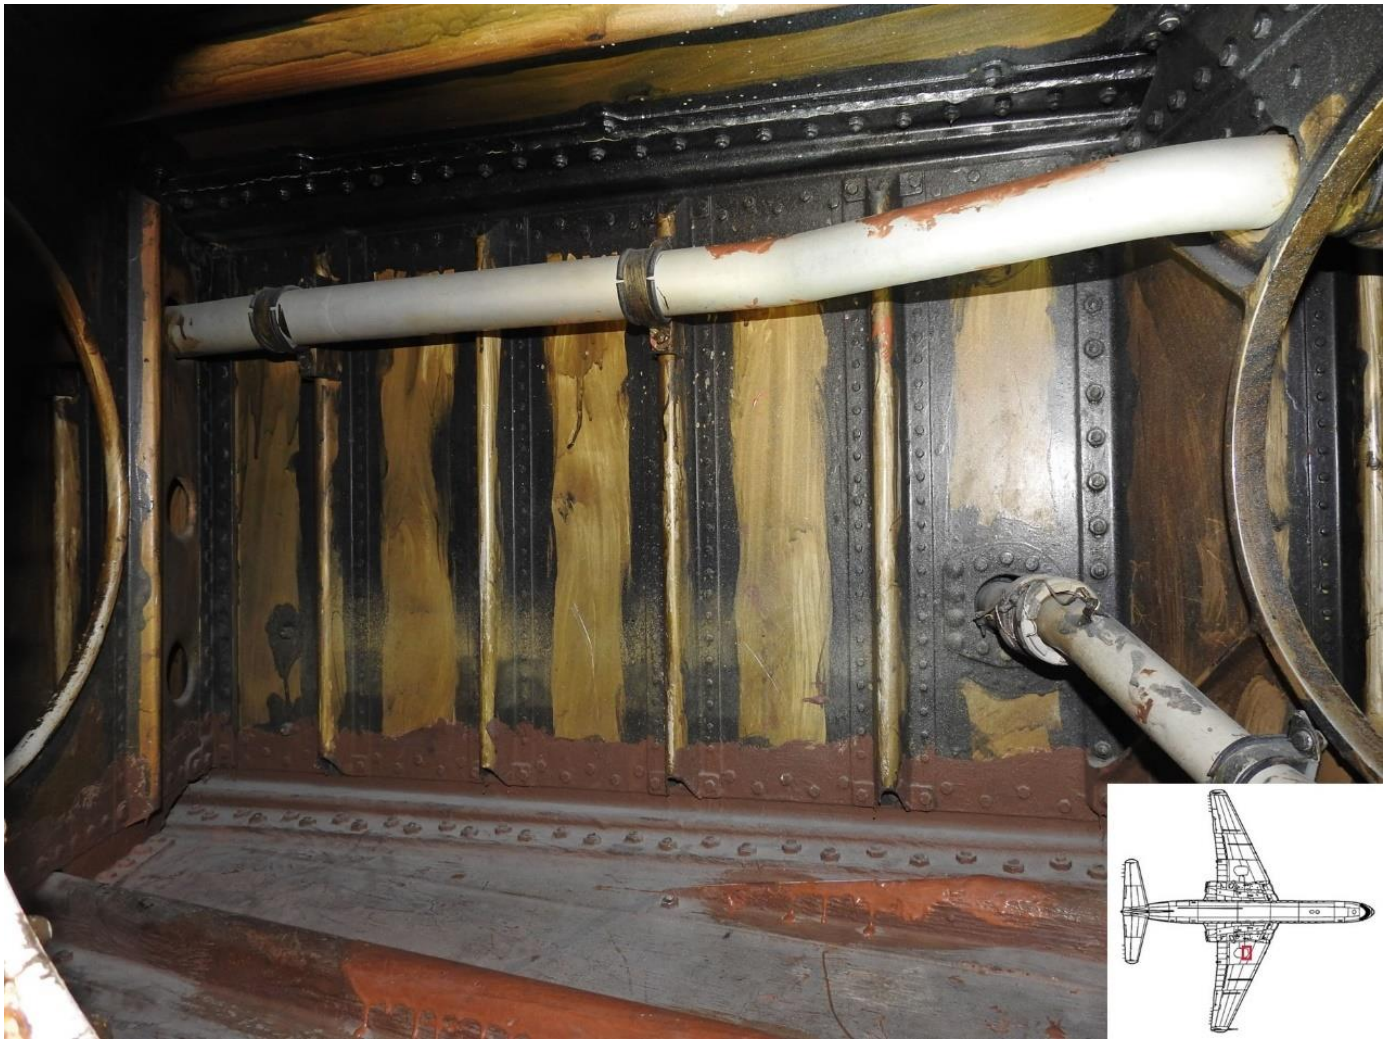
In 2013, most of dH Comet C2 XK699, a Gateguard at the Royal Air Force base at Lyneham, had to be scrapped due to high levels of corrosion [9]. To determine whether the work that is being carried out on “our” Comet is worthwhile, more inaccessible areas of the aircraft were inspected. Hatches were opened which provide access to the main spars of the wings to ensure their structural integrity. The front main spars did not show any signs of corrosion (Figure 7). At a later stage, lining in the luggage holds was removed to inspect the structural integrity of the lower fuselage. Only a small amount of surface corrosion was found.

Figure 7. View of the right front main spar.

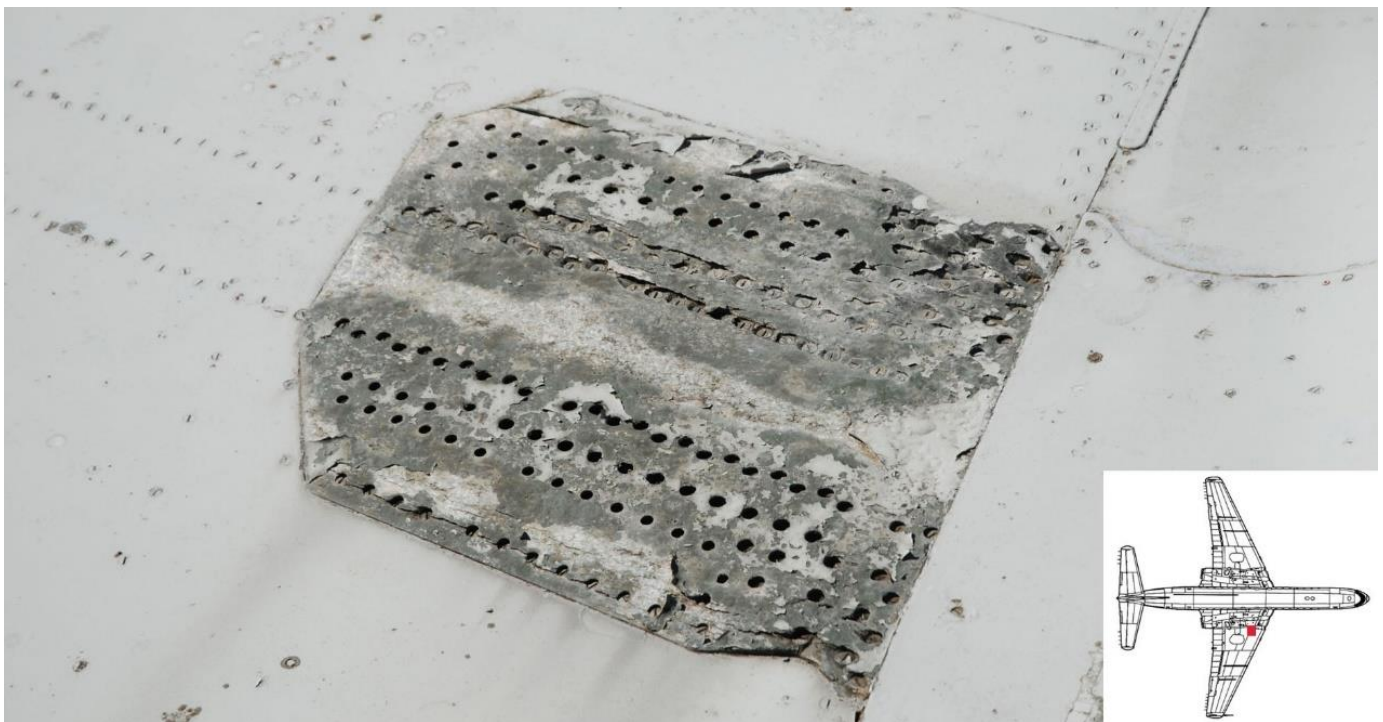
On top of the wings are reinforcing panels made of magnesium alloy. Those panels suffer from severe exfoliation corrosion (Figure 8). The corroded layers will be mechanically removed. The remaining panel will be inhibited with barium chromate primer and painted.

Figure 8. Severe exfoliation corrosion on magnesium alloy panel.

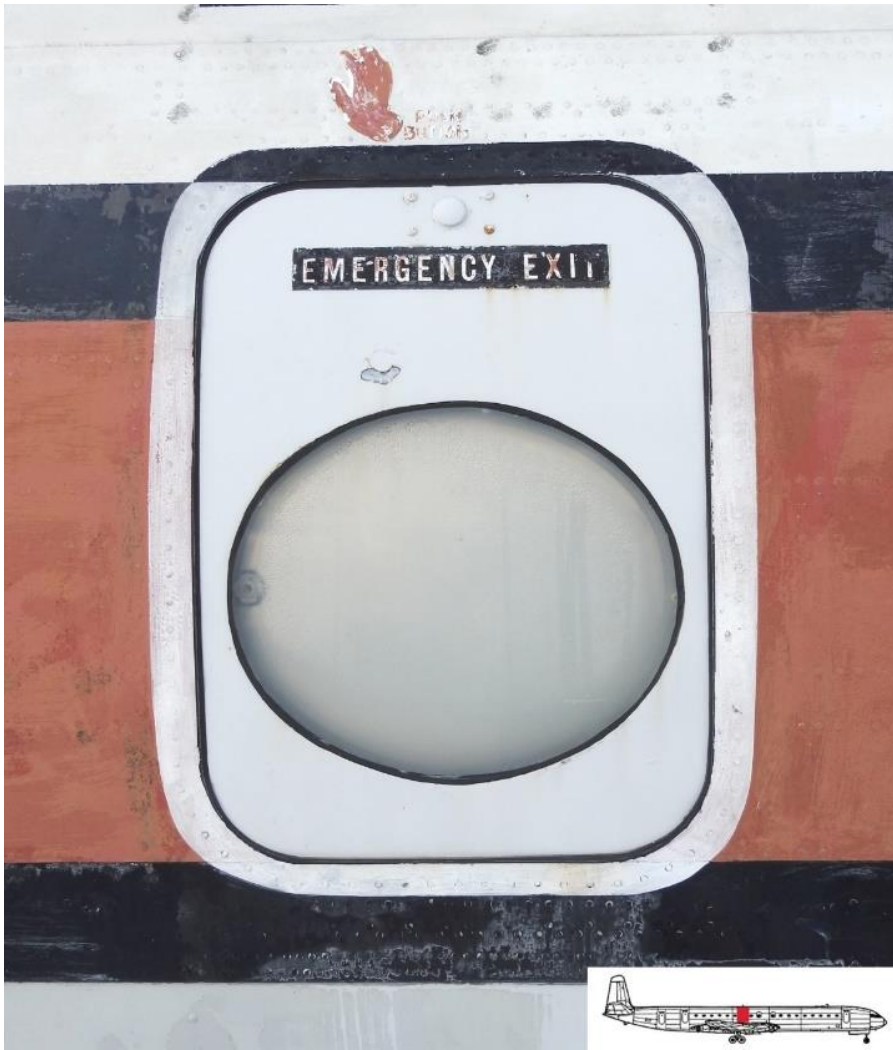
The over-wing emergency exit hatches started to corrode again (Figure 9). The corrosion will be ground out with a rotary tool and the holes filled with aluminium epoxy putty. In 2012/13 there was only grey aviation grade paint available. This time, the hatches will be repainted with Akzonobel Aerospace Eclipse Topcoat in their correct red and black colours.

Figure 9. Recurrent corrosion on emergency exit window.
