Replacement of cast iron piers on an 1886 wrought iron truss bridge in New South Wales, Australia – the challenge of preserving heritage significance during major rehabilitation work

Introduction

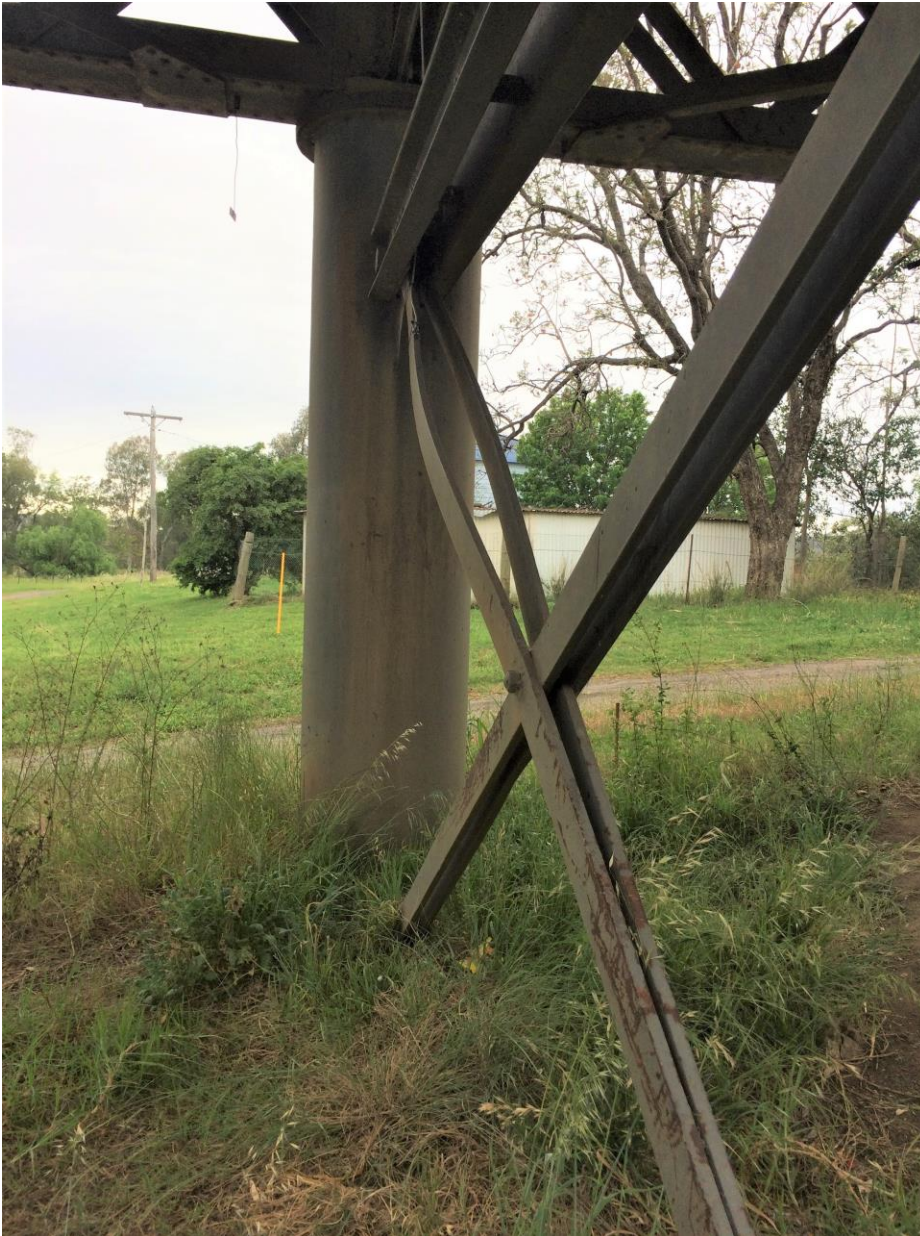
Figure 3. Buckled metal brace, Pier 1 (photo: C. Everett, 2017).

Maintenance records for the bridge only date back to 1949. A routine inspection of the bridge at that time reported settlement in Piers 1 to 4 and cracking at Piers 1 and 3. Repairs were suggested in the report but were never undertaken. Over the following decades inspection records reported distortion of the metal bracing (Figure 3) as well as additional cracks forming in the pier columns (Figure 4).

- Piers 1-5 be underpinned;
- Damaged braces and connections be repaired or replaced;
- All bearings on the approach span piers (1-5) be reset to level.

The horizontal bracing was replaced with the equivalent metric steel section (250 Parallel Flange Channel) and the diagonal bracing was machined from new steel plate to retain the geometrical features of the original elements. All bracing was connected to the new steel columns via new fabricated steel lugs and custom bolts used for connections to replicate original detailing. The new lugs were constructed from 50 mm steel plate and connected to the steel column via a large radius weld to provide visual similarity to the original casting process. The new pier columns replicated the above features to the greatest possible extent but on close inspection can be differentiated from the original design visible in the remaining original Pier 1 (Figure 6).

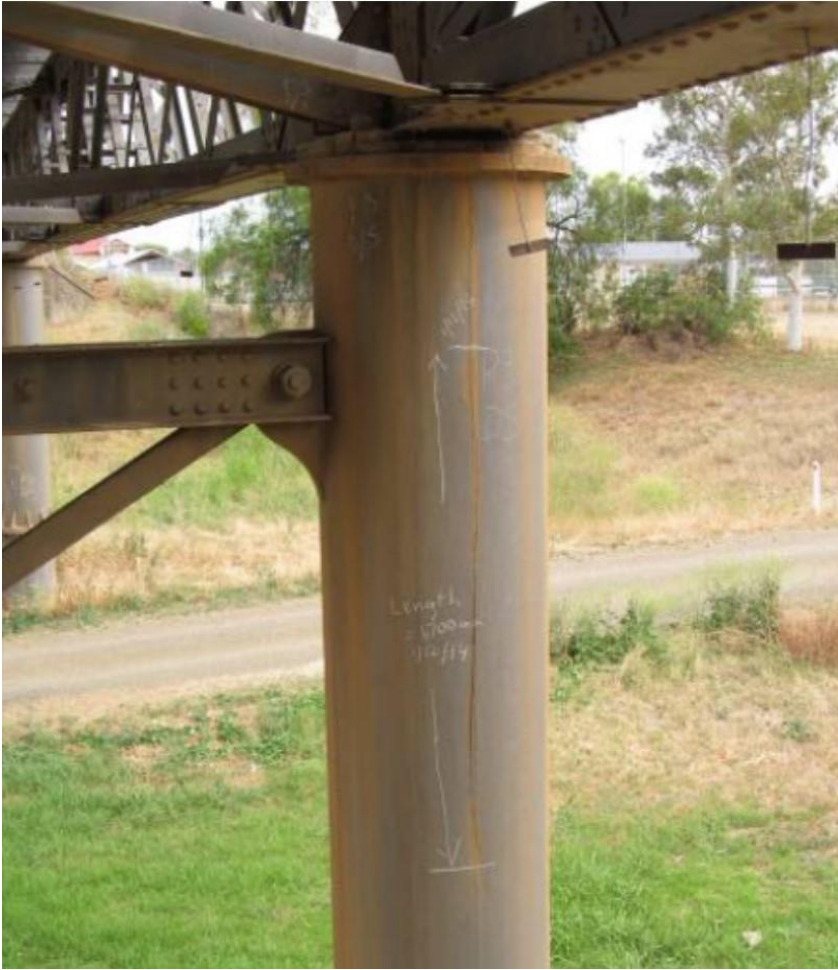
Figure 4. Crack in Pier 3 column (photo: C. Everett, 2017).

It became apparent that these additional cracks as well as the cracks identified previously meant the piers were no longer strong enough to support the load of the spans above and that additional cracks were likely to form. An immediate load limit was applied on the bridge and temporary supports installed at each pier.

As the damaged piers could not be repaired, four options were considered to address the cracking and allow the bridge to function free of the temporary support system. The options included iterations of individual element replacement through to full replacement of all pier columns and bracing. It was determined that full pier replacement would produce the best project outcome, noting that all other options, whilst retaining greater quantities of original fabric, would result in higher and avoidable permanent structural risk and would also not permit restoration of the bridge's original vertical alignment. Pier 1 was undamaged and did not require replacement.

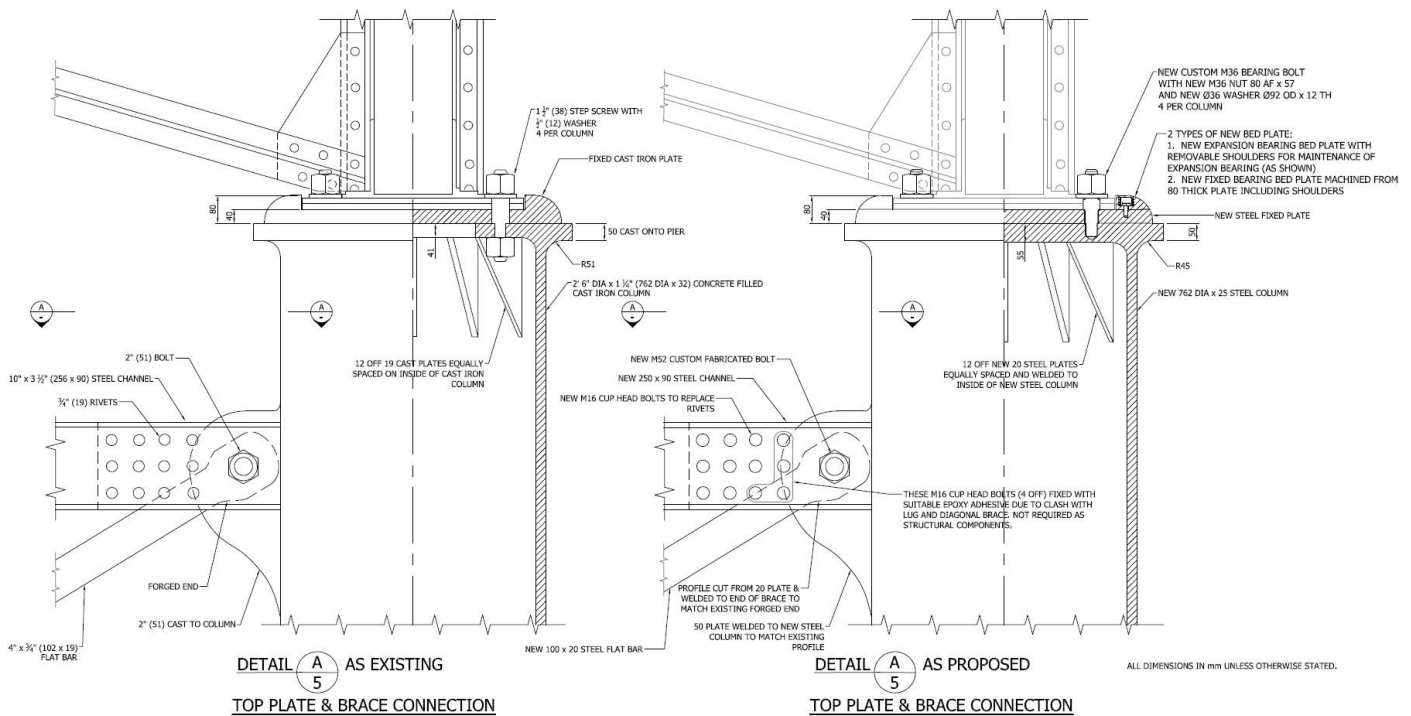
Figure 5. Comparison between original and new pier column top detailing [5].

The original top plates were cast with the pier columns with a casting radius of 45 mm between the top plate and the column wall. The new top plates were machined from a single piece of 100 mm thick steel plate to allow this detail to be retained, with the arrangement then welded atop the new steel tube sections. The hole in the top plate was removed to allow the new column segments to be hermetically sealed to prevent internal corrosion.

The guide plate was replaced with a new steel plate with 40 mm thick shoulders to guide the articulation of the bottom chord. The expansion bearings require periodic maintenance to remove dirt, debris and install additional grease, so the shoulder section of each plate was made removable to allow better access ([Figure 5](#)).

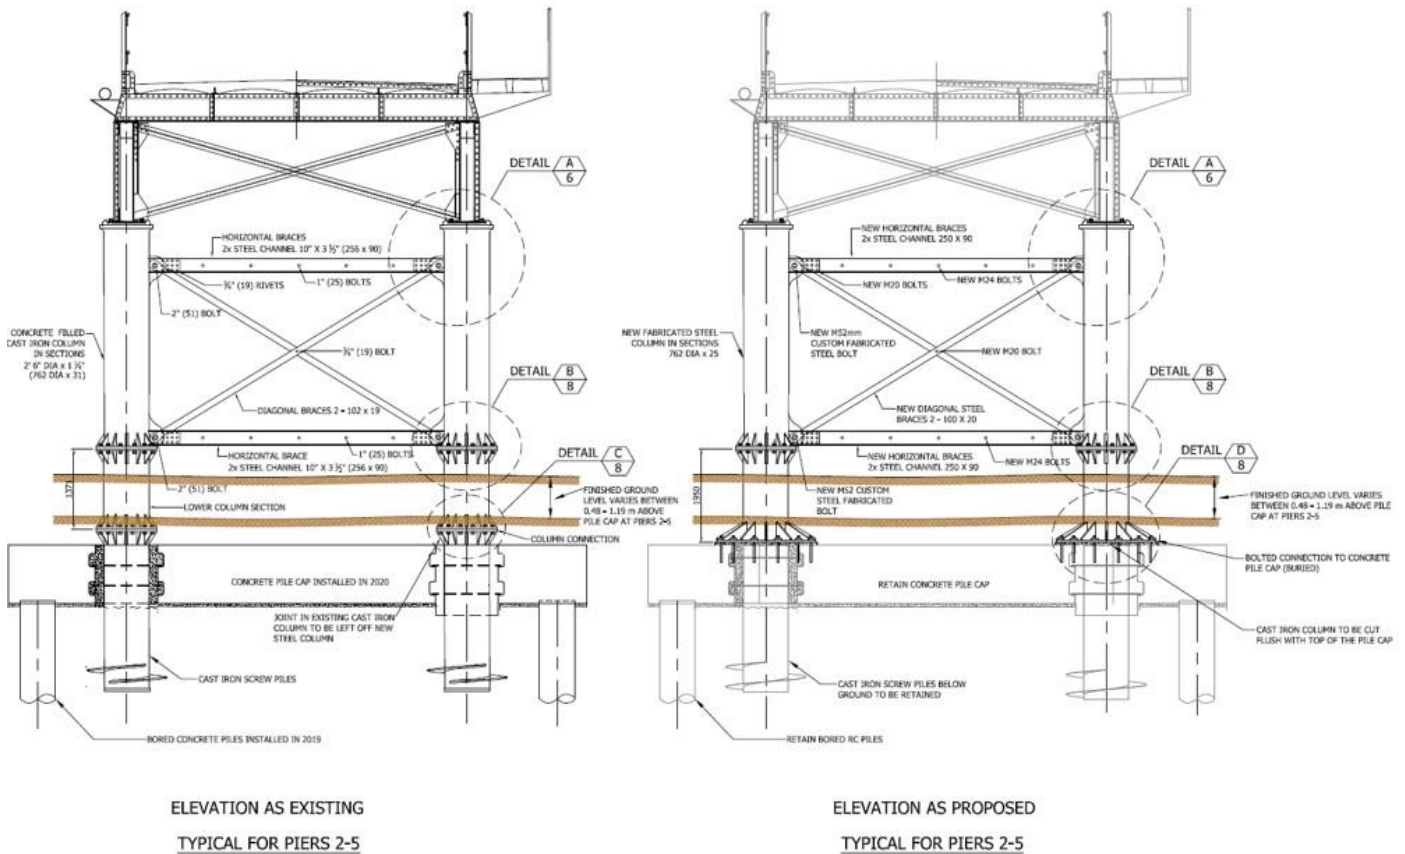
Figure 6. Design of original piers vs new [5].

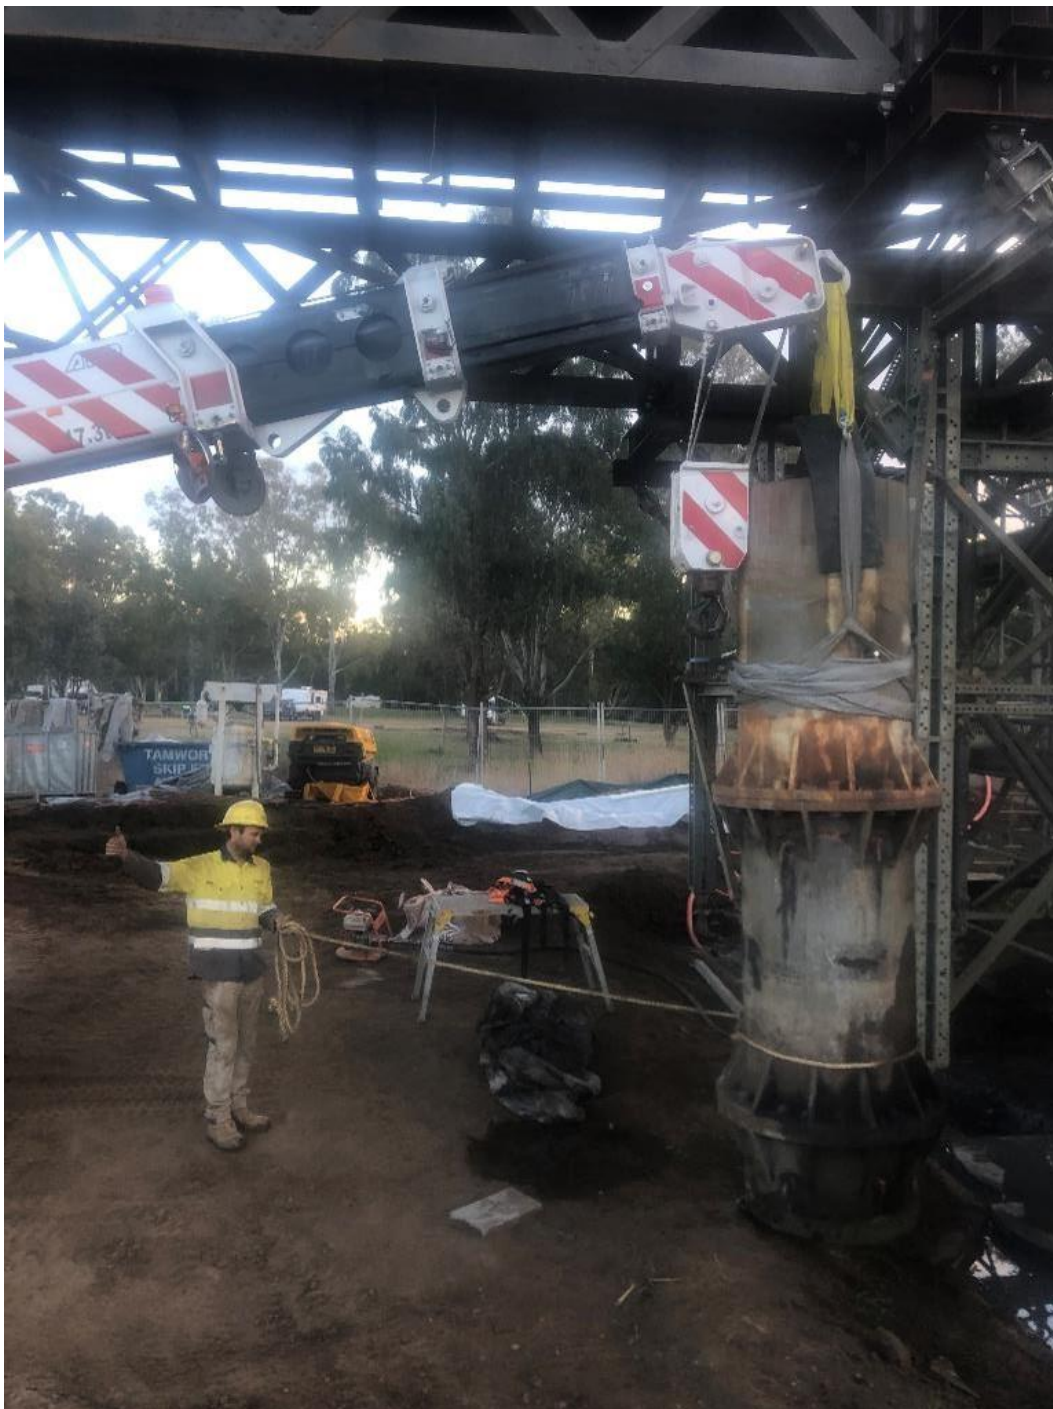
Figure 7. Pier removal using mobile crane (photo: A. Rosnell, 2021).

These physical constraints resulted in diamond wire sawing being selected to separate the piers into three sections for removal. Steel bars were installed to provide fixity between the cast iron column wall and the mass concrete infill, after which each column was cut into three sections and extracted by either a 24 t excavator with a hydraulic grab or mobile crane (Figure 7), with the place selection based on the mass of each section and available working room.

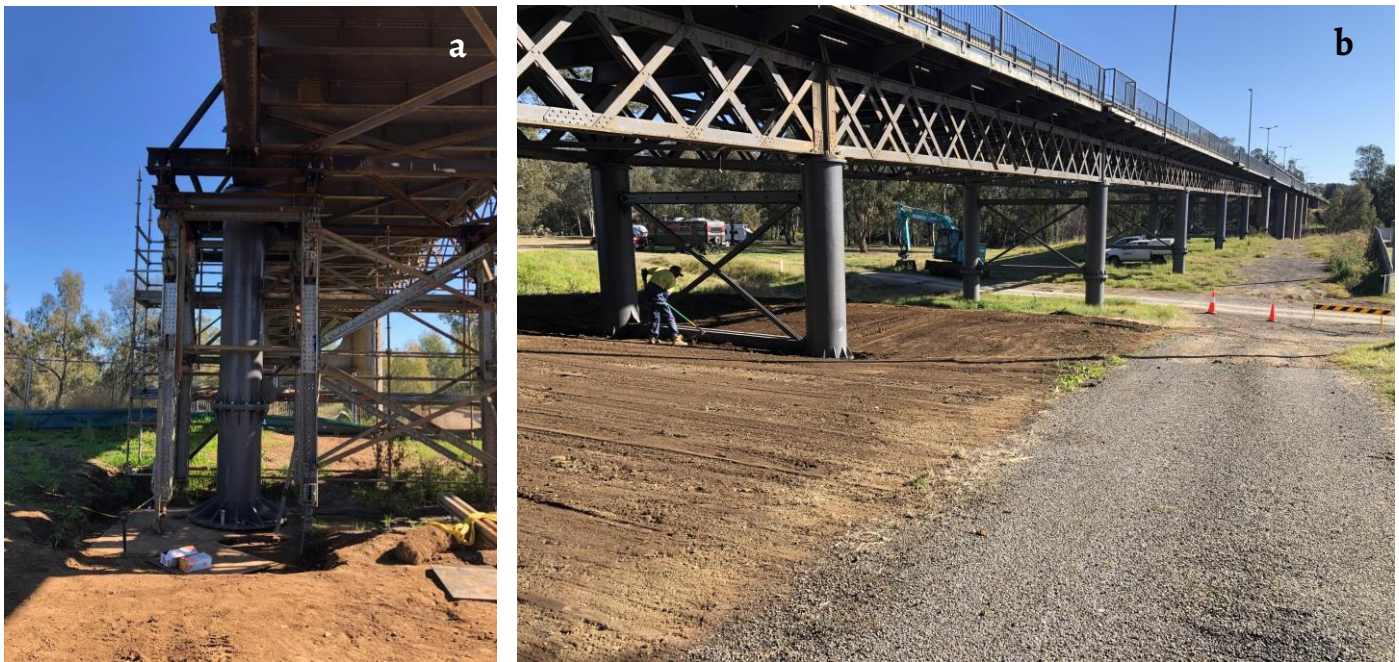
Figure 8. Bridge: a) completed column; b) new piers in place (photos: A. Rosnell, 2021).

The new piers were installed under strict dimensional tolerances to ensure that they would perfectly mate with the existing bridge at its restored vertical alignment. The piers were fabricated off-site and installed using a mobile crane (Figure 8a). New chemical anchors were match-drilled into the reinforced concrete pile cap, with the finishing touches including grouting under the new column base plates and patch painting of all field connections. The bridge was then lowered onto the new column top plates using a reversal of the jacking operation, thereby rendering the new piers functional and allowing the temporary support system to be removed (Figure 8b).
