A study of timber frame repair and the case of Gunns Mill's old blast furnace

The case study of Gunns Mill

Current condition and brief survey on timberwork

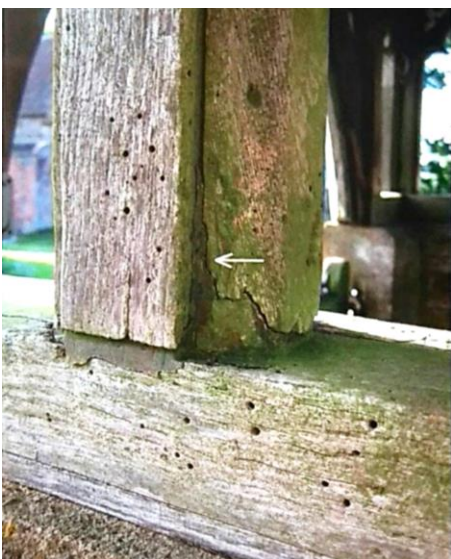
Figure 3. The white arrow points out the location of crack which indicates that the bond between resin and the decaying end grain of the timber was not strong, failure because of poor design [2, p. 318].

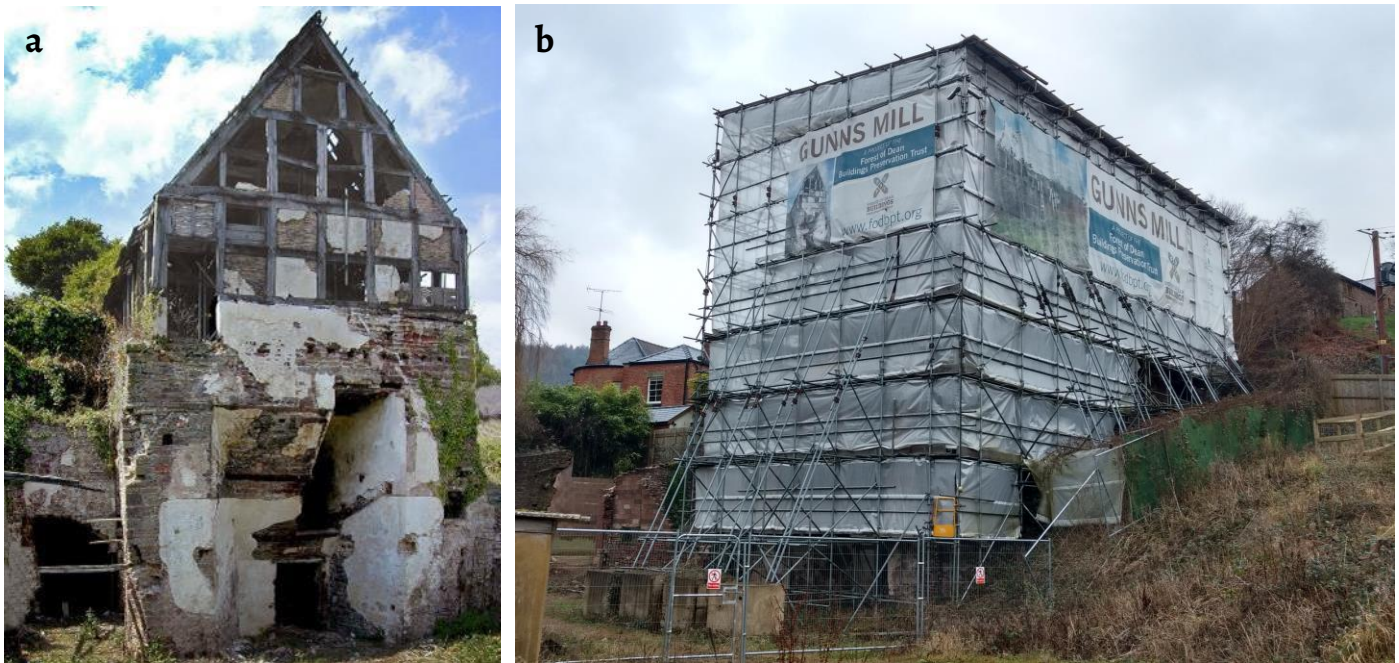
Figure 6. Gunns Mill: *a*) in the 1990s [24]; *b*) current state, view from Southeast (2017).

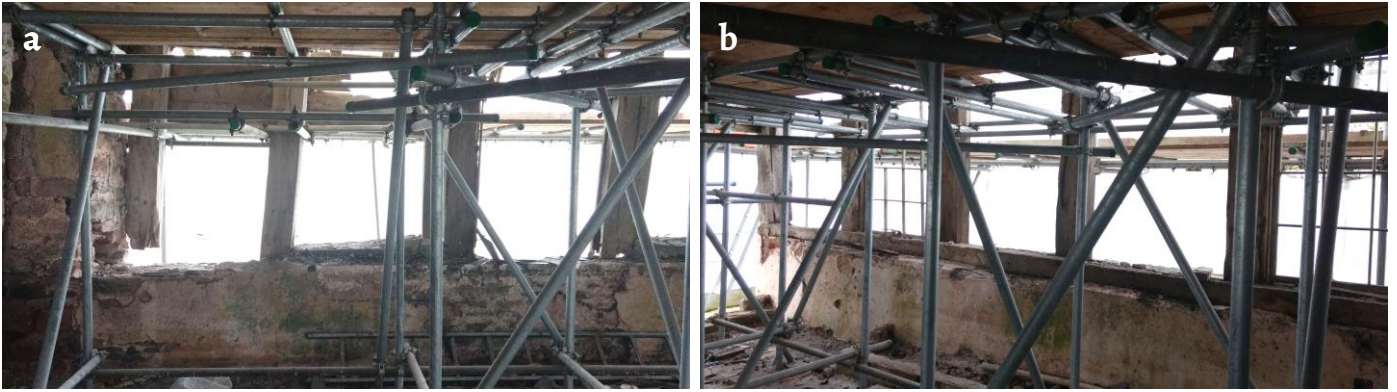
In summary, the east wall of the Charge House is leant because of many issues: failure of masonry underneath, movement of decayed roof, possible lateral force below floor level in the anticipated destabilized fill, also as an effect in the east drying loft wall is leant too. The roof structure and east wall of drying loft decayed severely because of lack of covering. It requires complex in situ repairs (Figure 7) [22].

Figure 7. Drying loft: a) East wall; b) West wall (2017).

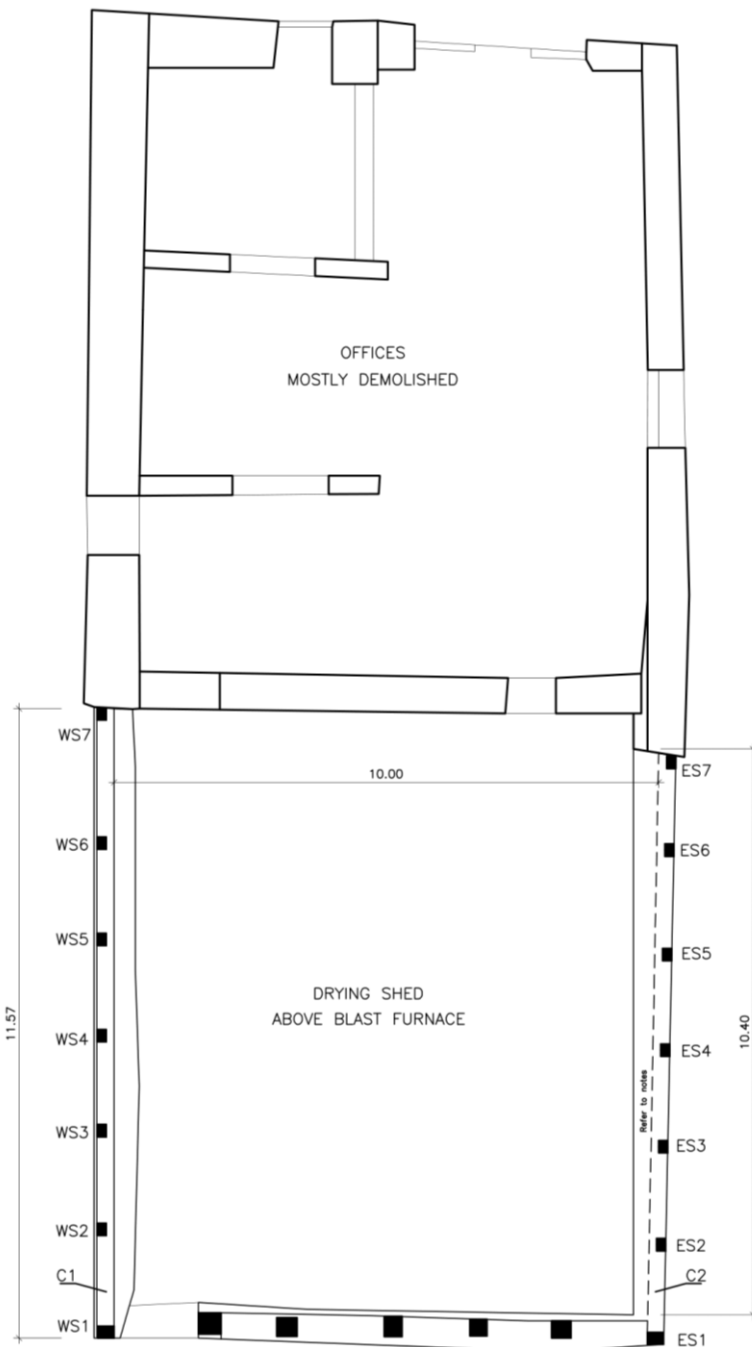
Figure 8. This is the construction of the timber frame over the blast furnace in c.1740 [27]. The sill plate on the east side has almost disappeared because of decay. ESY stands for East Wall Stud “Y”; WSX stand for west wall Stud “X”, C1 West sill plate and C2 East sill plate.

- Sill plates: The complete replacement of the east sill plate is necessary as it is nearly non-existent. Additionally, repairs to the plinth wall are required. These repairs should be performed according to the scheme outlined on page 10. On the west side, partial replacement is necessary, as some parts of the timber are sound. The repairs should follow the scheme on page 10. On the west wall, traditional methods, such as re-pegging, should be used to regenerate joints where necessary. On the east wall, new scarfs joints should be re-joined to the new sill plate.

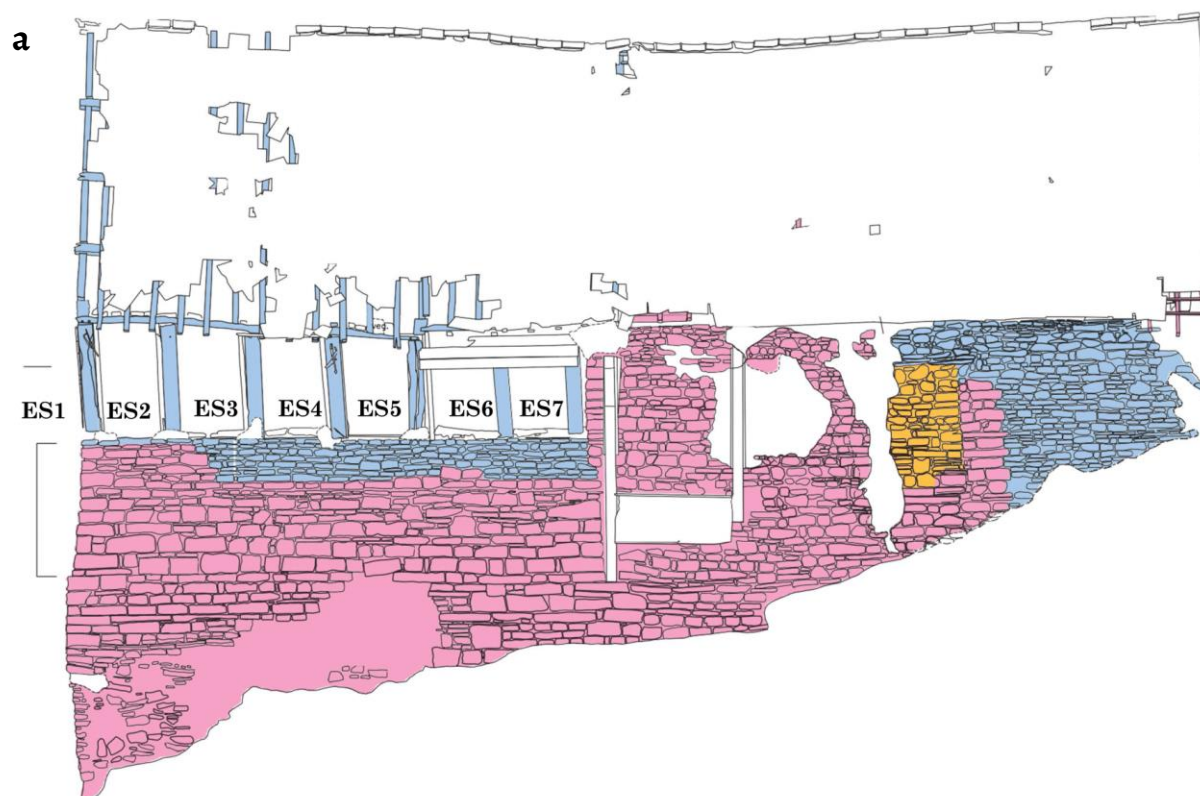
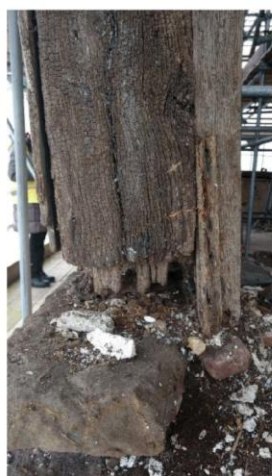
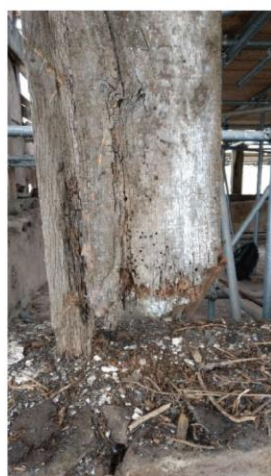
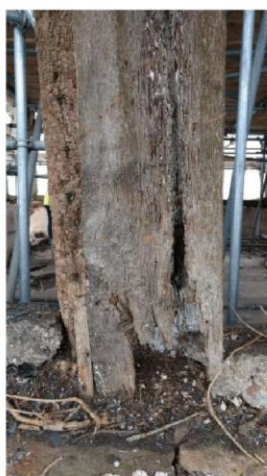
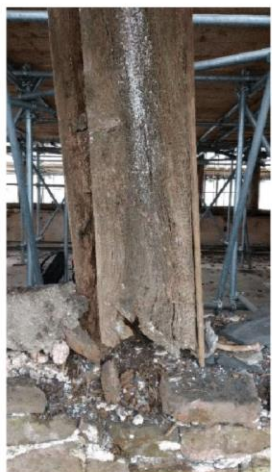
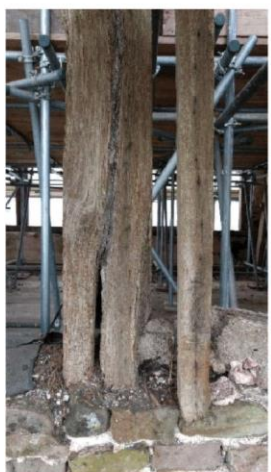
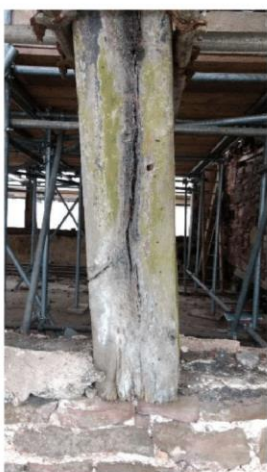
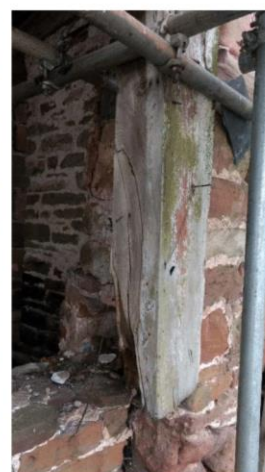
Figure 9. Detailed survey of the East elevation: a) Localization scheme of the East wall studs, and b) Individual stud details (2017).

- Studs: On the east wall, new scarfed joints will be added to the bottom part of all seven studs.
- Decay and infestation: The west wall shows signs of beetle attack and woodworm, for instance, refer to west stud 01. However, these attacks are likely to be historic, as they are dark and dirty and there are many spider webs nearby. The beetles are likely to have been killed by predators, so there is no cause for concern as they are inactive.

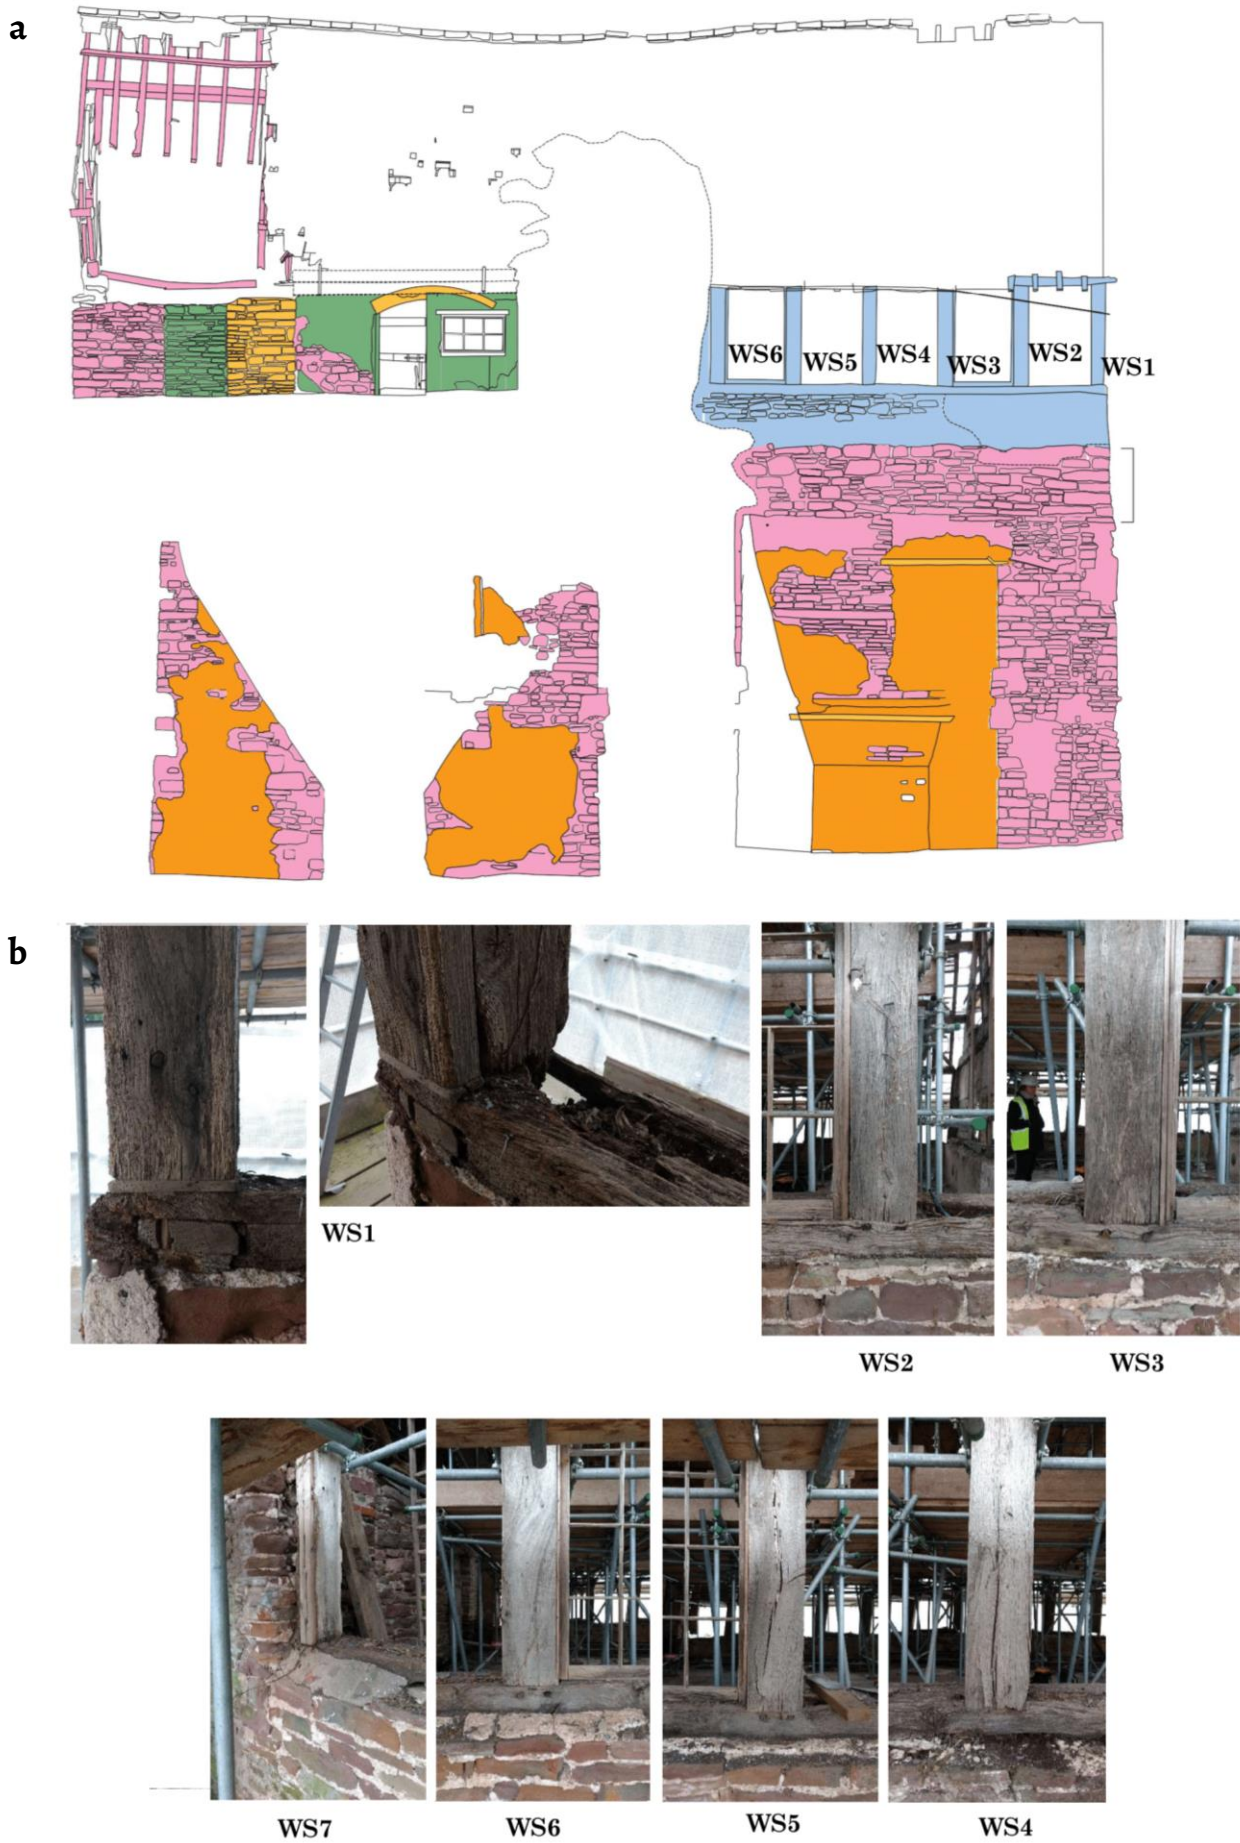
Figure 10. Detailed survey of the West elevation: *a*) Localization scheme of the West wall studs, and *b*) Individual stud details (2017).
