Characterization of early 20th-century German bandstands metal alloys exposed to the Amazonian weathering of Belém, Brazil

THAINÁ THAIS SILVA
OLIVEIRA ^{1*}

Abstract

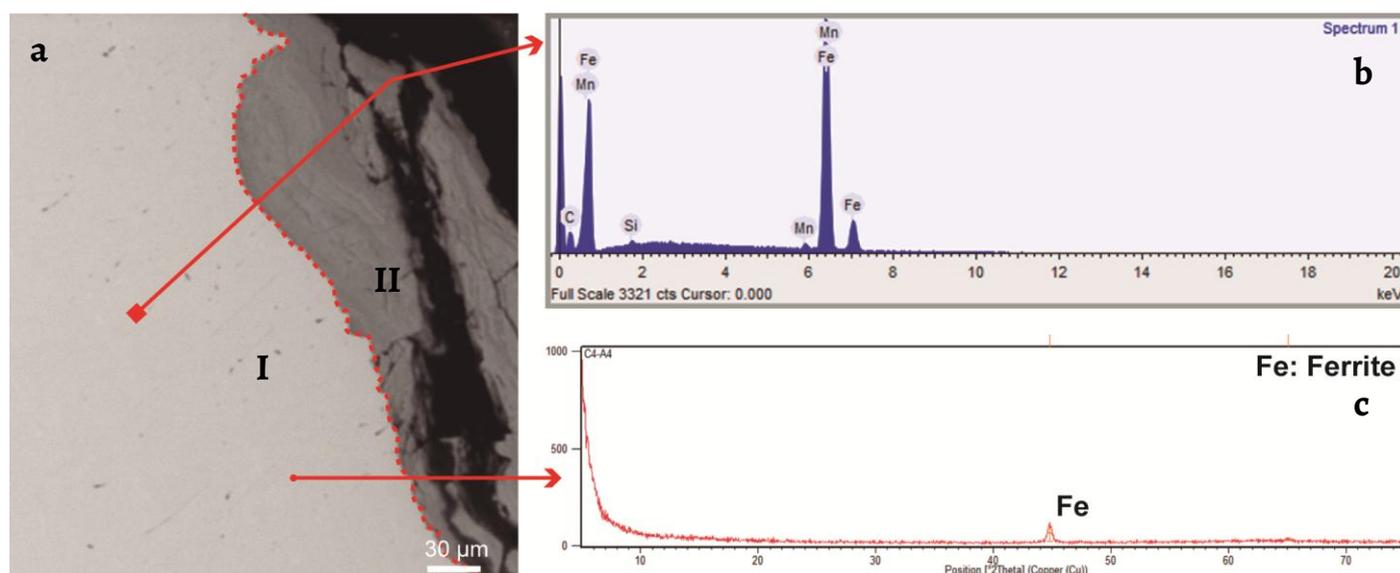
The EDS spectra confirmed that the chemical composition of the unaltered metal is primarily iron. Some points also revealed smaller amounts of other elements such as carbon, manganese, silicon, sulfur, and phosphorus ([Figure 3](#)). The diffractogram in [Figure 3](#) supports these findings, pointing ferrite (α -Fe, pure iron) as the predominant mineral phase [\[15\]](#). Additionally, the B3-A3 sample exhibited an extremely low copper peak in its mineralogical composition. The only exception was in sample 1D-A4, where only zinc was identified by XRD ([Figure 4](#)).

Figure 3. Sample B4-A4: *a)* SEM image indicating the boundary between the I) uncorroded metallic substrate and II) corrosion product layer; *b)* EDS spectrum; *c)* X-ray diffractogram, showing its chemical and mineralogical characterization.

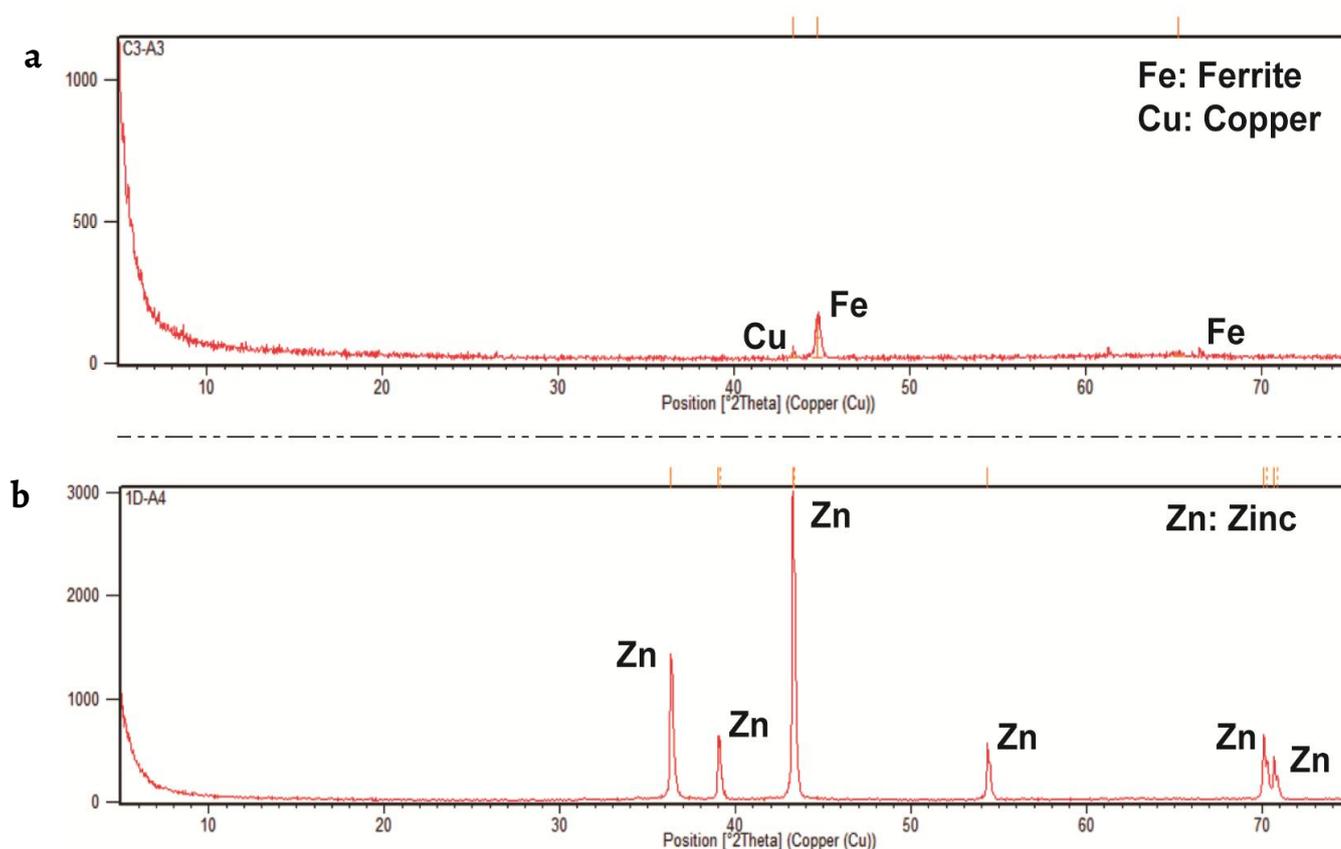
Figure 4. X-ray diffractograms: *a)* sample B3-A3 showing Fe and Cu; *b)* sample 1D-A4 showing Zn.

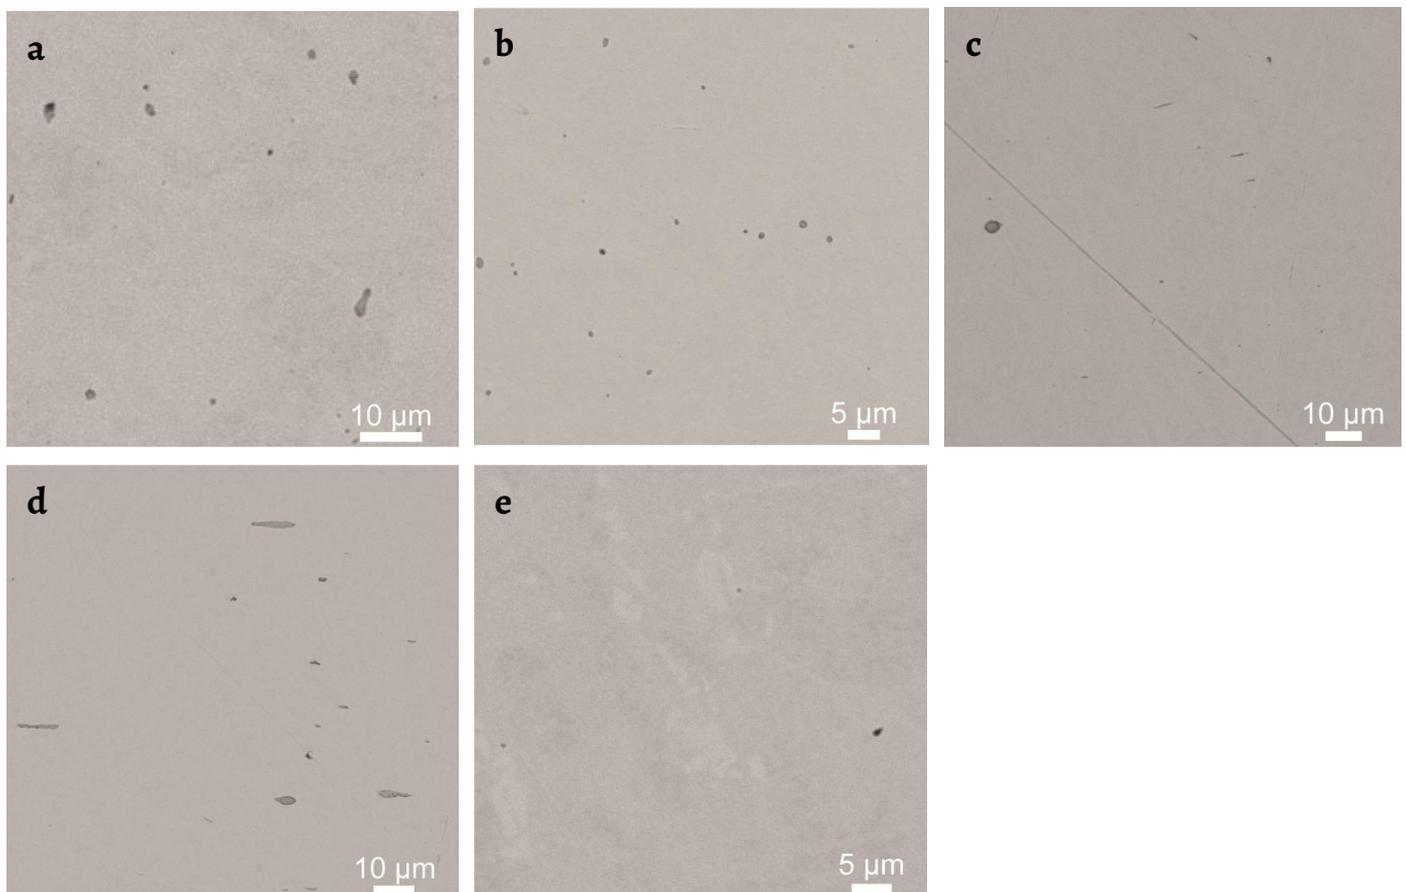
Exclusively circular inclusions were identified in the unaltered iron matrix. These inclusions are not perfectly round and tend to appear moderately elongated, as observed in samples taken from the guardrails and pillars (Figure 5). This type of microstructure is characteristic of malleable or nodular (ductile) gray cast iron. Malleable cast iron is produced through heat treatments of white cast iron, which promote the formation of nodules. Nodular cast iron, on the other hand, is directly obtained during the casting process through the addition of inoculants that promote the nodular precipitation of graphite [16, 22].

Figure 5. SEM images showing circular inclusions in the microstructure of the samples: a) 1D-A1; b) B1-A4; c) B2-A4; d) B3-A3; e) B4-A4.

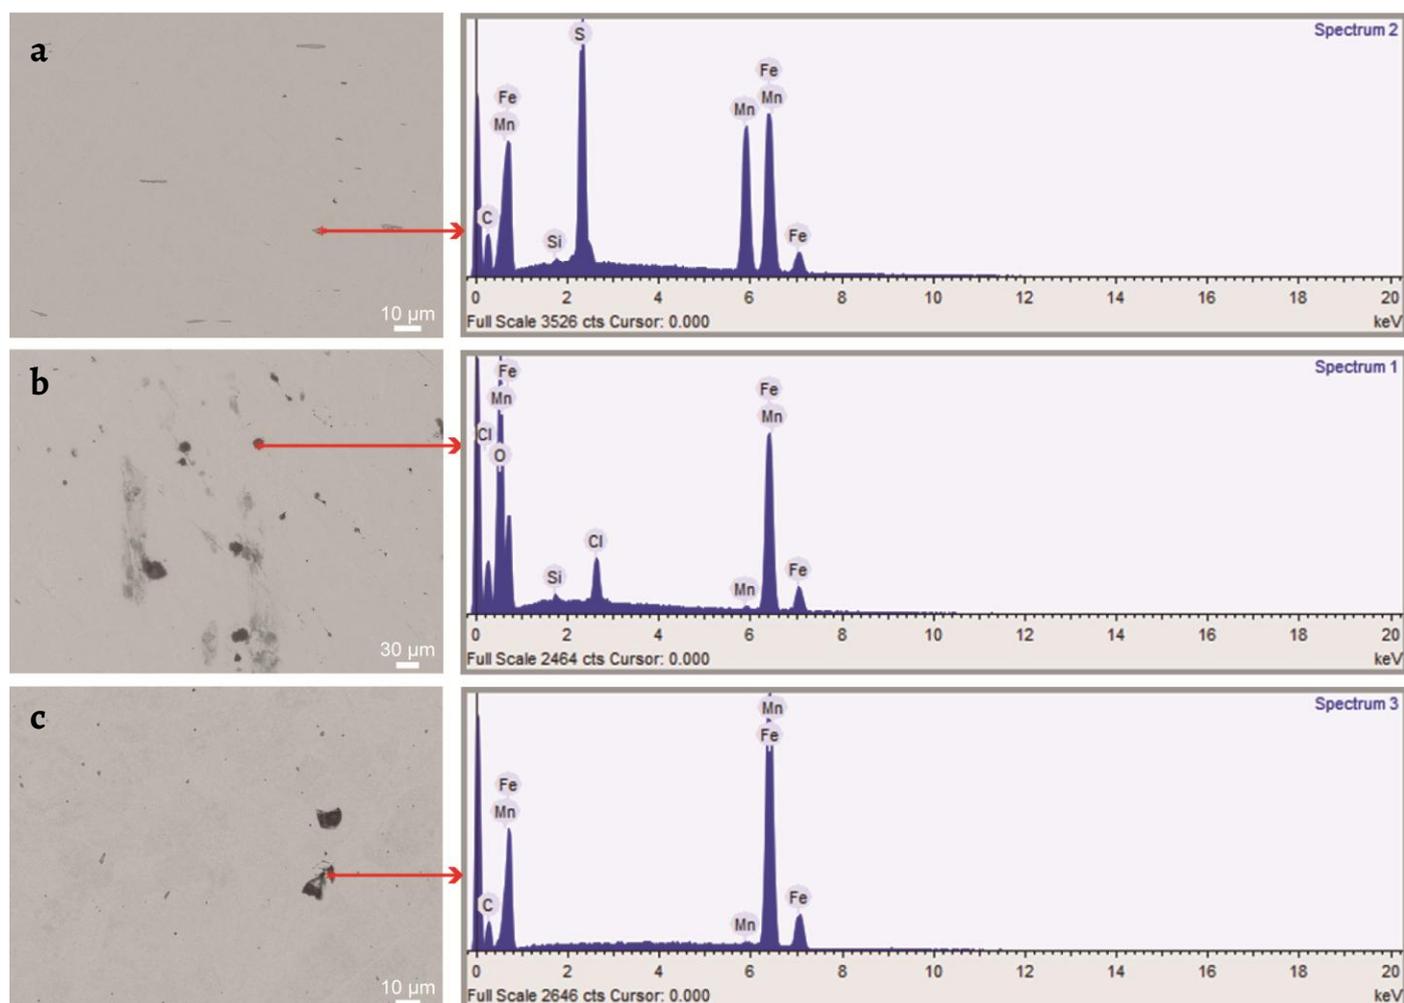
According to the chemical characterization of samples B1-A4, B2-A4, and B3-A3, the nodular precipitations are composed of elements other than iron: primarily carbon, manganese, silicon, oxygen, sulfur, and phosphorus. The isolated presence of aluminum and chlorine in samples B2-A4 and B4-A4 suggests contamination (*e.g.* from soil dust particles) and active corrosion in the alloy, leading to the formation of chlorides [15, 21] (Figure 6).

In samples 1D-A1 and B1-A4, areas (voids) with a different shape from the inclusions and a slightly darker gray color can be observed. However, there is no significant contrast in composition, as iron, carbon, oxygen, manganese, sulfur, and silicon were identified, almost entirely matching what was detected in the unaltered alloy and inclusions (Figure 6). This minimal variation can be attributed to the homogeneity in type, raw material of origin, and fabrication technology of the alloys.

Figure 6. SEM images (left) and EDS spectra (right) showing: *a*) the chemical composition of the circular inclusions in sample B3-A3; *b*) the Cl identification in sample B4-A4; *c*) the chemical composition of the void areas in the sample 1D-A1.

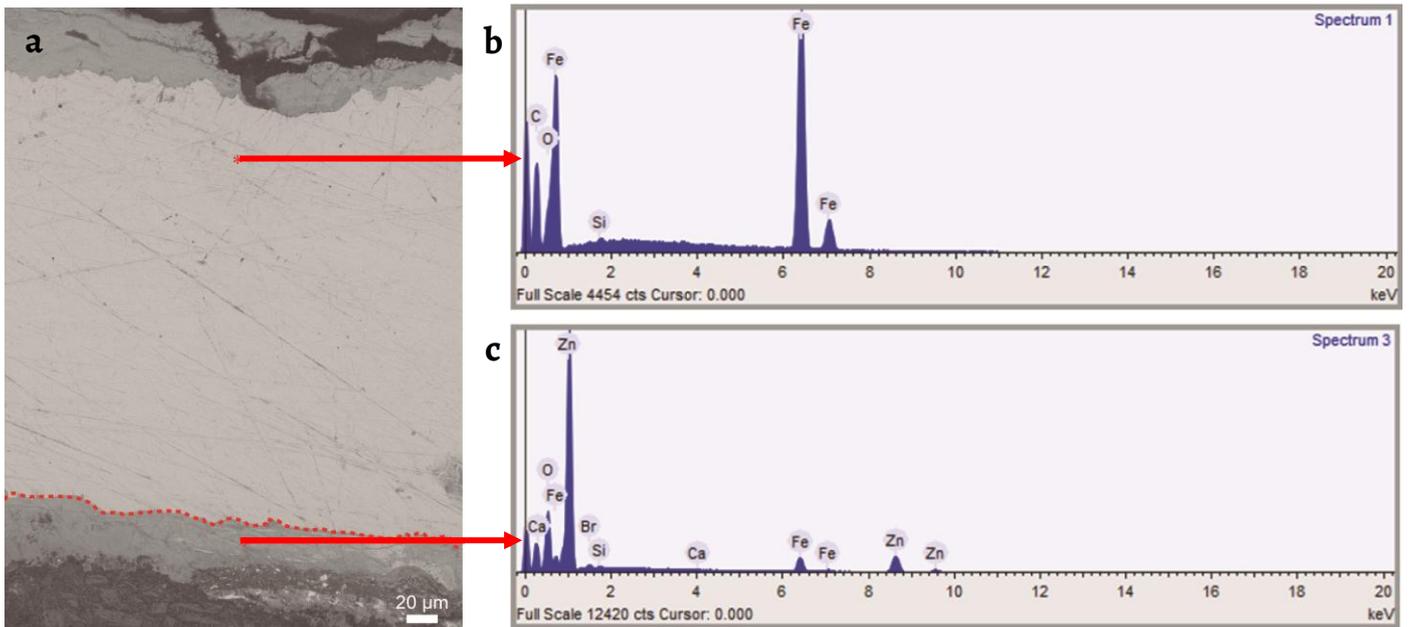
One sample, 1D-A3, from a roof sheet, has a smooth texture and is free of inclusions. EDS analysis identified that the unaltered metal area is primarily composed of iron (Figure 7). In contrast, the XRD analysis of sample 1D-A4, taken from one of the faces of the same element as 1D-A3 and shown in Figure 4, indicates that the surface composition is zinc. The microstructure and zinc-rich surface composition were observed only on these roofing samples.

Although zinc is a typical metal for roofing in bandstands from the nineteenth and twentieth centuries [2], the contrasting chemical and mineralogical compositions suggest that it is an iron sheet coated with zinc. For an accurate determination of the ferrous alloy, the morphology and microstructure can be examined. According to the literature, lamellae and nodules are characteristics of gray cast iron; a fibrous texture formed by filamentous slags is typical of wrought iron; and the absence of these features distinguishes steel from the other types mentioned [22, 25-27]. Based on this information and the SEM images, it is reasonable to classify the 1D-A3 sample as a steel sheet.

Figure 7. SEM image (left) and EDS spectra (right) of the roofing element showing: a) the absence of inclusions in sample 1D-A3; b) the alloy composition; c) the Zn coating in one of its faces.

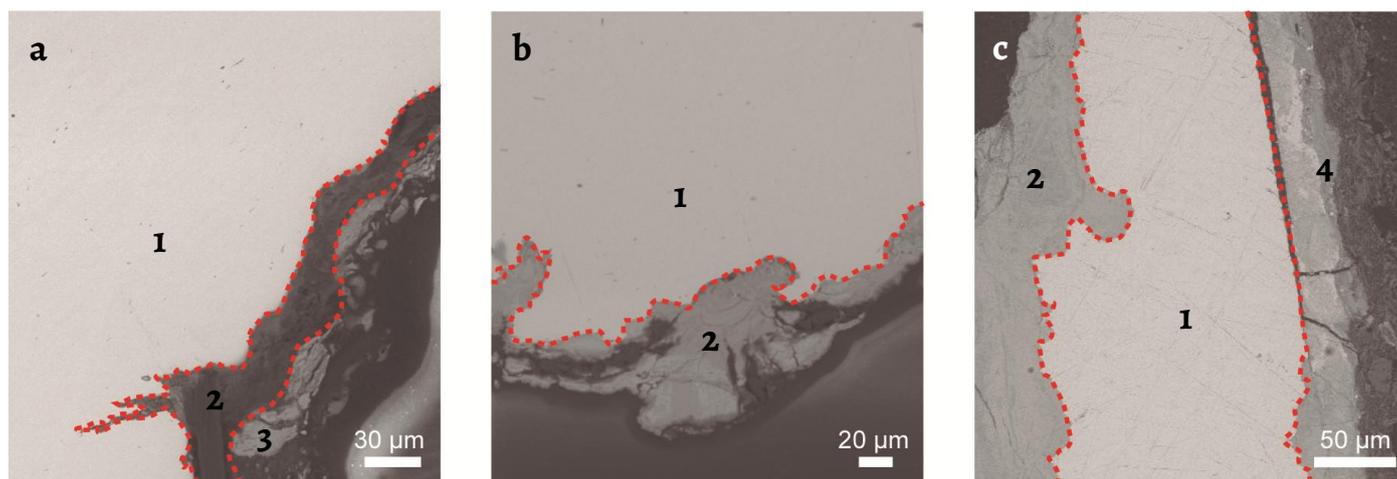
Three sequences of layers were displayed: 1) uncorroded metal as the inner layer, followed by corrosion products intermediately, and paint as the outermost layer; 2) uncorroded metal as the inner layer and corrosion products as the outermost layer; 3) uncorroded metal intermediately and the corrosion product and zinc coating layers on the opposite faces of the element. Examples of the orders are shown in Figure 8.

In the Primeiro de Dezembro Pavilion, the position and composition of the corrosion products in samples 1D-A1 (guardrail) and 1D-A3 (roof sheet) differ. In sample 1D-A1, the corrosion appears as an intermediate layer, with the remaining paint as the outermost layer in 1D-A1. In contrast, in sample 1D-A3, the layers are not consecutive, as the zinc coating is present on only one face of the source object (Figure 8).

Figure 8. SEM images showing the stratigraphy of the layers in: a) sample 1D-A1; b) sample B3-A3; c) sample 1D-A3. 1 – uncorroded metal, 2 – corrosion product, 3 – paint, 4 – zinc coating.

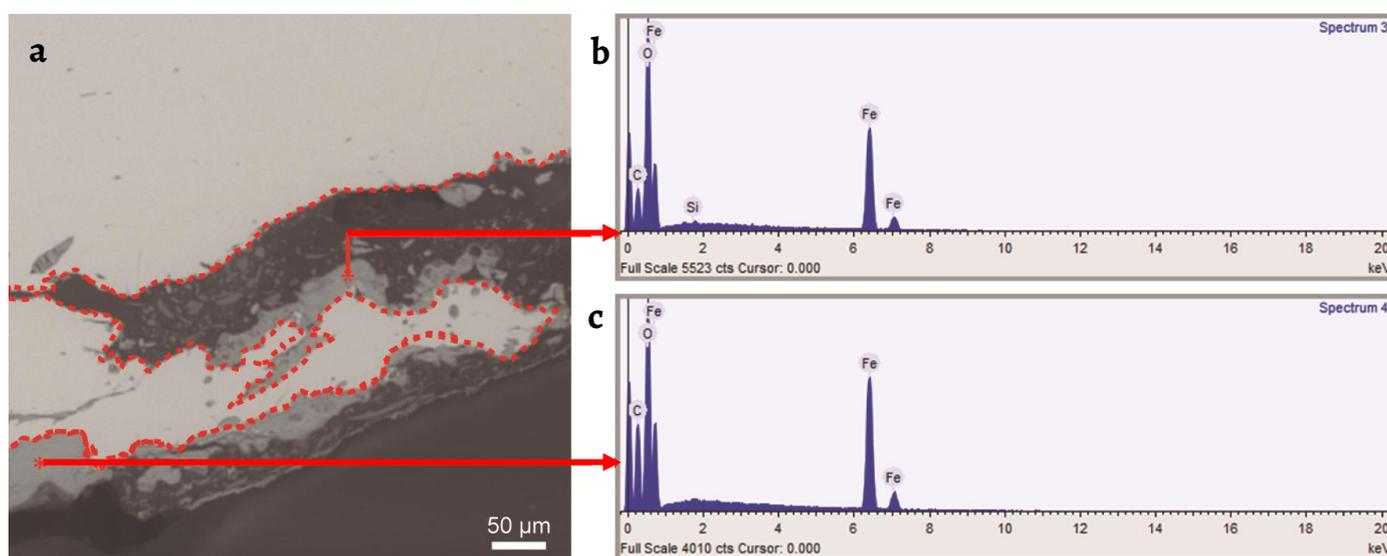
In the other four bandstands, B1, B2, B3, and B4, only corrosion product layers were observed, in addition to the unaltered metal alloy. A notable feature is the extremely non-uniform thickness of the layers, along with high levels of fragmentation due to the advance of corrosion. The estimated thicknesses of the layers, measured by image proportion, varied between 15-30 µm in sample 1D-A1; 50-60 µm in sample 1D-A3; 10-17 µm in sample B1-A4; 20-30 µm in sample B2-A4; 10-60 µm in sample B3-A3; and 60-65 in sample B4-A4. The chemical elements detected were primarily iron, oxygen, and carbon with small amounts of silicon, calcium, sulfur, and manganese (Figure 9).

Figure 9. Sample B2-A4: a) SEM image showing the corrosion product layer thickness; b-c) EDS spectra of its chemical composition.
