# Balancing artist's intent and durability: conserving a corroded outdoor painted iron sculpture

### George Lappas and his monochrome *Tree* sculpture

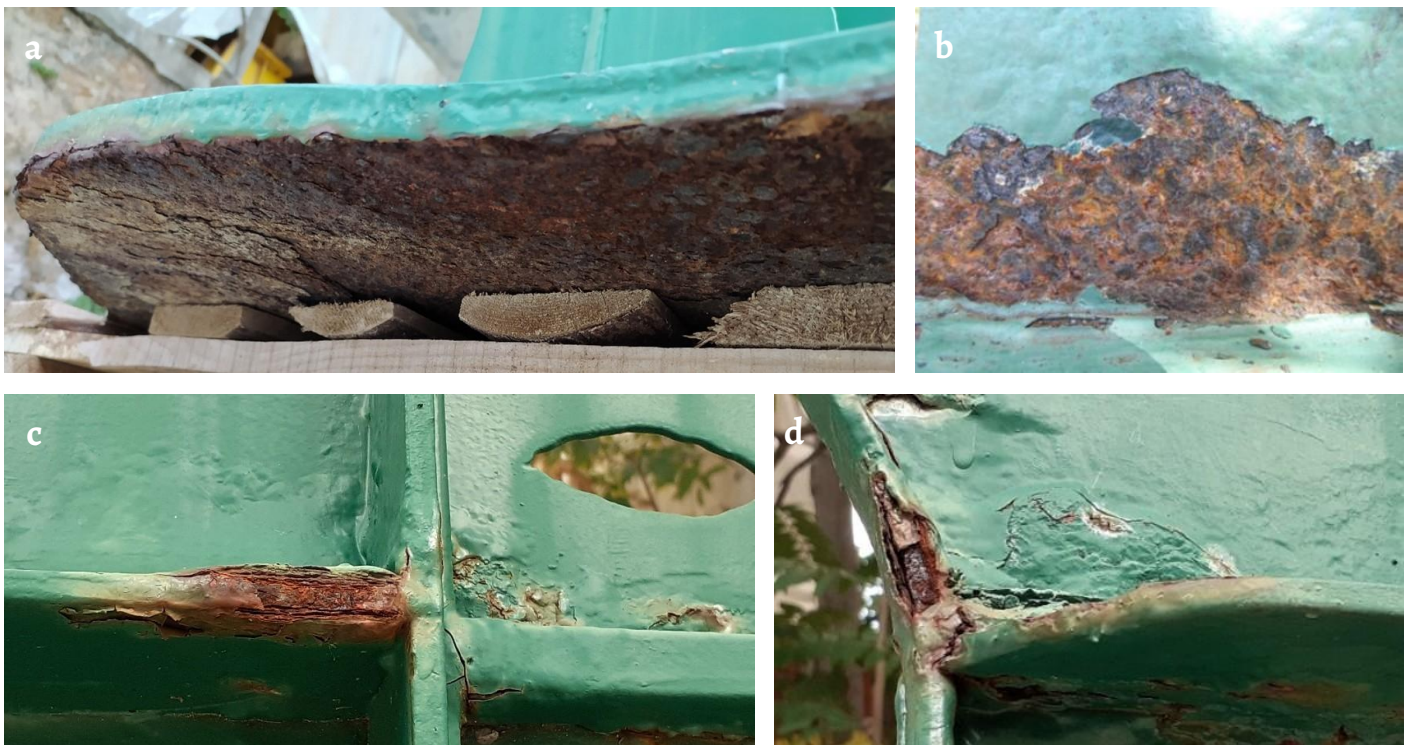
Investigative inspection revealed significant issues with the metal substrate and paint layers. The following problems were highlighted after the paint was removed (Figure 2):

- electrochemical corrosion of iron occurred in areas where the paint layers exhibited cracking, delamination and loss of adhesion to the metal substrate, resulting in the formation of composite corrosion layers containing probably iron oxides and hydroxides, characterised by an increase in volume ('rust');

- active corrosion of iron (weeping iron) and the formation of chloride corrosion products ('spalling') in areas where the original paint layer has been lost and the repainting process has not involved proper preparation of the metal substrate by removing and/or stabilising corrosion products. Areas prone to electrochemical and active corrosion are those that retain moisture, such as hollow base sections, joints between metal plates and frame slats, the slats themselves and lateral buttresses where they connect to the base;

- loss of parts due to crevice corrosion caused by active corrosion and mechanical stress. Paint removal revealed missing decorative elements at the joints, as well as holes in the frame slats, where moisture had entered and caused deep craters and material loss.

**Figure 2.** Corrosion types: *a-b*) uniform corrosion with formation of black and brown/orange corrosion products and stress mechanical cracking; *c-d*) bulk corrosion products in areas characterized by spalling and detachment of material.

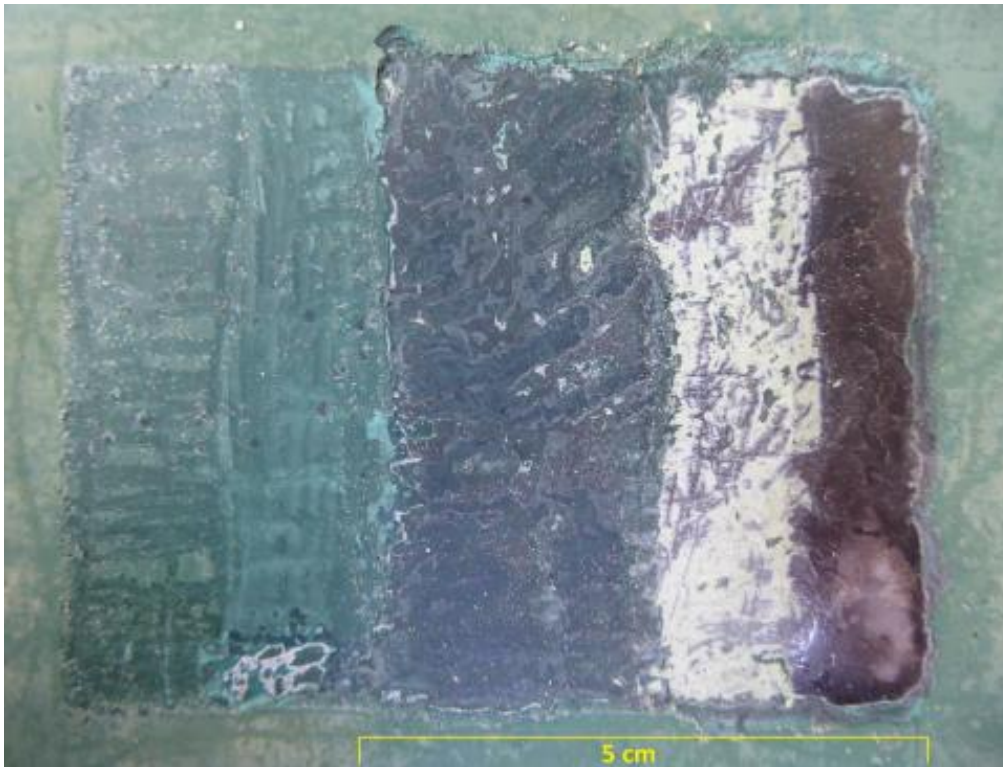
Cleaning revealed that the sculpture had been repainted several times, often without full paint removal or proper substrate preparation. Local retouching showed signs of wear and tear, and in some cases, evidence of painting over corrosion. Removing the overpaints exposed four to five paint layers with varying green hues, likely due to ageing or inconsistent colour matching. The original artist-selected colour was found to be the initial layer over the metal surface (Figure 4).

**Figure 4.** Investigative cleaning section revealing 3 layers of green paint and a white primer.

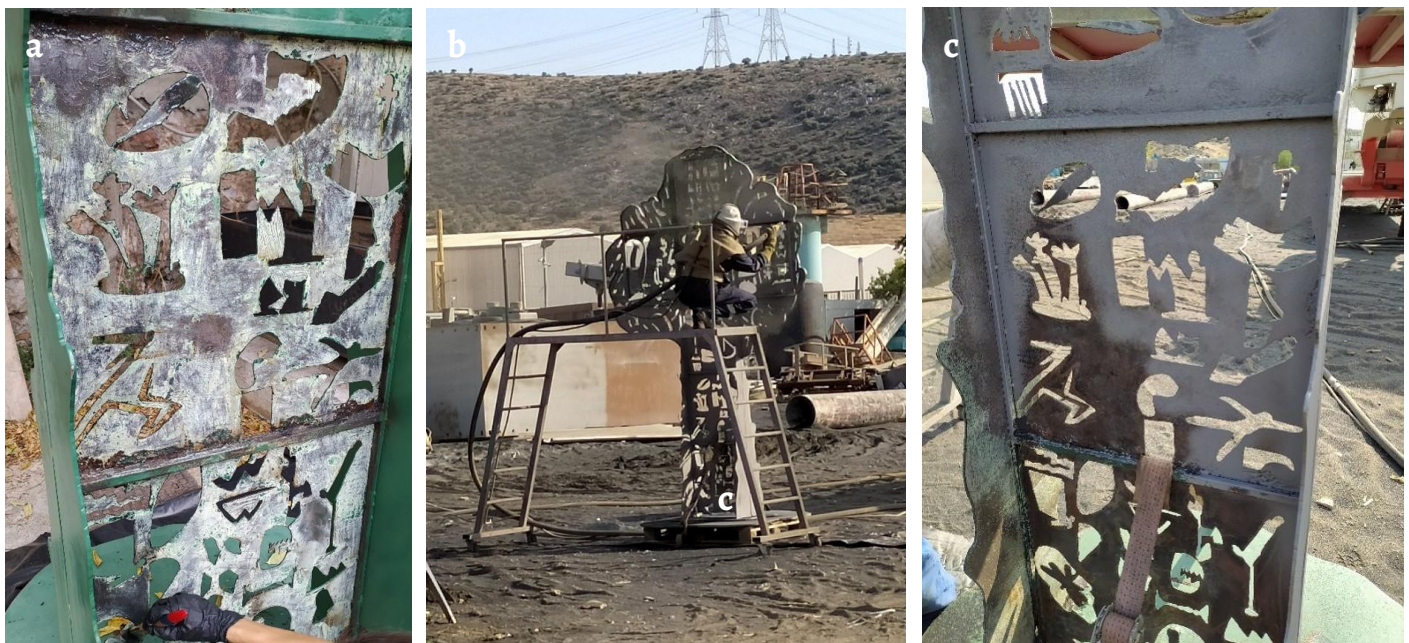
**Figure 6.** Mechanical cleaning of paint layers: a) cleaning result of paint layers with commercial paint remover and a hot air gun; b) cleaning with an industrial air blast system; c) view of a cleaned area with the sandblasting system, revealing the blackening of the surface due to the process of metal cutting for creating the symbols. The details of the cutting of the symbols are better observed.

Cleaning tests were conducted using a combination of mechanical cleaning with hand tools, such as a scalpel, and a Dremel rotary tool fitted with various brushes and abrasives. The commercial ecological paint remover 600 ECO Paint Remover Gel was also tested. A hot air gun was also used to gradually strip the paint layers down to the metal substrate (Figure 6a).

Finally, an industrial air blast system using quartz sand (0.1-0.5 mm) was employed at a controlled operating pressure (Figure 6b). The paint and corrosion layers were completely removed, including from the underside of the base (Figure 6c).

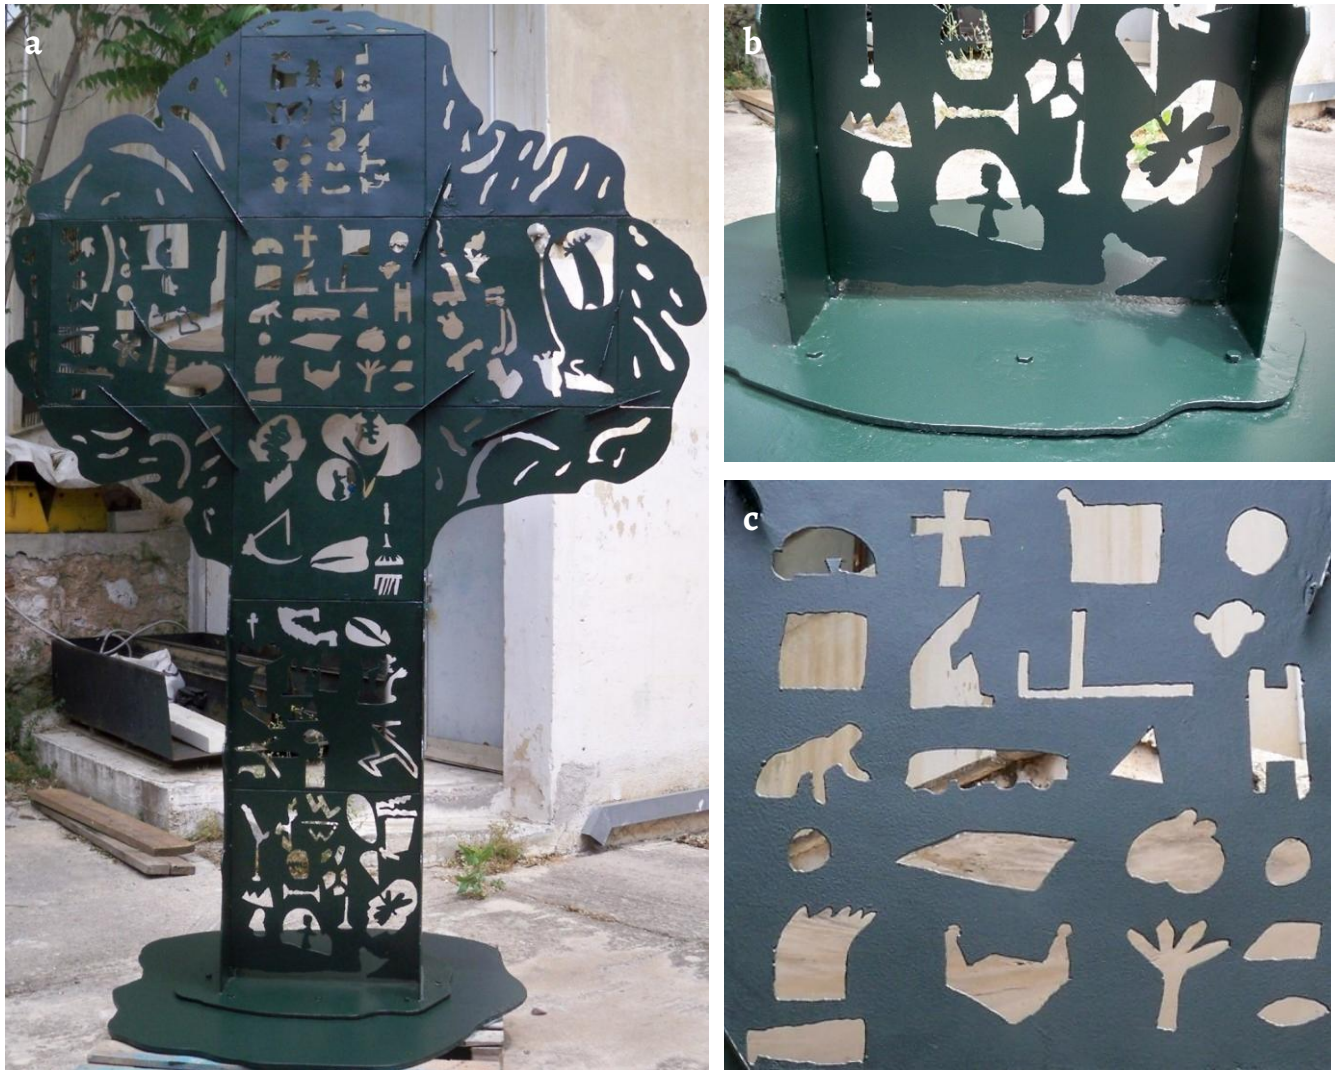
**Figure 8.** Repainting with a polyurethane system: a) the *Tree* after the application of the polyurethane paint system; b) detail of the area of the base; c) detail of a plate.

The colour paint was sourced from an industry survey of manufacturers producing paint systems for heavy industrial applications. The company used was Technochrom and the selection was made after consulting the chemical engineering department and providing images of the sculpture and information on the exposure environment. Such communication was essential since the decision was made to add an opacifier to reduce the satin gloss of the paint and achieve better aesthetic results given that the sculpture is exposed to sunlight. According to these, the selected polyurethane paint system was Technodur (RAL 6009), a two-component, aliphatic, polyester-based, chemical reaction polyurethane paint, suitable for the marine environment (Figure 8). The paint was applied in two layers using a soft-bristle brush and roller; the second layer was applied after 48 hours. The paint dried within 24 hours and reached full hardness and mechanical strength after seven days at 20 °C.
