# Balancing artist's intent and durability: conserving a corroded outdoor painted iron sculpture

MARIA GIANNOULAKI \*

University of West Attica, Dept. of  
Conservation of Antiquities &  
Works of Art, Ag. Spyridonos,  
Aigaleo, 12 210, Greece

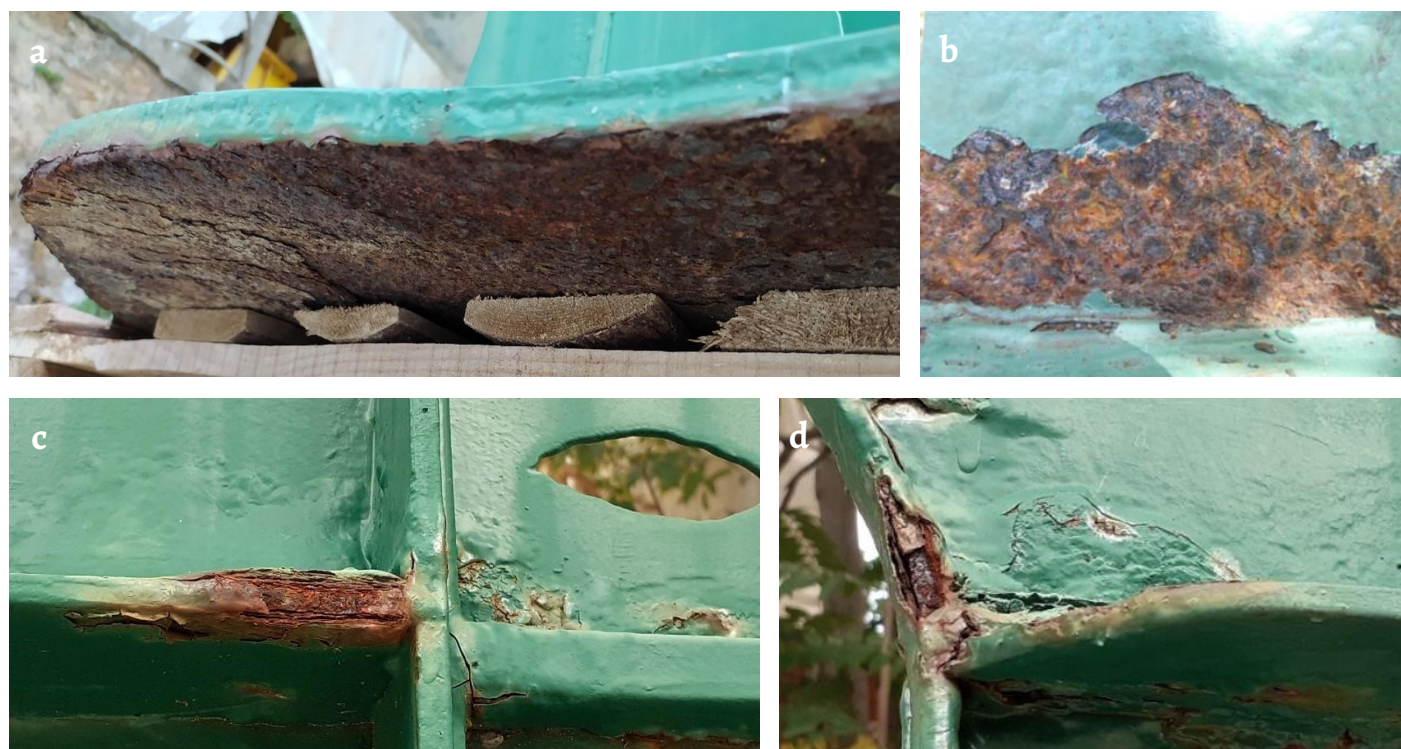
The following problems were highlighted after the paint was removed (Figure 2):

- electrochemical corrosion of iron occurred in areas where the paint layers exhibited cracking, delamination and loss of adhesion to the metal substrate, resulting in the formation of composite corrosion layers containing probably iron oxides and hydroxides, characterised by an increase in volume ('rust');

- active corrosion of iron (weeping iron) and the formation of chloride corrosion products ('spalling') in areas where the original paint layer has been lost and the repainting process has not involved proper preparation of the metal substrate by removing and/or stabilising corrosion products. Areas prone to electrochemical and active corrosion are those that retain moisture, such as hollow base sections, joints between metal plates and frame slats, the slats themselves and lateral buttresses where they connect to the base;

- loss of parts due to crevice corrosion caused by active corrosion and mechanical stress. Paint removal revealed missing decorative elements at the joints, as well as holes in the frame slats, where moisture had entered and caused deep craters and material loss.

**Figure 2.** Corrosion types: *a-b*) uniform corrosion with formation of black and brown/orange corrosion products and stress mechanical cracking; *c-d*) bulk corrosion products in areas characterized by spalling and detachment of material.

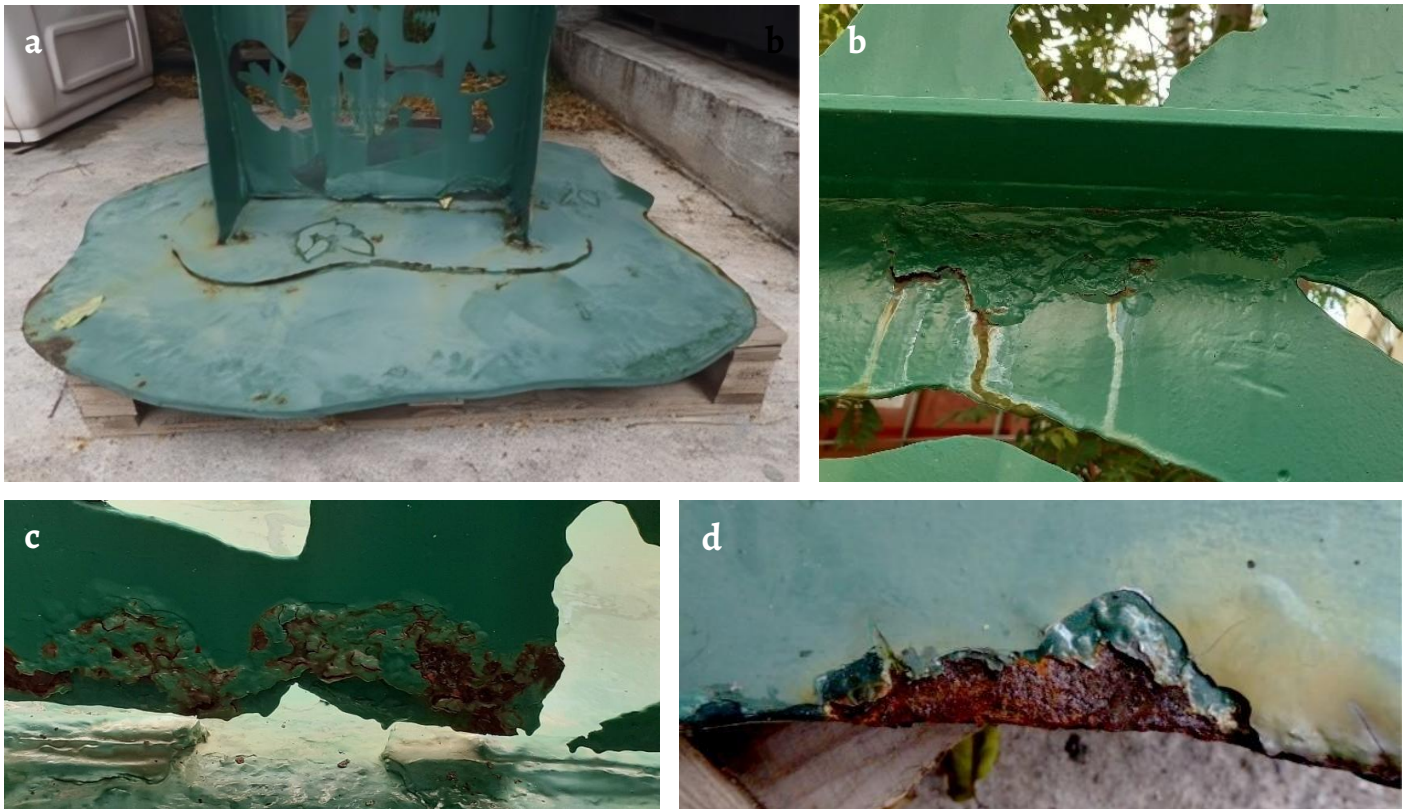
**Figure 3.** Paint layer degradation: *a)* discolouration and material heterogeneity; *b)* paint detachment; *c)* exfoliation, cracks and blistering; *d)* area with repainting.

Prolonged environmental exposure has significantly deteriorated the paint layer, impacting the appearance of the artwork and the artist's original intent. The following has been documented (Figure 3):

- severe discolouration, blisters, cracks and extensive flaking, particularly where corrosion beneath had expanded;
- paint thickness is locally reduced due to uncontrolled substrate corrosion;
- repaint layers show poor interlayer adhesion, leading to localised delamination;
- material heterogeneity, weak adhesion and surface damage compromise the artwork's appearance and accelerate its degradation by allowing oxygen and moisture to reach the metal, perpetuating a cycle of decay.

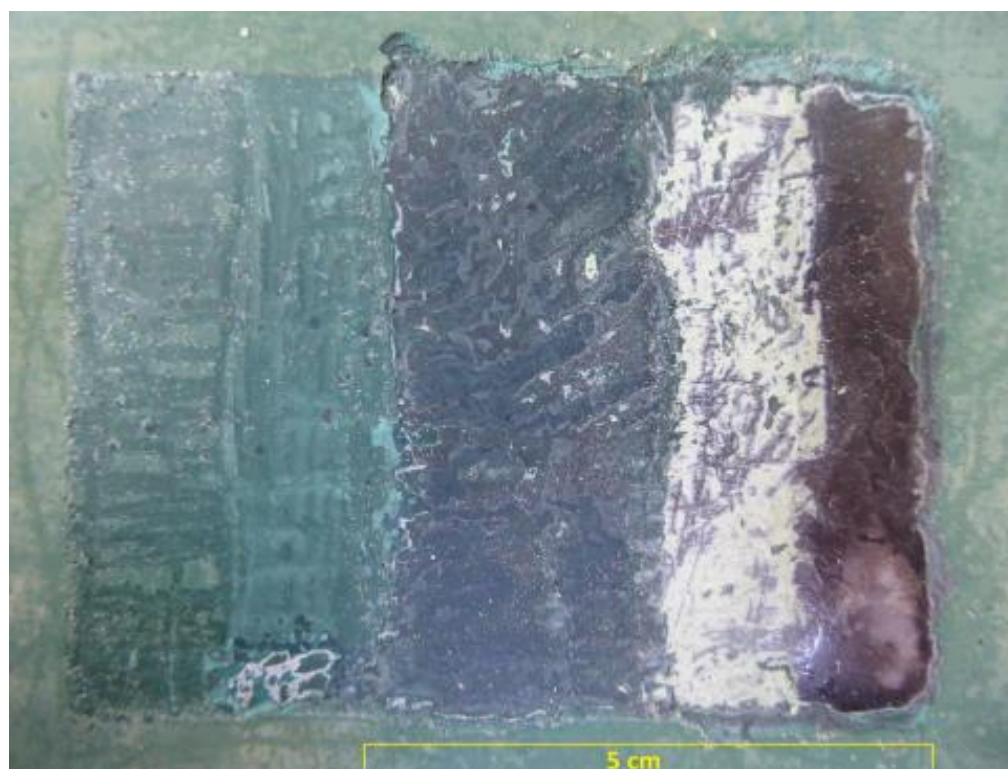
Cleaning revealed that the sculpture had been repainted several times, often without full paint removal or proper substrate preparation. Local retouching showed signs of wear and tear, and in some cases, evidence of painting over corrosion. Removing the overpaints exposed four to five paint layers with varying green hues, likely due to ageing or inconsistent colour matching. The original artist-selected colour was found to be the initial layer over the metal surface (Figure 4).

**Figure 4.** Investigative cleaning section revealing 3 layers of green paint and a white primer.

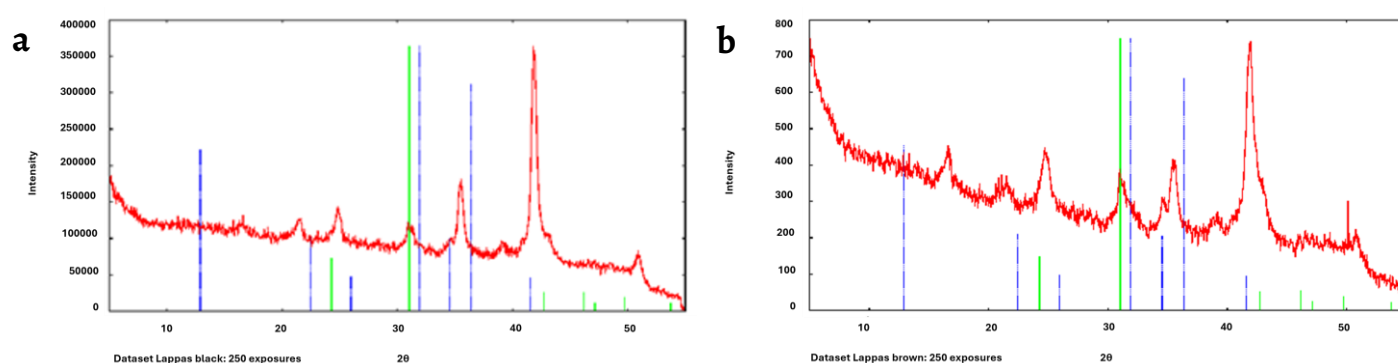
Observation and processing of the spectra documented the presence of iron oxide-hydroxides (magnetite, goethite and lepidocrocite). The spectra present a lot of background 'noise' and regions of many small peaks due to the amorphous and semi-crystalline nature of the hydrated iron products. Although characteristic peaks of magnetite and lepidocrocite (Figure 5a) and goethite and magnetite (Figure 5b) can be identified.

**Figure 5.** XRD results: *a*) characteristic peaks of magnetite (35,5°) and lepidocrocite (~14° and 23°); *b*) characteristic peaks of goethite (~21.5° and 36°) and magnetite (35,5°).

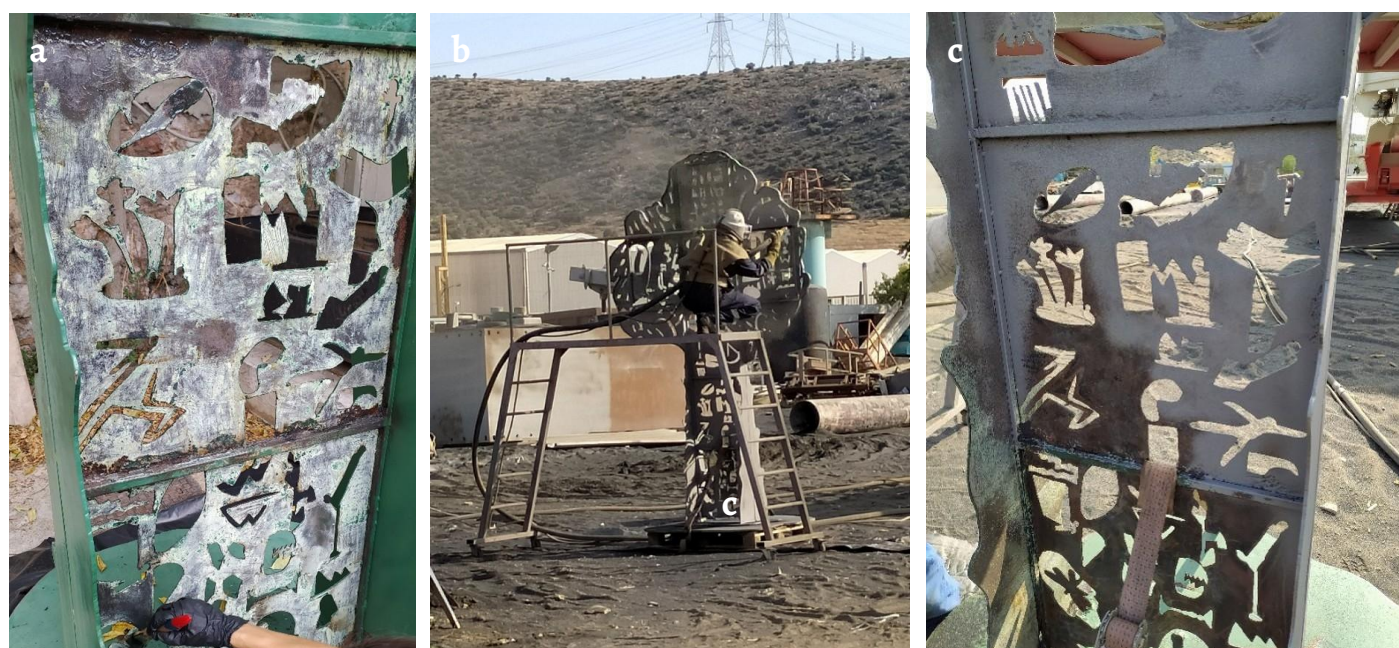
**Figure 6.** Mechanical cleaning of paint layers: a) cleaning result of paint layers with commercial paint remover and a hot air gun; b) cleaning with an industrial air blast system; c) view of a cleaned area with the sandblasting system, revealing the blackening of the surface due to the process of metal cutting for creating the symbols. The details of the cutting of the symbols are better observed.

Cleaning tests were conducted using a combination of mechanical cleaning with hand tools, such as a scalpel, and a Dremel rotary tool fitted with various brushes and abrasives. The commercial ecological paint remover 600 ECO Paint Remover Gel was also tested. A hot air gun was also used to gradually strip the paint layers down to the metal substrate (Figure 6a).

Finally, an industrial air blast system using quartz sand (0.1-0.5 mm) was employed at a controlled operating pressure (Figure 6b). The paint and corrosion layers were completely removed, including from the underside of the base (Figure 6c).

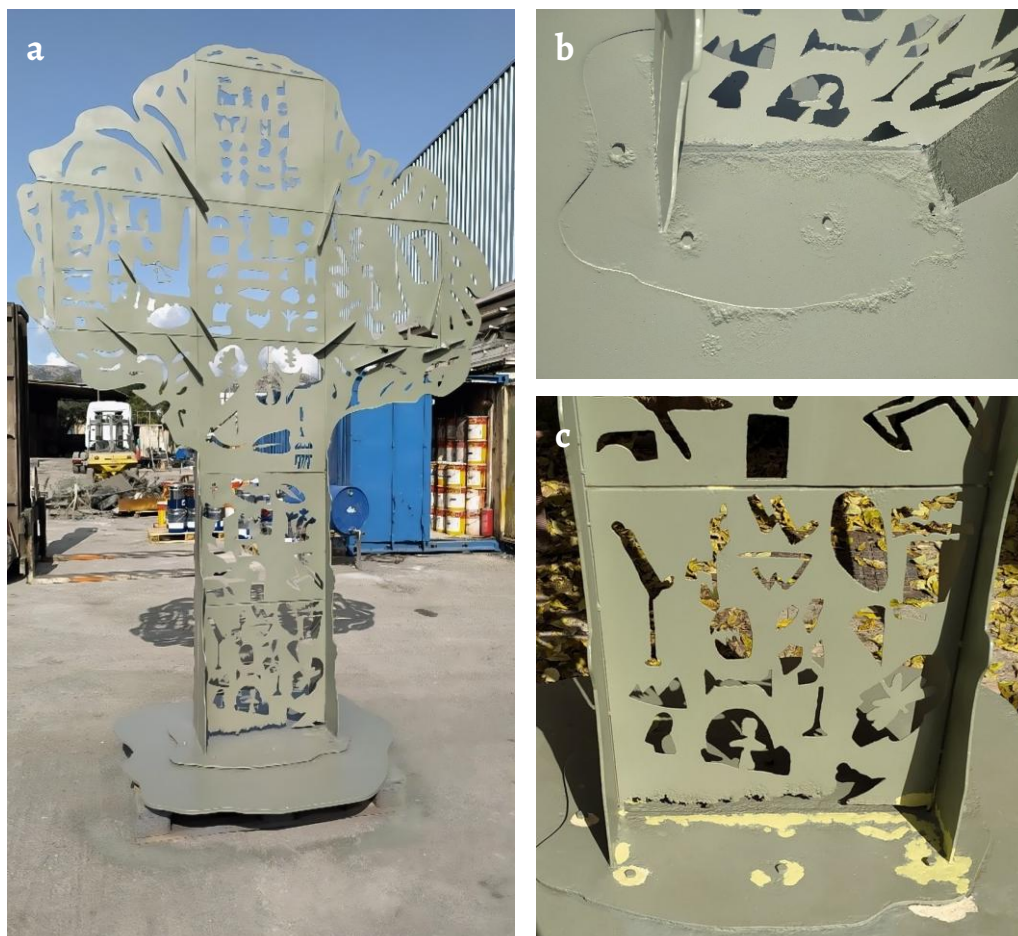
Sandblasting revealed three issues that required restoration (Figure 7b):

- openings in the back and slats allowed moisture to enter, causing internal oxidation;
- removal of the corrosion layers left behind hollow recesses and irregularities;
- extensive oxidation resulted in large gaps and material loss.

**Figure 7.** Preparation of metal substrate: a) the *Tree* after the application of two layers of zinc-based primer; b) hollow recesses and irregularities; c) gap filling process.

An epoxy protection system suitable for the marine environment was used. This included a primer (Hempel's zinc metal pigment 97170) that offers cathodic protection followed by a second layer of primer (Hempel's speed dry ZP 500 17500) as a base/preparation coat for the polyurethane paint. Both were applied by spray for optimal penetration (Figure 7a).

Gap filling was used to address the material loss (Figure 7c). Milliput Standard 490 (yellow-grey) an epoxy putty was used for larger losses of material, and Milliput Standard Superfine (white) for fine finishes. They were both applied to the primed metal surface. In category 1, the holes were completely filled with epoxy resin. For category 2, small, localised additions were made to smooth the surface without overfilling, adhering to minimal conservation principles. Category (3) involved making major additions to cover gaps and restore the form only to the extent necessary to maintain the sculpture's aesthetic integrity.

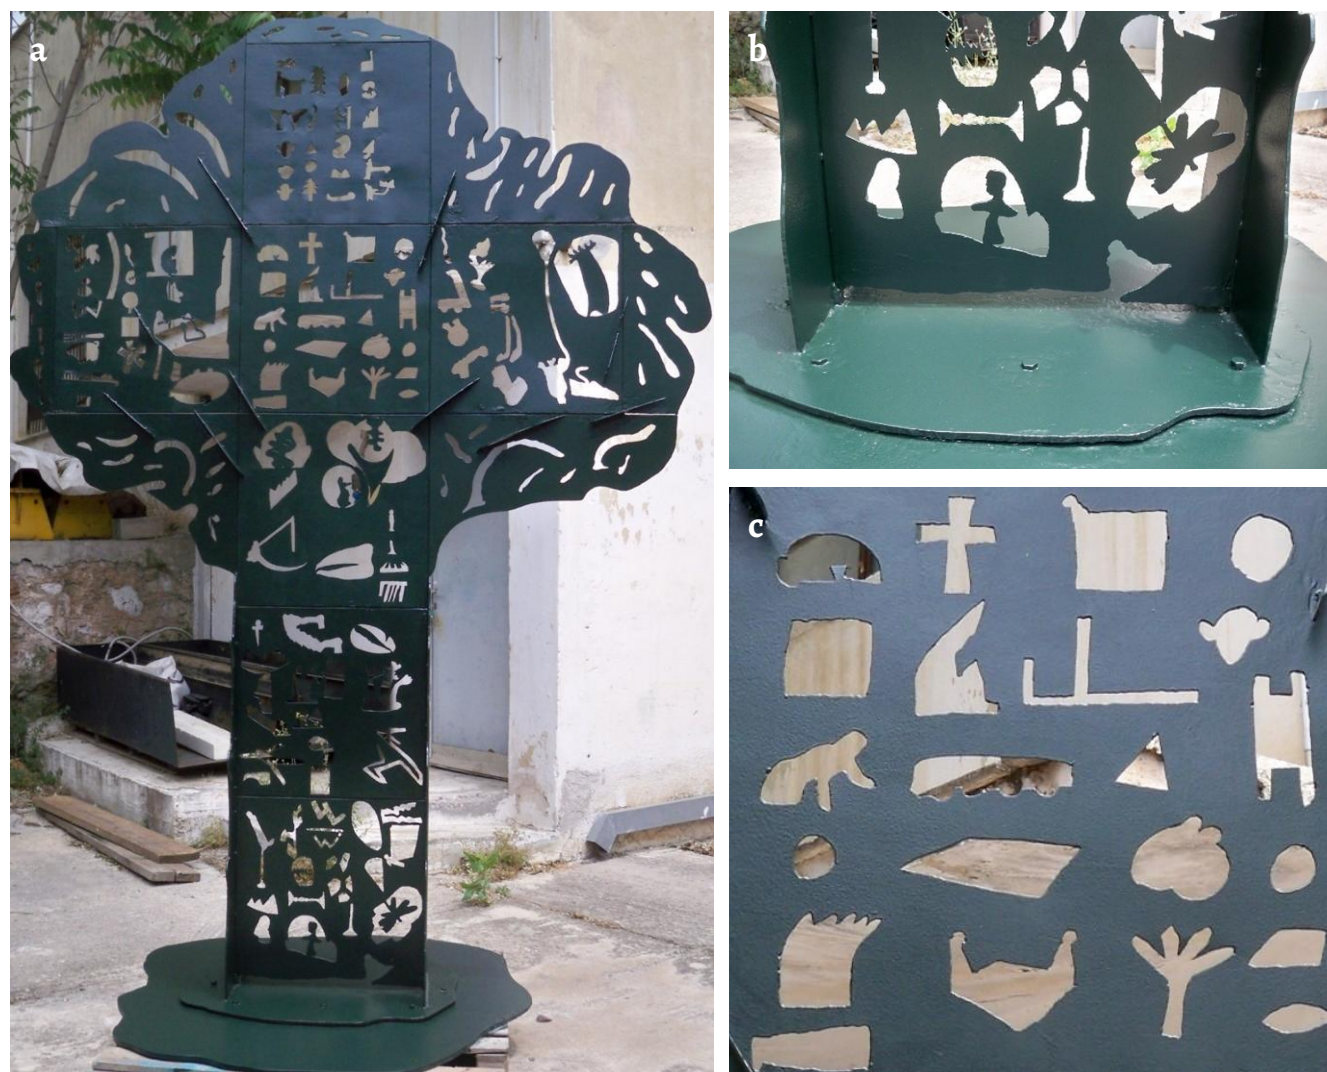
**Figure 8.** Repainting with a polyurethane system: a) the *Tree* after the application of the polyurethane paint system; b) detail of the area of the base; c) detail of a plate.

The colour paint was sourced from an industry survey of manufacturers producing paint systems for heavy industrial applications. The company used was Technochrom and the selection was made after consulting the chemical engineering department and providing images of the sculpture and information on the exposure environment. Such communication was essential since the decision was made to add an opacifier to reduce the satin gloss of the paint and achieve better aesthetic results given that the sculpture is exposed to sunlight. According to these, the selected polyurethane paint system was Technodur (RAL 6009), a two-component, aliphatic, polyester-based, chemical reaction polyurethane paint, suitable for the marine environment (Figure 8). The paint was applied in two layers using a soft-bristle brush and roller; the second layer was applied after 48 hours. The paint dried within 24 hours and reached full hardness and mechanical strength after seven days at 20 °C.
