# Sequential approach of the re-using the historical military barrack in the Old Mardin Heritage in Turkey

İZZETTİN KUTLU<sup>1\*</sup>  
ZEYNEP YEŞİM  
İLERİSOY<sup>2</sup>  
ASENA SOYLUK<sup>2</sup>

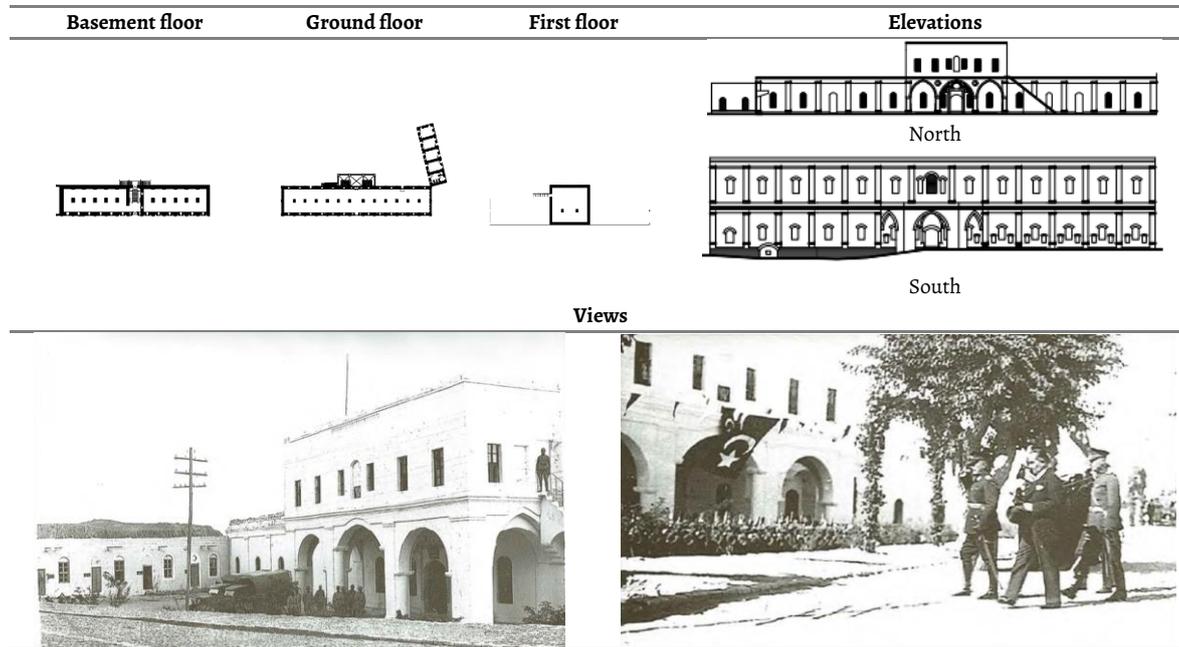
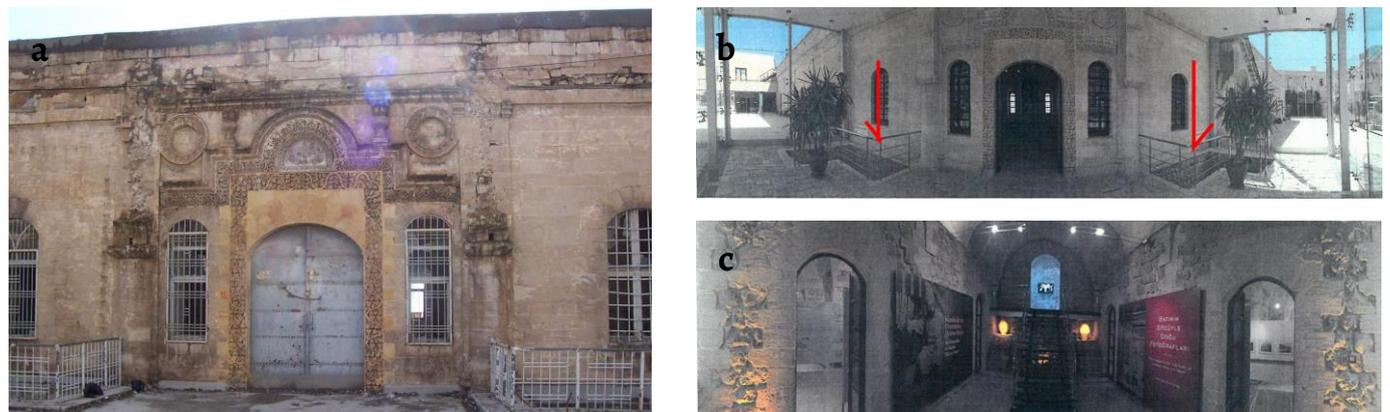
**Figure 3.** a) Ornaments surrounding the northern front entrance gate of the historical military barrack (2004), photograph by Murat Çağlayan and two stairs symmetrically placed next to the entrance door: b) outside and c) inside (2009), photograph by Şanlıurfa Regional Board of Conservation of Cultural Heritage.

In the ornamentation surrounding the north gate, a grape-panicle figure is used, which is grown in the region, and is also featured in other historical buildings. There are two stairs designed symmetrically to the left and right of the door, providing access to the lower floor (Figure 3).
