# Estimating the firing temperature of a brick sample from a church *convento* archway ruin in Quipayo, Camarines Sur, Philippines

JAN-MICHAEL C. CAYME<sup>1\*</sup>  
ERIC T. MIRANDA<sup>2</sup>

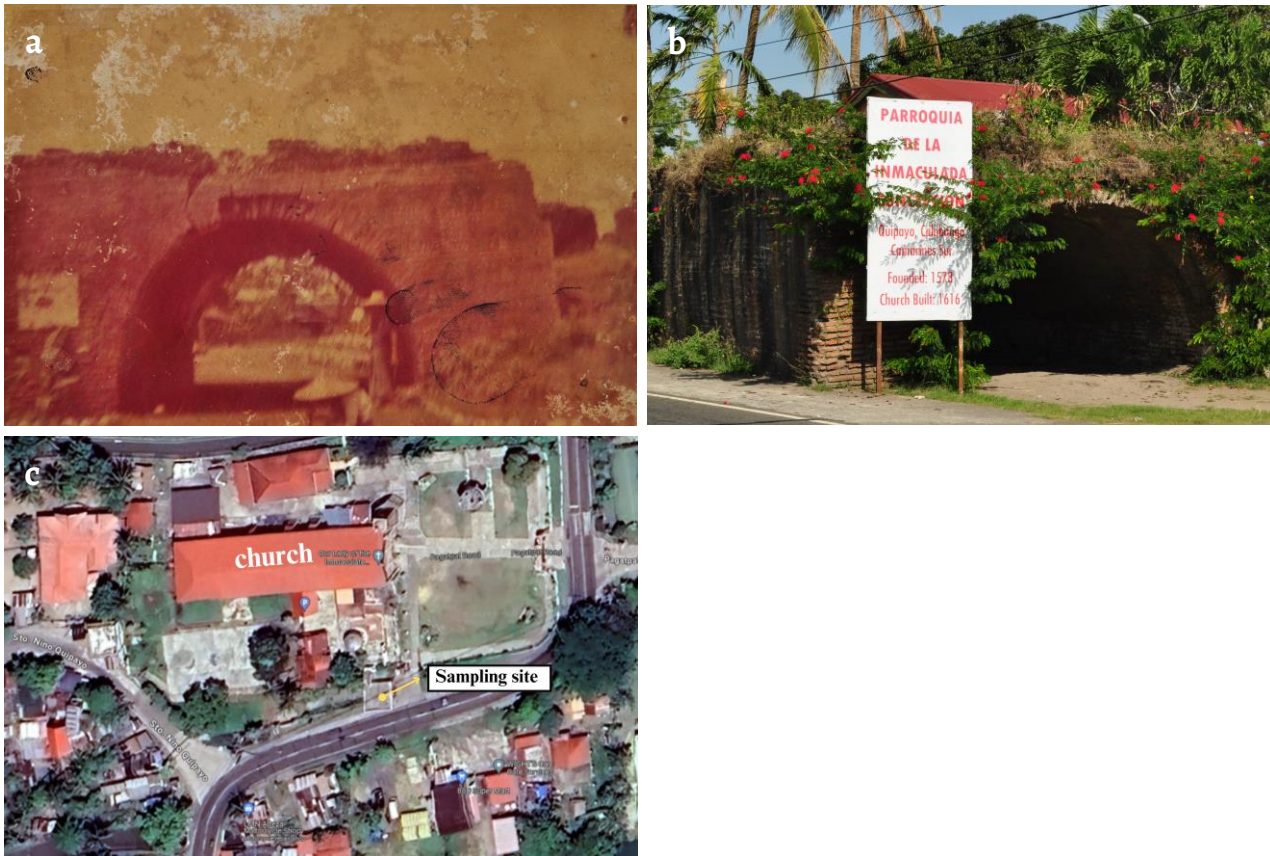
**Figure 2.** Quipayo church *convento* archway ruin: a) archival photo facing east (October 1973, photography: *Parroquia de la Inmaculada Concepcion* parish office); b) archway ruin facing east (April 2014, photography: J. C. Cayme); c) view of the archway ruin relative to the main church structure (photography: Google maps).

The archway ruin is the only visible part of the historical *convento* that remained (Figure 2a-b). Like any church structure in the Philippines which was originally made of bamboo or wood and thatch-roofed during the early Spanish Colonial Period, the frequency of strong typhoons and other natural disasters perennially destroyed church buildings. As a remedy, renovation works have used more permanent building materials such as bricks [7]. Based on the relative position of the archway ruin to the church facade, it is most likely located on the extreme end of the *convento* either as an extension or part of a series of arches spanning the ground level (Figure 2c). The archway ruin may have supported a deck above, which may have been used as an open area or a service area attached to a kitchen. The area below the arch can be used for either storage or a horse stable [19]. Scant historical records state that the original brick masonry structure was probably built in the early seventeenth century, and the present *convento* ruins were believed to be a nineteenth century construction [20]. The archway ruin's structural purpose and a construction year of about the early to mid-1800s was ascribed by rough comparison with existing church *conventos* in the Philippines having similar architectural features [19].

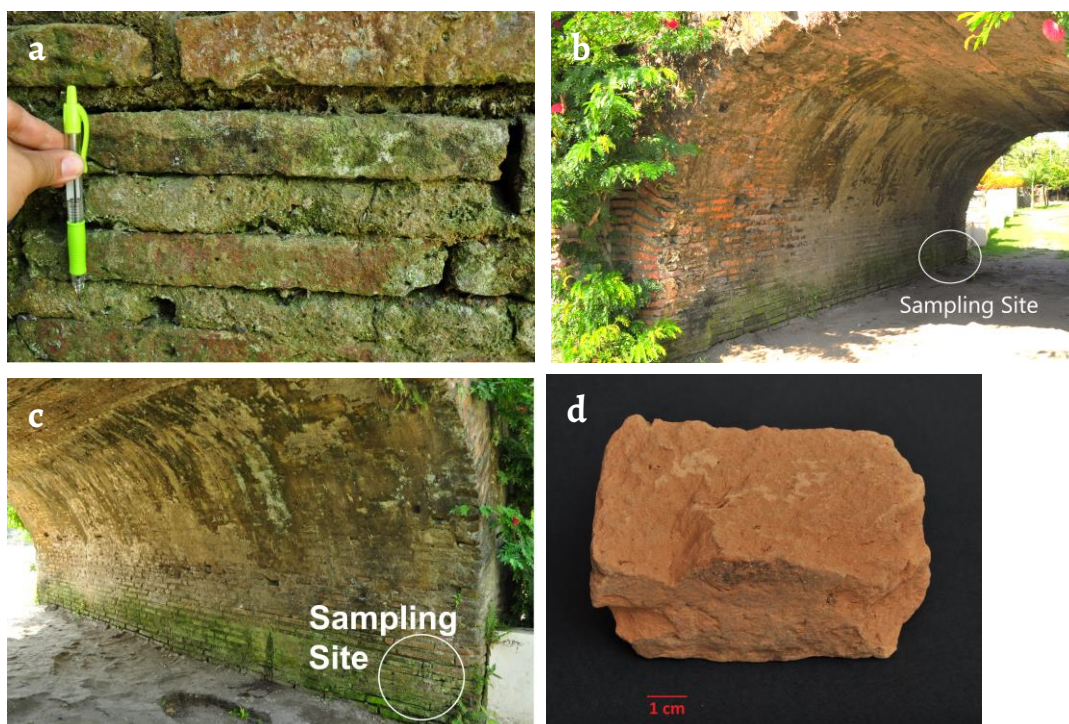
**Figure 3.** Archway ruin: *a*) Portion of the brick masonry wall where the sample fragment was retrieved; *b*) View of the front portion of the inner archway facing the east side; *c*) View of the back portion of the archway facing the west side (the approximate sampling site is indicated); *d*) The brick fragment, where the representative sample was obtained and tested with the different analytical techniques (photographs: J. C. Cayme, April 2014).

The brick masonry comprising the archway ruins are composed of bricks with average sizes of approximately 30.48 (length) × 6.99 cm (height) relative to its outer surface. Biological growth is also apparent from the brick's surface, especially those near the base. This is due to the damp and moist environment conducive to the development of algae, molds, fungi, or lichens [21] (Figure 3a). The brick fragment used in this study was collected in April 2014 inside the lower western end side of the *convento*'s archway (Figure 3b-c).

A brick fragment measuring about  $7.87 \times 3.81 \times 2.54$  cm was removed from an inconspicuous part of the structure approximately 30.48 cm from the base (Figure 3d) using a hammer and chisel. Extreme care was exercised in obtaining the fragment, and only an adequate amount was taken, which is enough for all the chemical characterizations used in this study. This precaution was practiced to ensure the historical authenticity of the ruins is maintained and preserved. From this fragment, a 16.2 g representative sample was scraped off from the inner portion about 1-2 cm from the surface to guarantee that no contaminants from the surroundings would affect the chemical analyses. This representative sample was homogenized and was dried completely at room temperature (around 37 °C) before testing using EDXRF, FTIR, TGA, SEM-EDX, and XRD analyses, respectively.

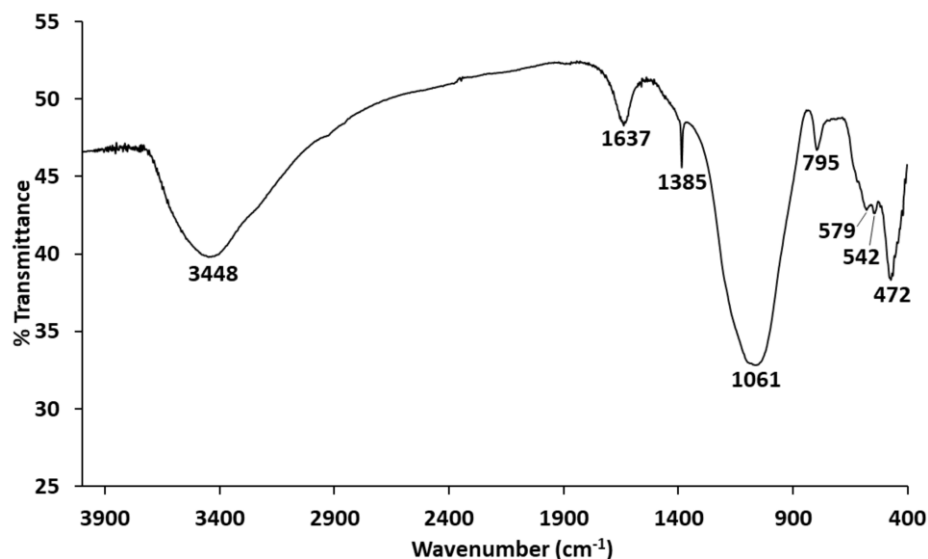
Figure 4. FTIR spectrum showing the significant absorption peaks.

The FTIR spectrum (Figure 4) provides insights into the brick material's firing temperature range based on the absorption peak's intensity. The absence of detectable peaks at  $1100\text{ cm}^{-1}$  (Si-O stretching) and  $915\text{ cm}^{-1}$  (Al-OH bending), but instead, an intense broad peak centered at  $1061\text{ cm}^{-1}$  was present, are typical spectrum patterns that resulted from the dehydroxylation and rearrangement of aluminum octahedral sheets in clay minerals. This transformation usually occurs when the material is fired above  $650\text{ }^{\circ}\text{C}$  [30]. The shift of the Si-O band toward higher frequencies accompanied by the intense broad peak is also indicative of a firing temperature that has reached  $800\text{ }^{\circ}\text{C}$  [31].

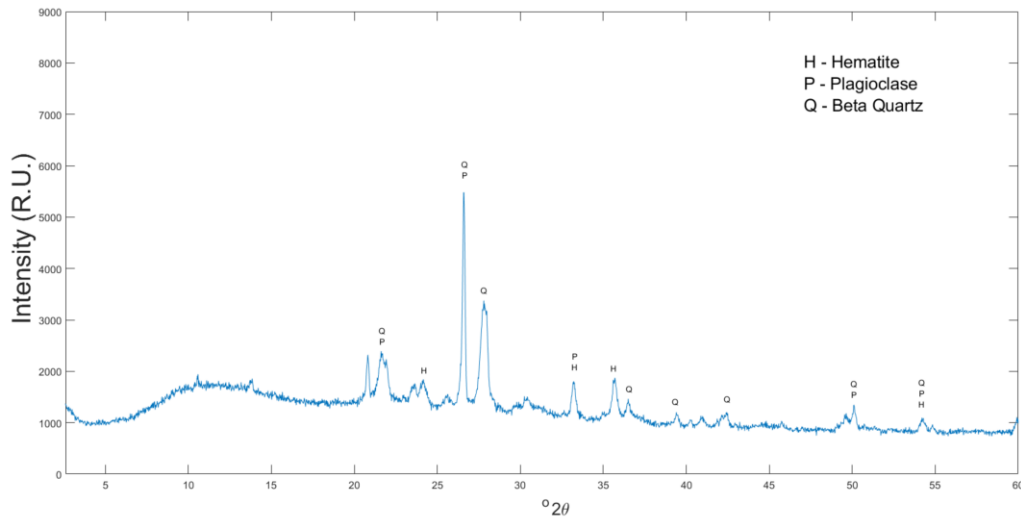
**Figure 5.** XRD patterns showing the different mineral phases.

The existence of certain mineral types in the brick sample can also be utilized as an indicator of firing temperature. As seen in Figure 5, the transformation of quartz from the  $\alpha$ - to the  $\beta$ -structure occurs abruptly at  $573\text{ }^{\circ}\text{C}$  [32]. The brick sample originated from a highly sandy montmorillonitic soil; hence the sand content minimized the amount of Ca and Na detected in the EDXRF and EDX. Montmorillonite, which was originally present in the raw clay material based on the EDXRF data, was absent in the XRD pattern, implying a firing temperature above  $850$  to  $900\text{ }^{\circ}\text{C}$ . Montmorillonite decomposes within this temperature range, and this property was employed to ascribe a possible lowest firing temperature limit of about  $900\text{ }^{\circ}\text{C}$  [33], consistent with the FTIR results. A similar analysis reported in literature for Spanish Colonial Period bricks in the Philippines from Pagsanjan and Liliw, both in the Laguna Province, have montmorillonite still present in the XRD pattern, hence have a lower temperature range compared to the Quipayo brick sample [12]. The brick sample was also made from a non-calcareous raw clay based on the EDXRF (Table 1) explaining the absence of newly formed calcium-silicate mineral phases [34]. Furthermore, since  $\beta$ -quartz is the only predominant polymorph of  $\text{SiO}_2$  in the brick sample, as opposed to the high-temperature variety, which is cristobalite, the highest firing temperature should not exceed  $1,100\text{ }^{\circ}\text{C}$  [35].

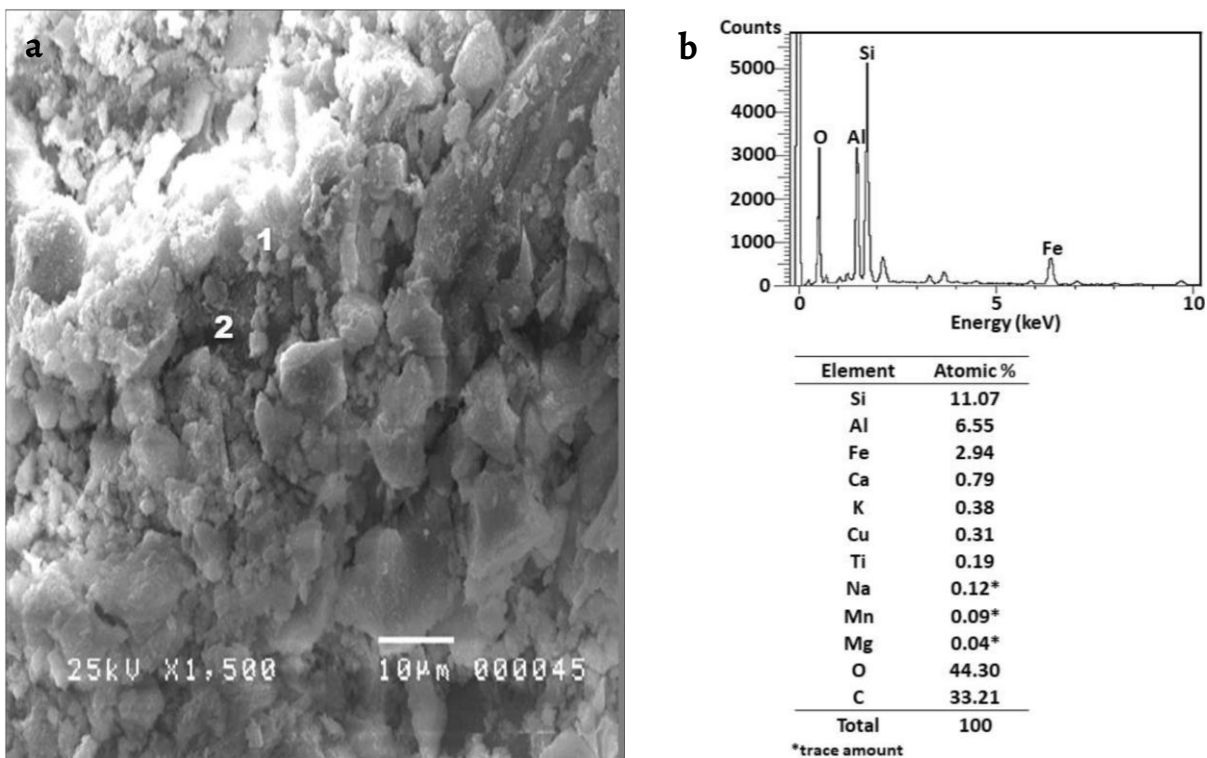
**Figure 6.** Brick sample (inner core): a) SEM image (magnification of 1,500×); b) EDX spectrum and quantitative atomic percentage.

SEM results (Figure 6) show the appearance of buckling in the clay plates (marked as 1) and starting to coalesce (marked as 2). These developments are classified as an extensive vitrification that typically forms at a temperature exceeding  $950\text{ }^{\circ}\text{C}$  in an oxidizing atmosphere [26, 36]. The presence of high refractory fluxes, as determined by the EDXRF data and confirmed through EDX (Table 1), implies that a higher temperature is needed to completely vitrify the brick's microstructure. The SEM did not detect any significant bloating pores, which are usually influenced by the decomposition of calcite or the release of  $\text{CO}_2$  in  $\text{CaCO}_3$ . Since the brick sample is non-calcareous based on the EDXRF data and the EDX detected only  $< 1.0\%$  of calcium on the representative SEM image, calcite is found to be negligible and not involved in the formation of pores.

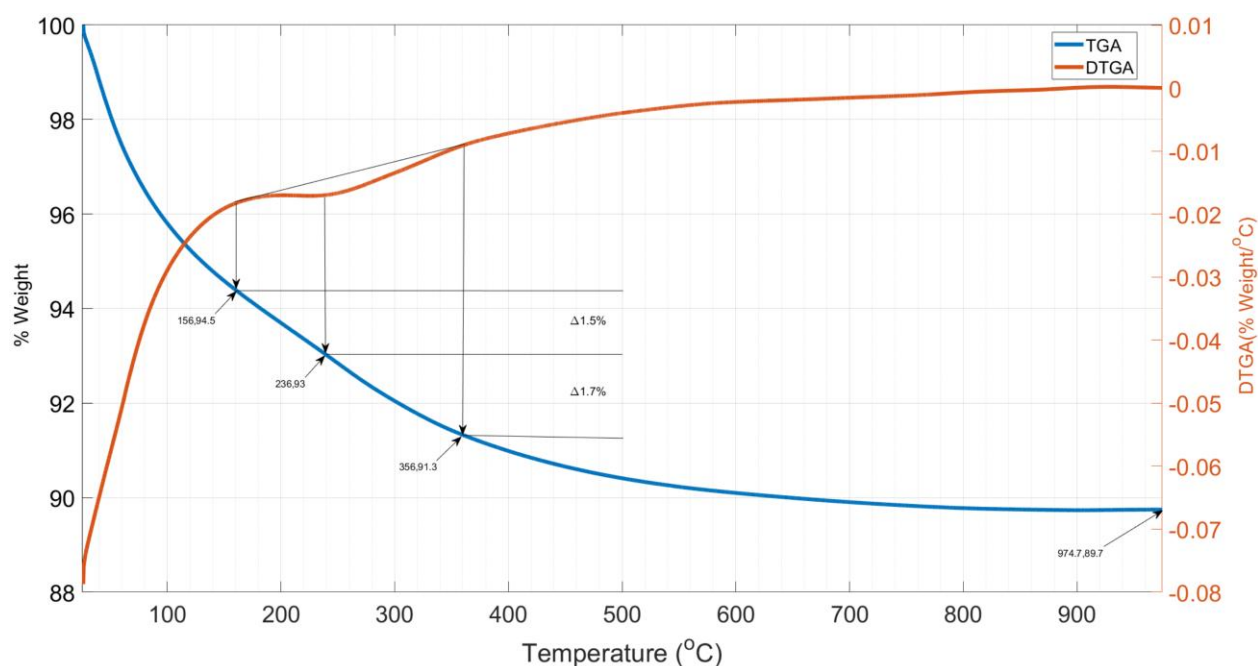
**Figure 7.** Thermogravimetric data of the brick sample. The blue line corresponds to the weight loss and the orange line is the first derivative plot.

TGA methods were used to evaluate the dehydroxylation of clay minerals and the possible presence of calcite or  $\text{CaCO}_3$  in the brick's microstructure. The TGA graph (Figure 7) recorded a continuous weight loss having a total mass loss of 10.3 %wt. from room temperature ( $\sim 26^\circ\text{C}$ ) to  $1,000^\circ\text{C}$ . Two distinct weight losses were observed from the graph, one at  $236^\circ\text{C}$  attributed to the absorbed hygroscopic water (1.5 %wt.) and another at  $356^\circ\text{C}$  (1.7 %wt.). The latter is due to the combustion of highly volatile organic compounds, possibly from organic residues embedded in the ceramic matrix during the manufacturing process, clay mineral dehydration, and hydroxide decomposition, respectively [37]. There is no indication that  $\text{CaCO}_3$  is present in the brick sample due to the absence of massive weight loss between  $700$  to  $850^\circ\text{C}$ .
