The Jerónimos Monastery (Lisbon, Portugal) and the Venice Charter: conservation and restoration challenges of a UNESCO World Heritage monument over the past 25 years

CLARA MOURA SOARES *

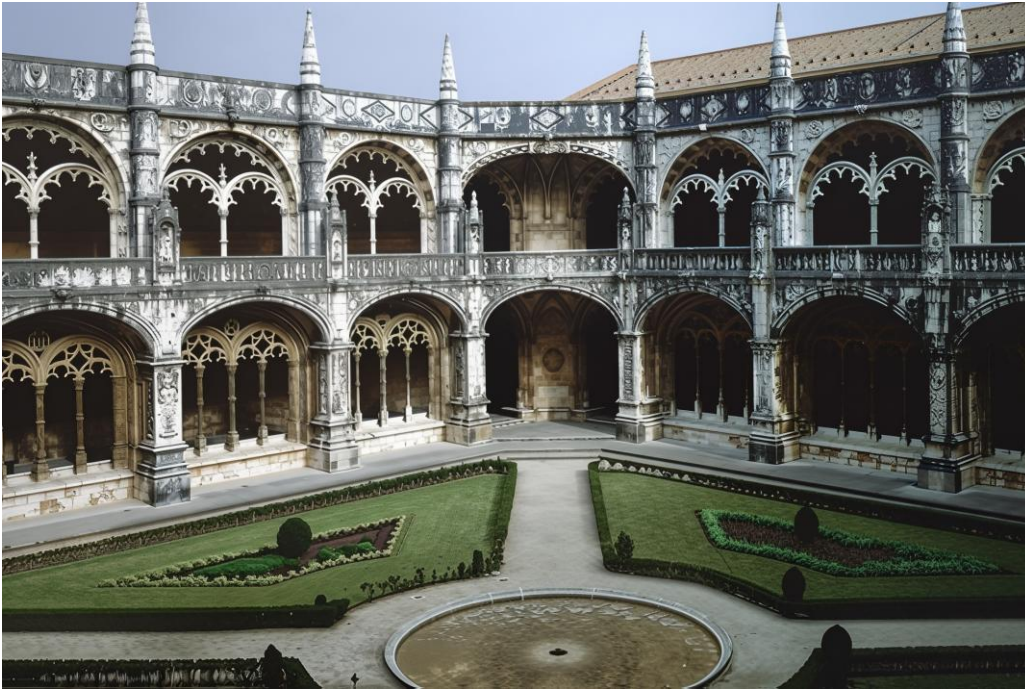
Figure 4. The cloister before the intervention, 1998 (photo: Nova Conservação, S.A.).

By the end of the twentieth century, more than a century after the last major intervention to the cloister, its decorative qualities had been obscured by a layer of black stains. These were caused by excessive direct exposure to rainwater, resulting from alterations to the hydraulic system during the nineteenth century works [18, pp. 74-75] (Figure 4).

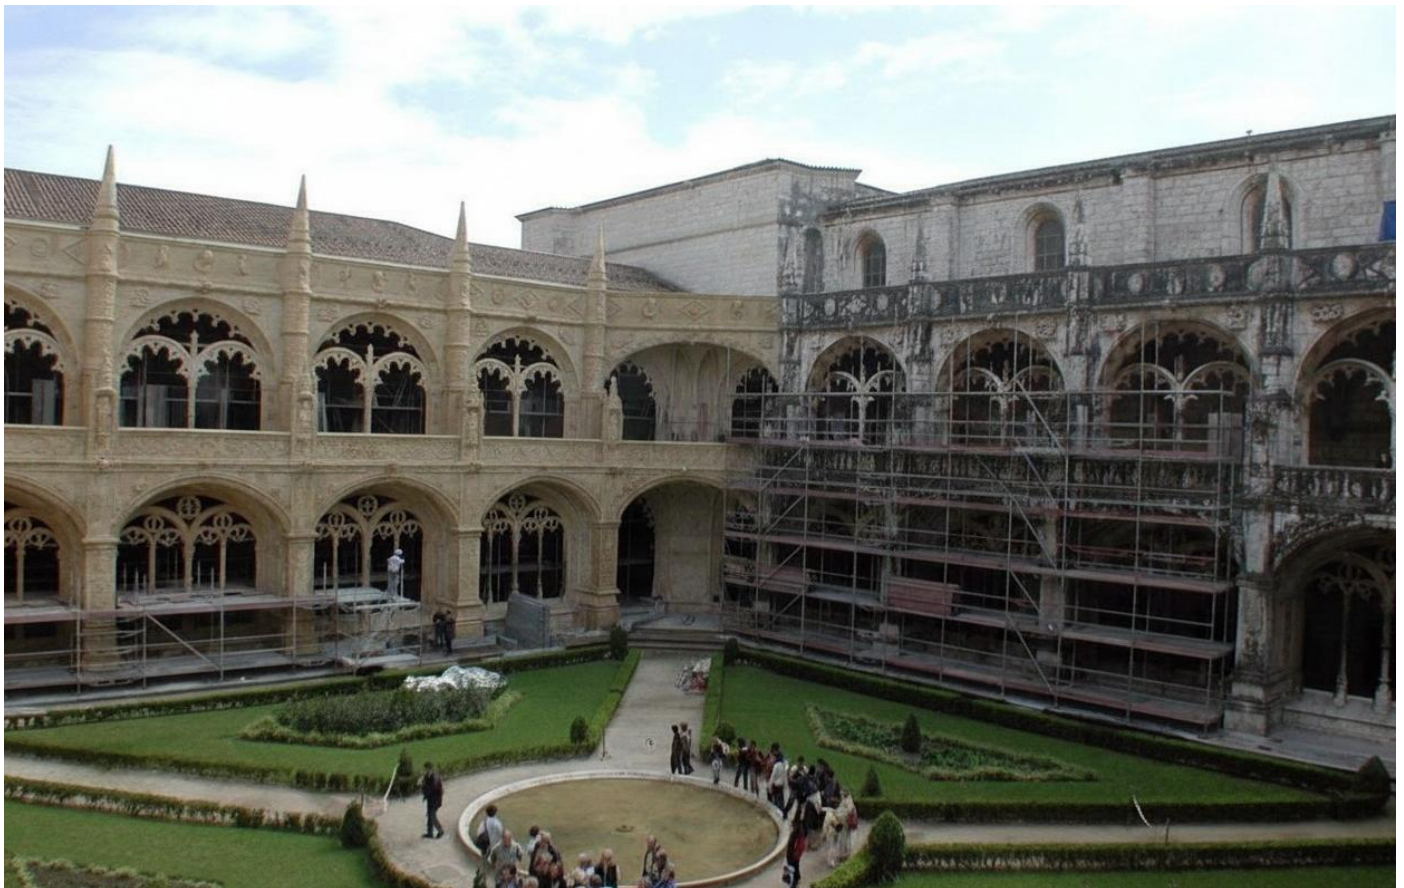
Figure 5. Ongoing works in the cloister, with visitors contemplating the intervention, c. 2000 (photo: D. Caldeira).

In terms of intervention management, the pioneering decision in Portugal to keep the space open to the public during the works, with all necessary safety measures in place should be highlighted [21]. This was achieved through a phased approach, addressing one elevation of the cloister at a time [22, p. 85]. Concurrently, small documentary exhibitions were organised, allowing the public to observe the ongoing work and to perceive directly the intervention's progressive effects (Figure 5).

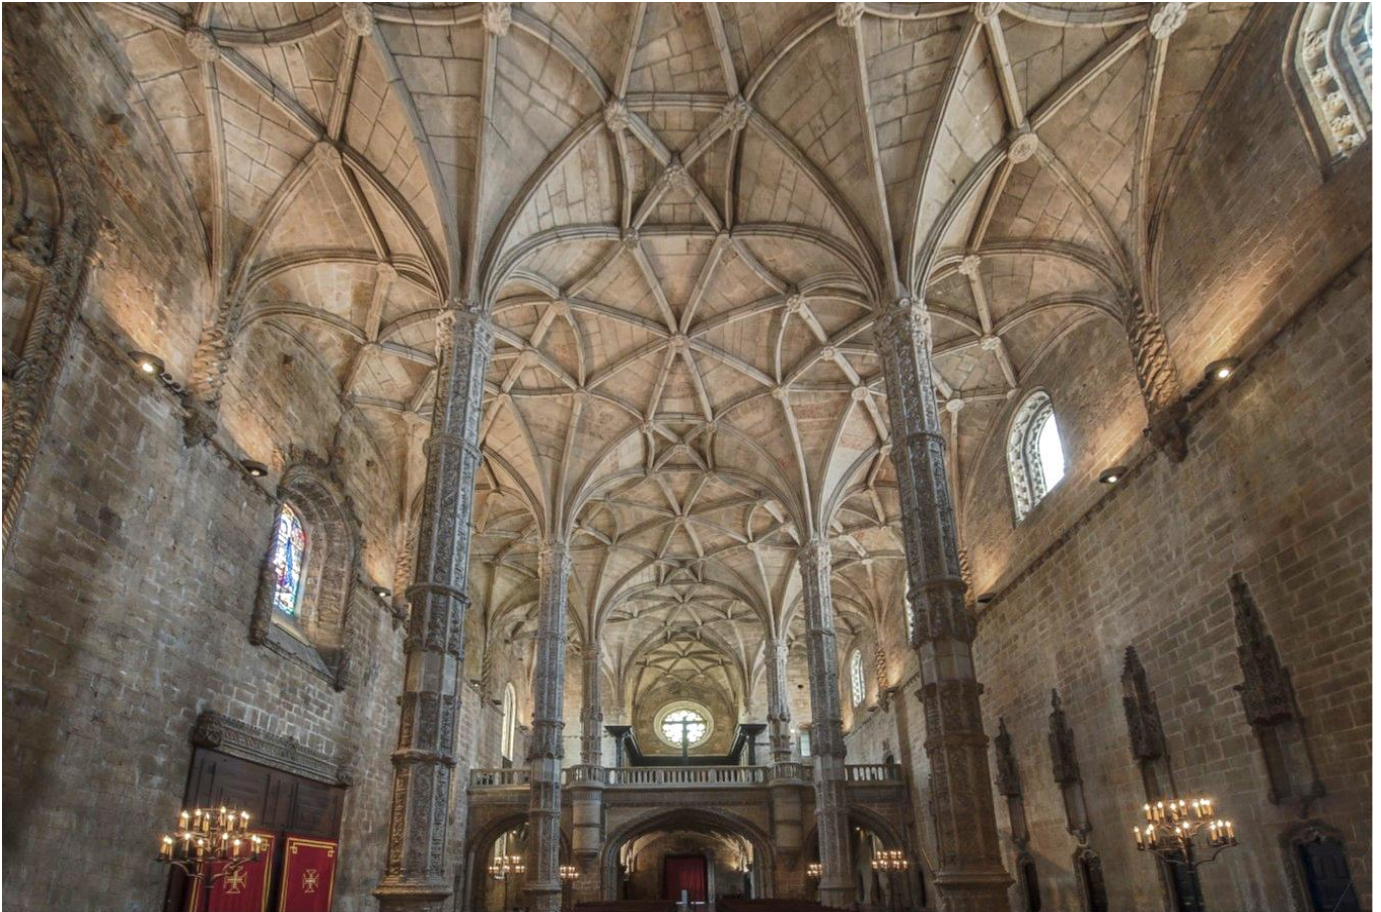
Figure 6. Church, nave vaults, 2013 (photo: A. Serralheiro).

The technical excellence, visual impact, and contribution to the overall monumentality of the space rendered by the vaults of the church makes them unique (Figure 6). However, concerns regarding their conservation status have persisted for many years, with documentation dating back to at least the early twentieth century. Severe infiltrations, akin to those observed in the cloister, have resulted in deterioration of the joint fillings and stone materials, leading to the detachment of fragments. Over time, various interventions have been undertaken to waterproof the roofs and ceilings, as well as to consolidate the vaults and seal the joints [29]. Nonetheless, despite recognising the problem, its underlying cause remained elusive, resulting in the implementation of solutions that primarily mitigated rather than resolved the issue.

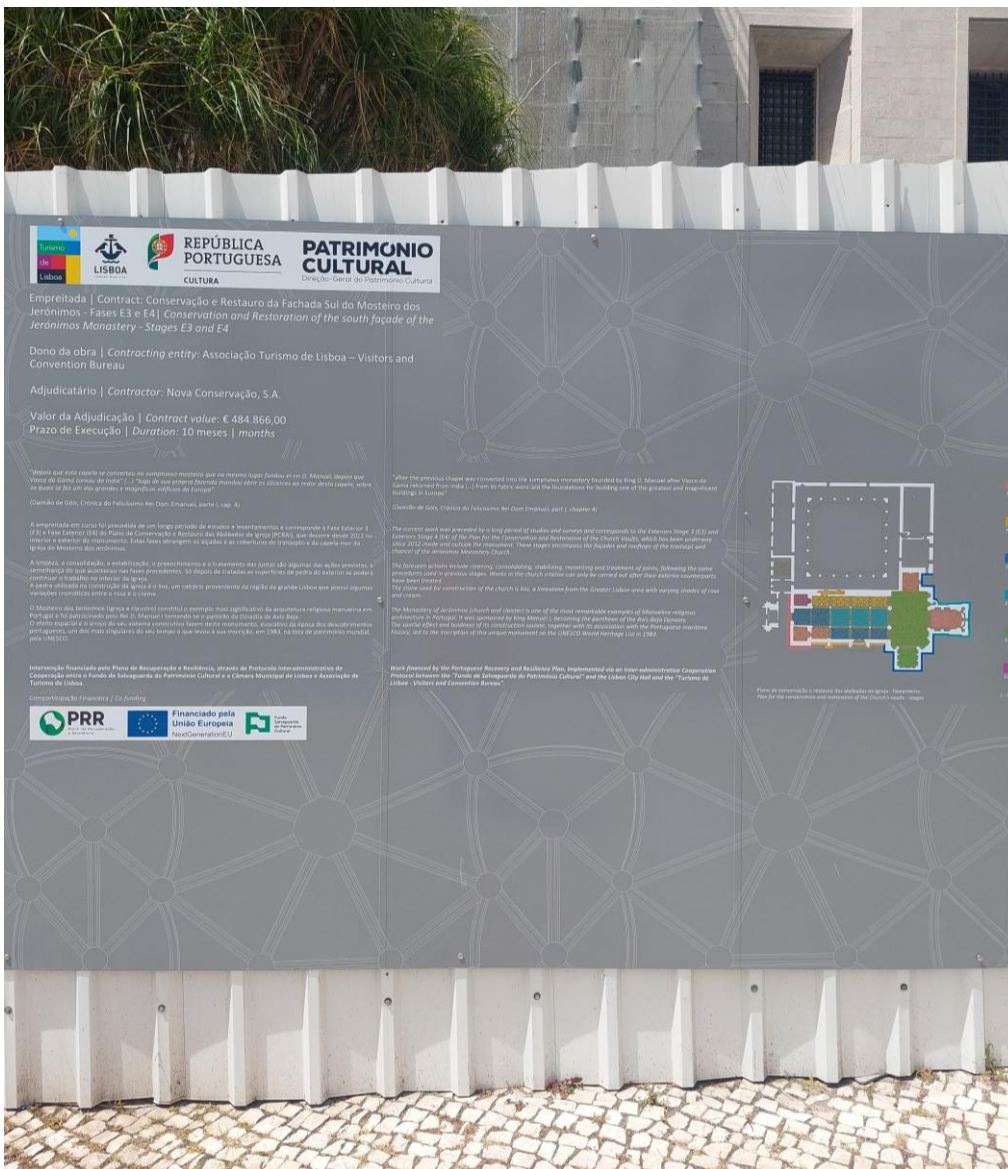
Figure 7. Panel explaining the intervention areas, both in Portuguese and English, 2024.

Under the motto “open for works” [36], special guided visits have been organised for professionals and researchers (architects, engineers, conservators-restorers, art historians), providing, through access to scaffolding, a privileged view of the vaults and the upper sections of the columns. Simultaneously, with engaging daily visitors to the monument in mind, various informational panels have been installed to explain the ongoing works (Figure 7).

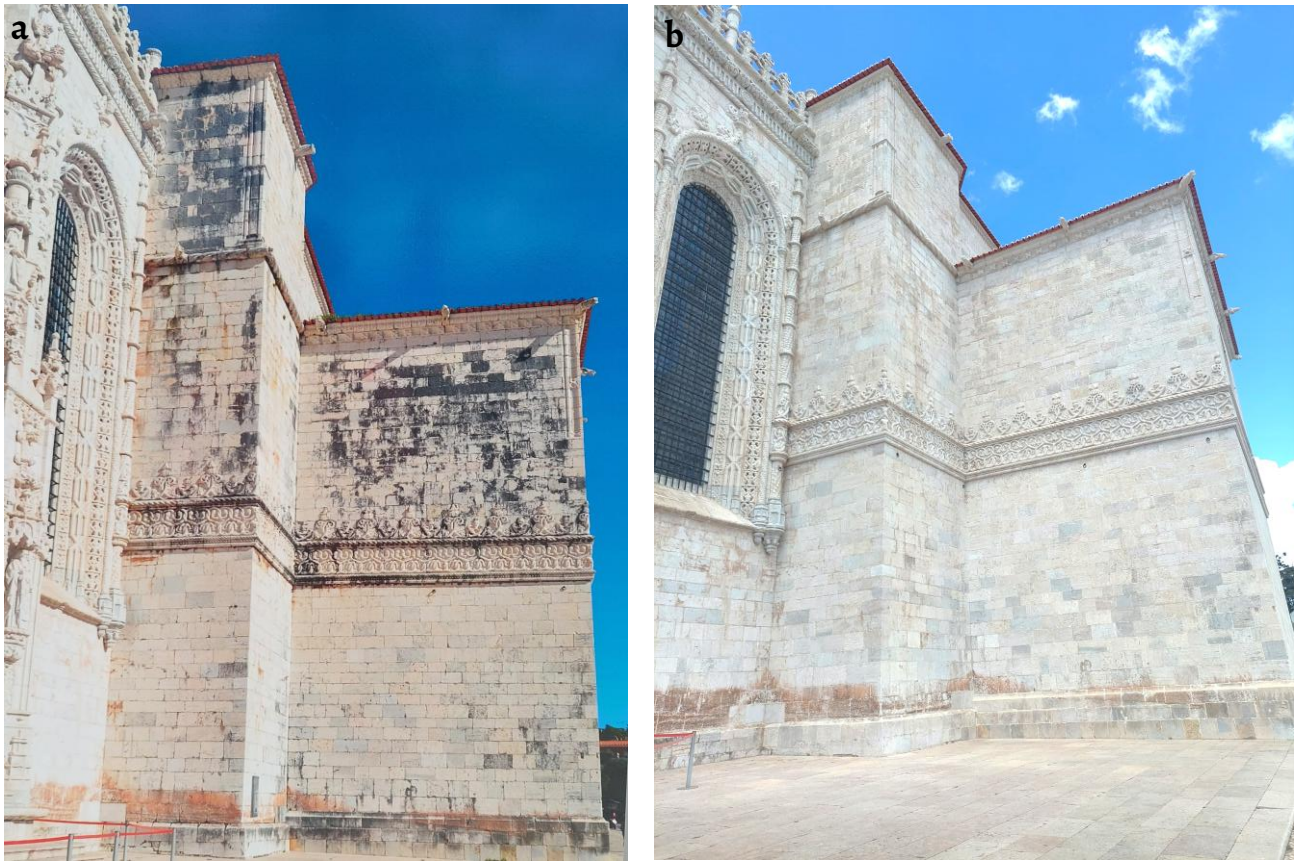
Figure 8. Southern transept chapel façade: *a)* before and *b)* after the intervention, 2024.

The first phase of the works consisted of surveying the conservation state of the intervention area, with the corresponding photographic and graphic documentation. This included markings from the quarrying process, tracing marks, and inscriptions. Following this, conservation and restoration interventions were carried out, which included a cleaning process. These comprised dry methods, wet methods, chemical methods, and mechanical ones, the latter being applied to darkened areas where the other techniques proved ineffective. For the vaults, the use of laser technology for cleaning was deemed unsuitable, as the dirt was superficial, and the surfaces were minimally ornamented.

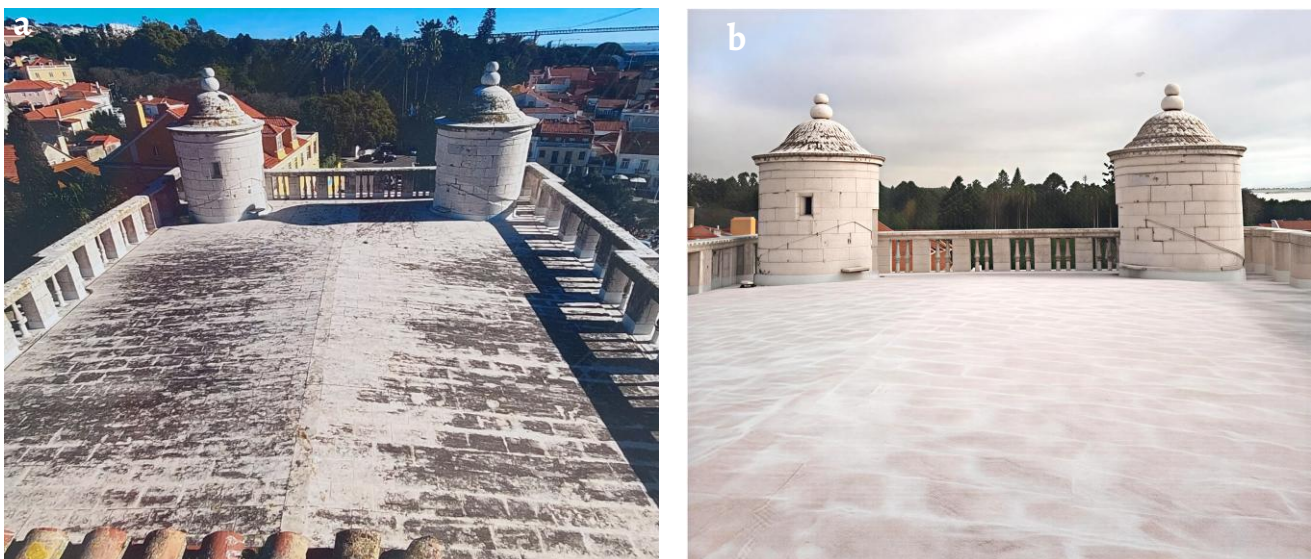
Figure 9. Chancel's roof: *a)* before (photos: Nova Conservação, S.A.) and *b)* after the intervention, 2023.

Structural reinforcements, stabilization of various elements, fixation and adhesion of displaced components, as well as the treatment of stone and metallic elements and joints, have constituted the primary interventions carried out. Concerning the joints, the actions have included the removal of degraded materials, filling with mortars that replicate traditional techniques, such as lime and sand-based mixtures, using injections, resealing of the joints, and finishing with micro-plastering. These efforts were made to achieve chromatic harmony of the surfaces through the application of natural pigments [37]. Externally, an inspection of the roof and covering system was conducted, along with the rectification of the drainage system, including the gutters (Figure 9).

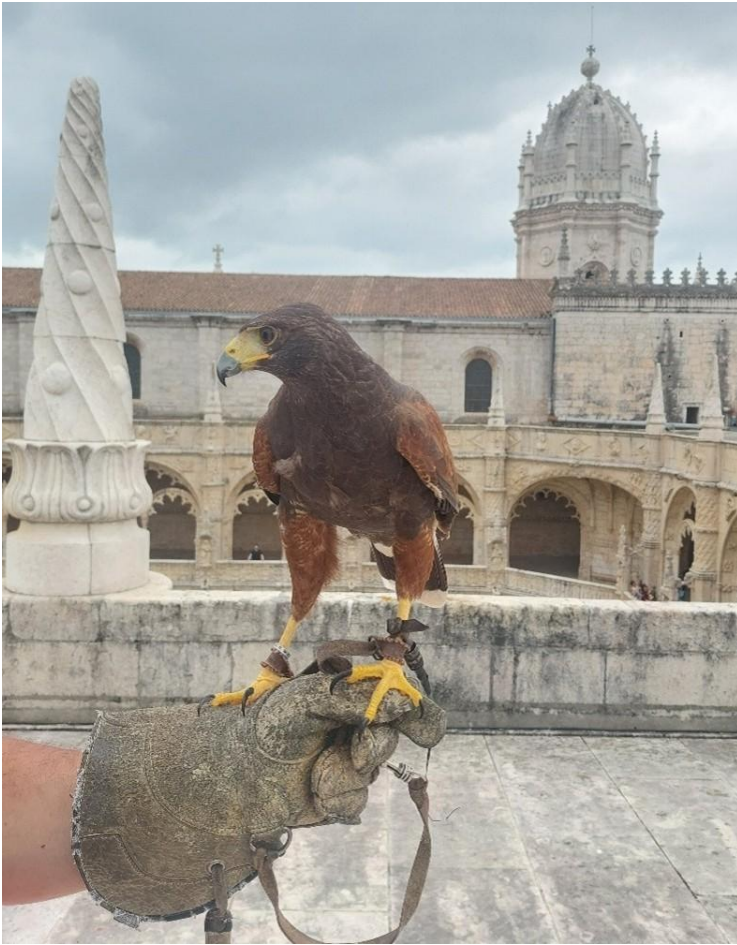
Figure 10. Falcon and falconer hand, doing its rounds on the cloister's roof, May 2024.

Recently, bird control measures have proven to be effective in deterring seagulls, as they help to protect the monument without causing harm to wildlife. The ineffectiveness of the previous employed method, which was based on an electric repellent system installed in 1994 and subsequently destroyed by the seagulls themselves, led to the adoption, in 2020, of a practice involving the use of raptors, such as eagles and falcons. This approach does not involve capturing or hunting prey, rather, it aims solely to dissuade the birds from inhabiting the territory occupied by the predator (Figure 10). The method has previously been utilised
