Número *Issue* 8 | Dezembro *December* | 2008

| Conservar Património |

HMC 08 | HISTORICAL MORTARS CONFERENCE
24th TO 26th SEPTEMBER 2008 | LNEC | LISBON | PORTUGAL

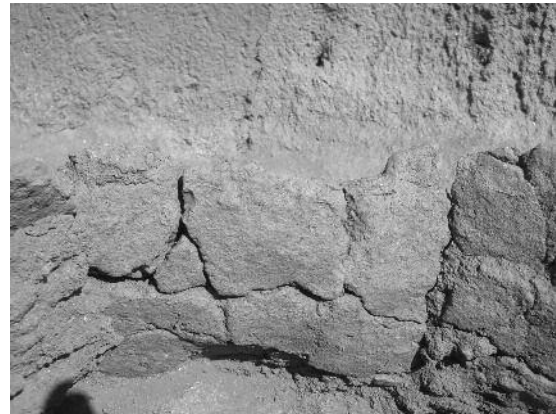
Fig. 6 Defesa de Cima 2: detail of pit 5 interior renderings (photo: Filipe Santos/ Arqueohoje).

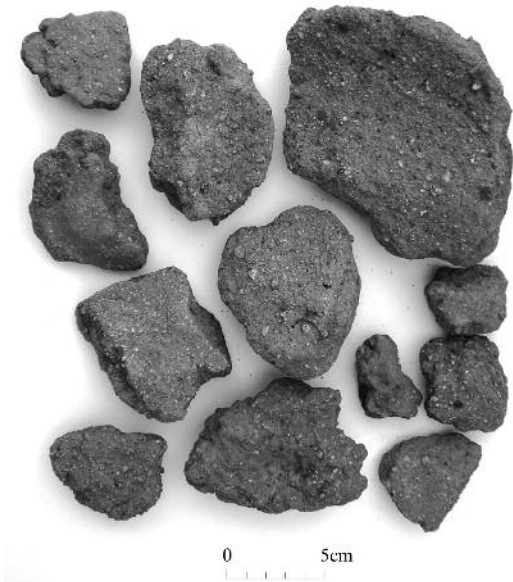
Fig. 7 Defesa de Cima 2: samples from pit 5.

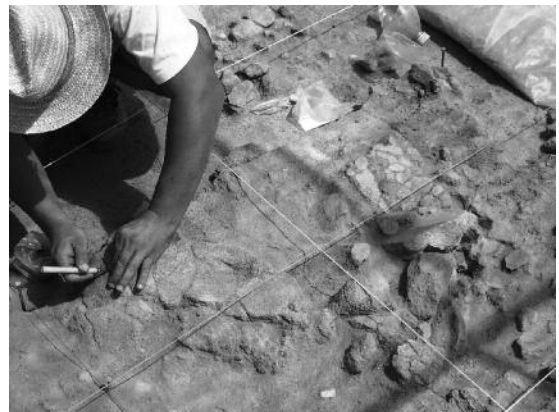
Fig. 9 Combustion structure L8.1 of Lajinha 8 before dismounting, with vestiges from the probable covering.

Structure L8.1 (figures 9 and 10) was made upon a pit with 90 cm of diameter and 20 cm of depth. Clayish renderings surfaced the walls and the base of the ditch; inside archaeologists found thermoclasts.

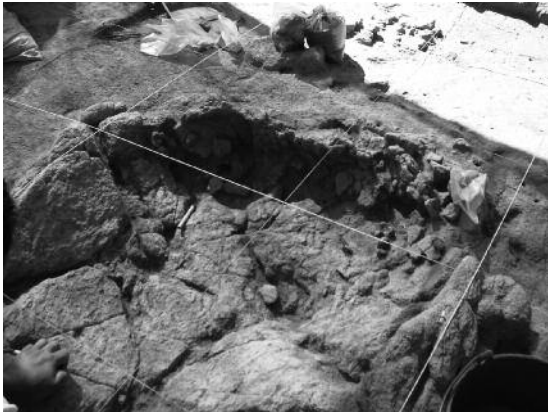
Fig. 10 Combustion structure L8.1 of Lajinha 8 after excavation, with renderings vestiges in situ.

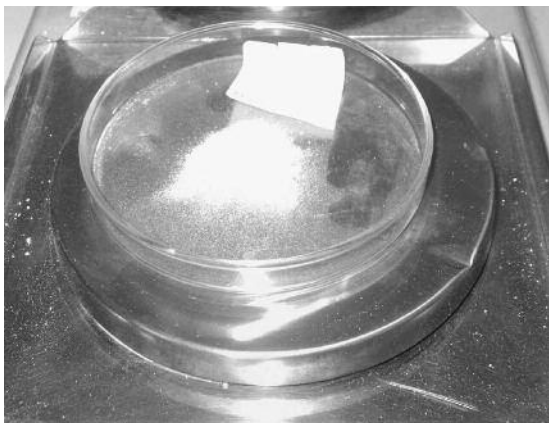
Fig. 1 Residue after drying of the simple limewater.

The drying of limewater additivated with metakaolin was also carried out and it was easily observed that the two dry products presented differentiated structures. The residue of the simple limewater was presented as a powder (calcium carbonate) with formation of small crystals, while the residue of the additivated limewater presented a greater amount of plate shaped crystals (figs. 1 and 2).

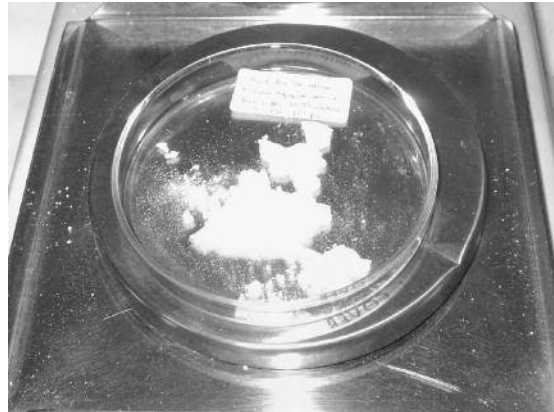
Fig. 2 Residue after drying of limewater additivated with metakaolin.

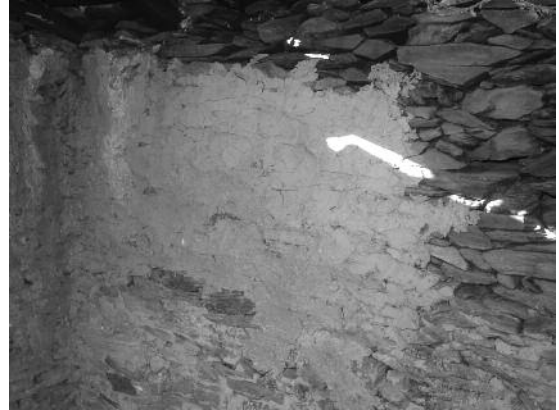
Fig. 2 Mozinhos – Penedono, indoors earth render.

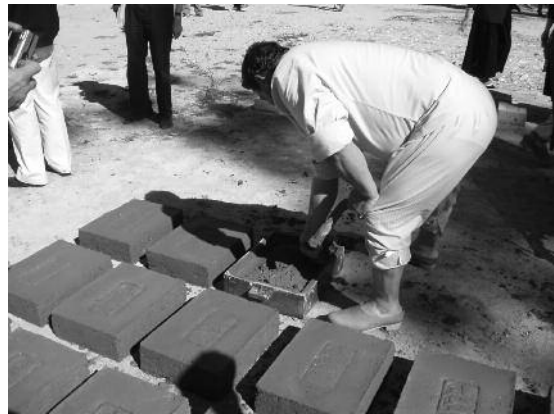
Fig. 4 Oliveirinha, workshop V ATP, the adobe production. Earth stabilized with lime.

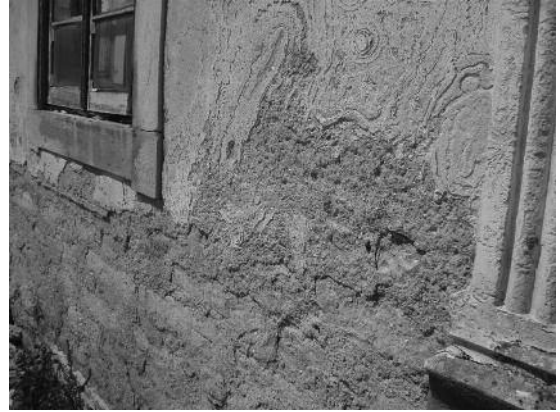
Fig. 7 Vilamar 1, architectonic surface detail.

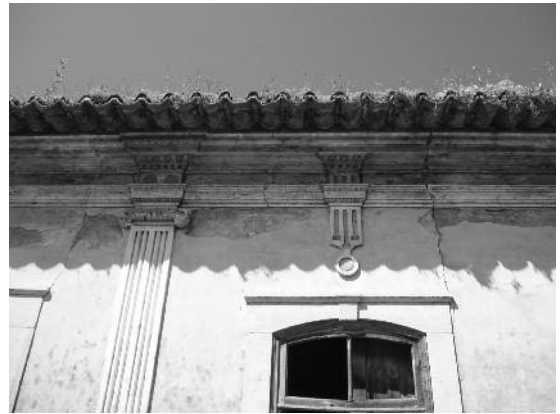
Fig. 8 Vilamar 2, decoration detail.

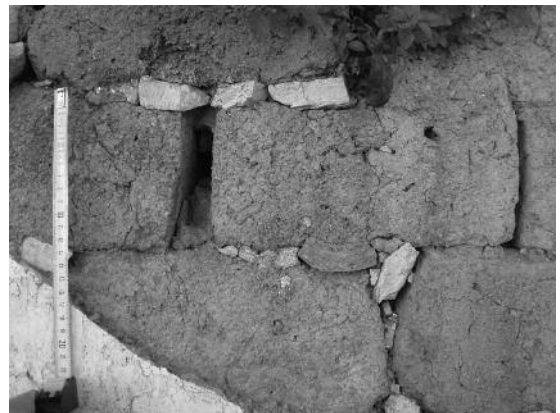
Fig. 9 Martingança (Leiria), adobe wall detail.

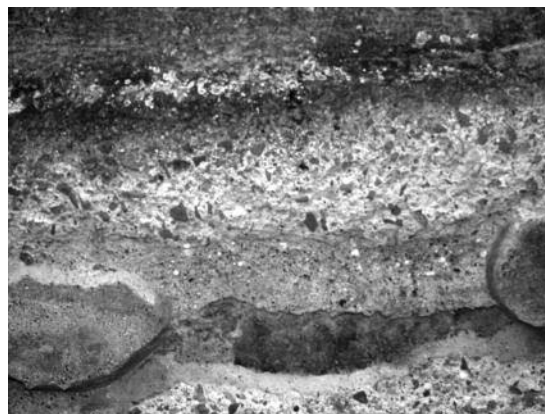
Fig. 1 Ceramic additivated mortars in Stabian baths in Pompey, Italy.

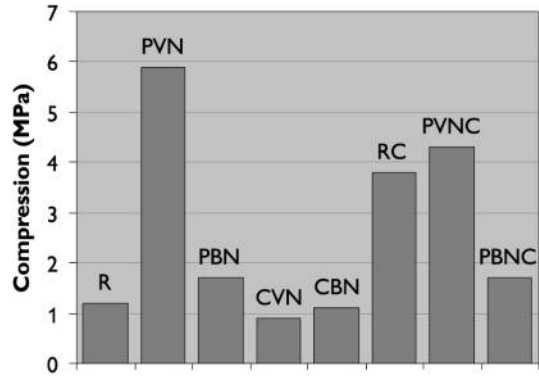
Fig. 3 Comparison of the mechanical strength. Preliminary tests with 1:2:1 (lime, sand and ceramic powder) in mass. Samples' codes: R= reference samples; P=powder; V=red; B=white; C= artificially carbonated; N= burned in lab.

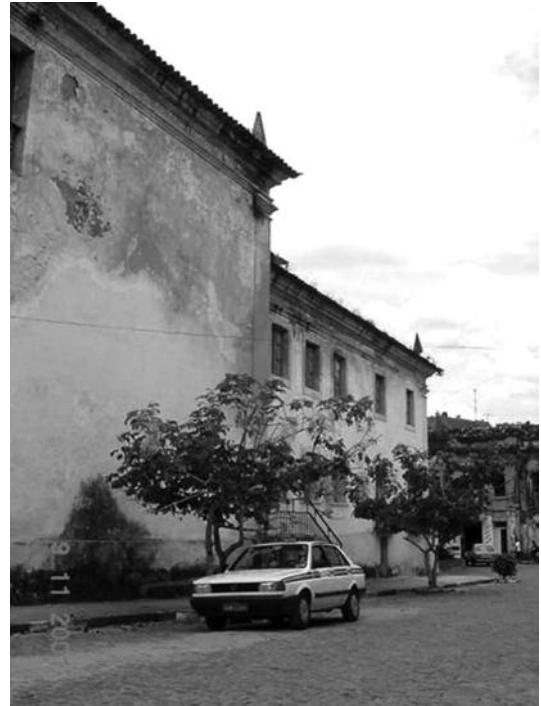
Fig. 11 Situation before the restoration (2001).

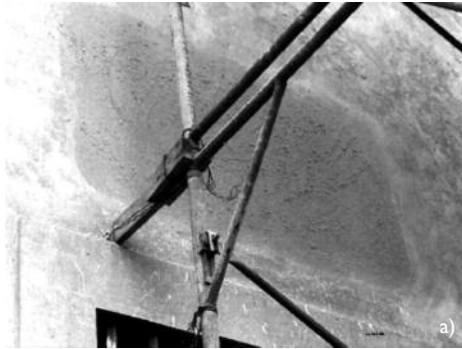
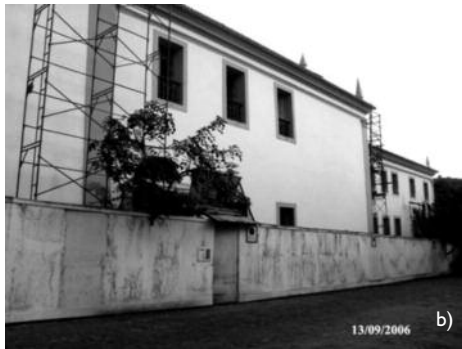
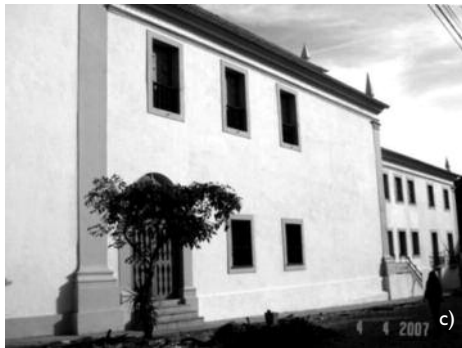
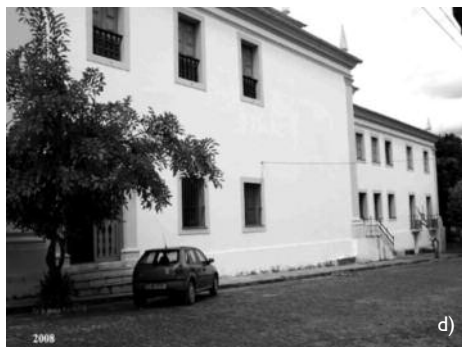
Fig. 12 a) Coating tests; b) After the application in 2006; c) Situation 2007; d) Condition in 2008.

The preliminary tests for the coating of the most affected area, using a mortar similar to the one found in that same place (lime+sand+"saibro"), showed that this mortar, in little time, exhibited signs of decay, which also happened when the lime was substituted by a cementitious material. Only the mortar with ceramic powder is holding on to the present day, with the final application of mineral paint (Fig. 12).

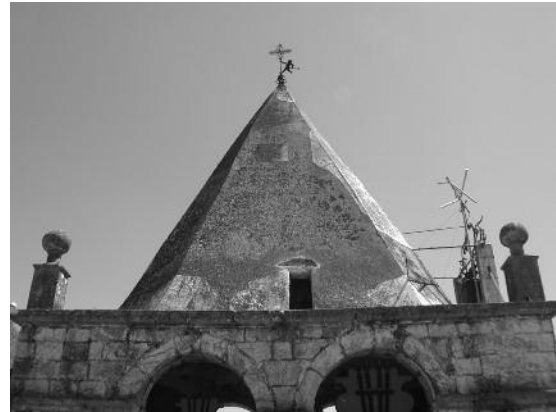
Fig. 3 Initial state of conservation of the pyramidal tower.

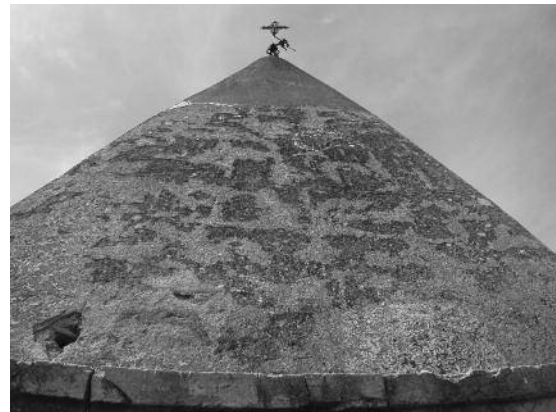
Fig. 4 Detail of the initial state of conservation.

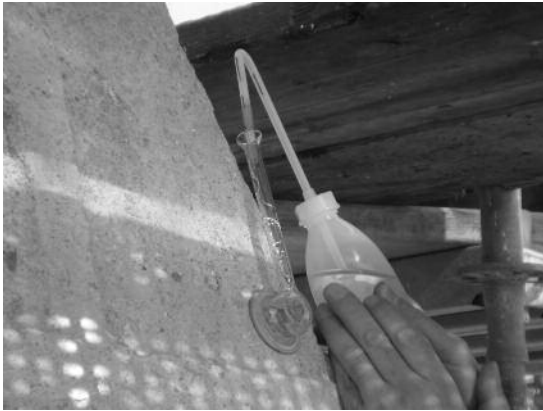
Fig. 8 In loco, water absorption experimental tests were made to characterise the original materials.

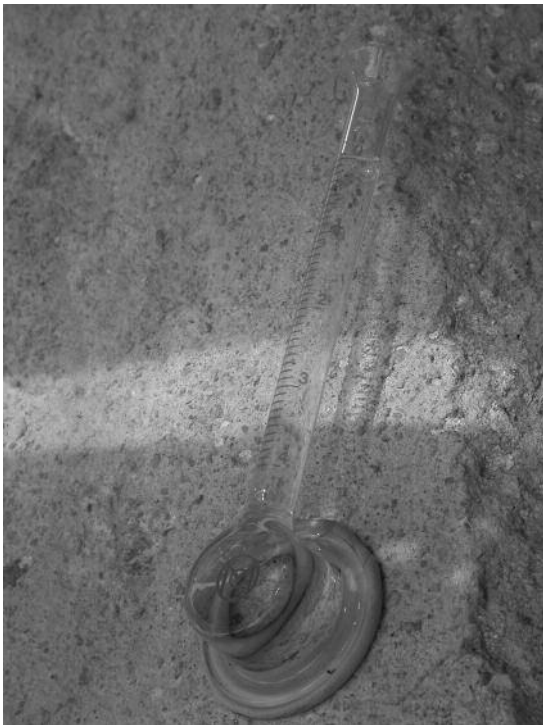
Fig. 9 Detail of the experimental tests.

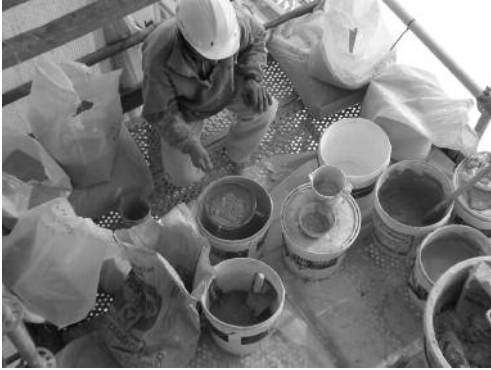
Fig. 10 Preparation the restoration lime mortar, mixed with washed sand and standard grain size.

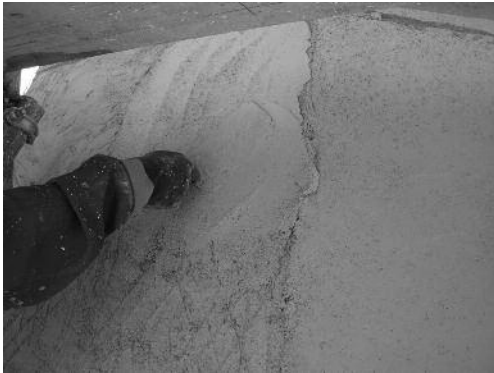
Fig. 11 Application of the restoration lime mortars, after the humidification of the support. Scattering until the render thickness was obtained.

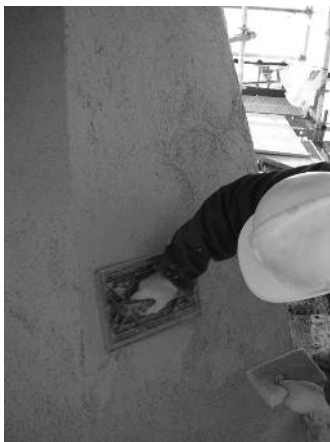
Fig. 12 Using the mason's mortar-board to compress the mortar; before adding different coloured sands to the mortar, and with the mason's mortar-board compressing again the render.

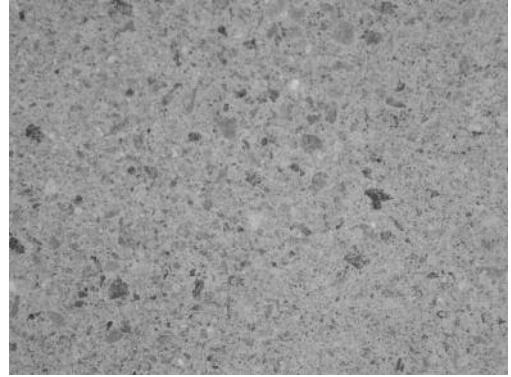
Fig. 13 To obtain this aesthetic aspect of the surface the following process was used: (1) Compressing, after the first drying, with a metallic mason's mortar-board, the surface again, through arch movements, until a "cream/gum" was formed; (2) water pulverization of the surface; (3) brushing the surface and removing the "cream/gum" using a humidified sponge until the coloured sand grains were seen.

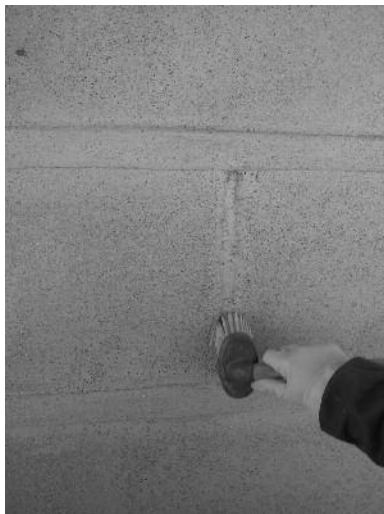
Fig. 17 Removing the mortar in joints with metal tools; cleaning and humidifying the furrows.

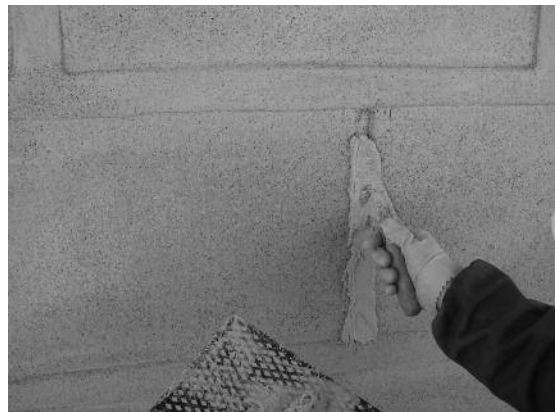
Fig. 20 Application of the mortar in the joint area.

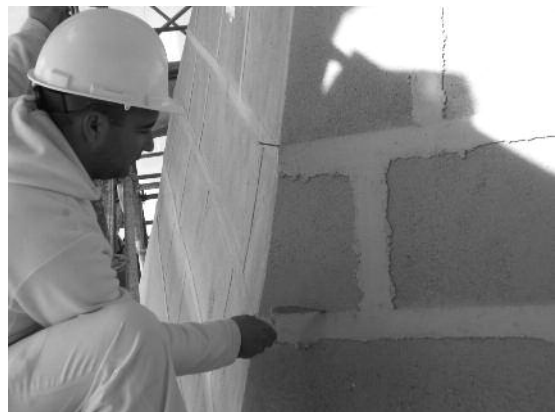
Fig. 21 Removing and cutting, after a first drying, the excess mortar, according to the decorative scheme.

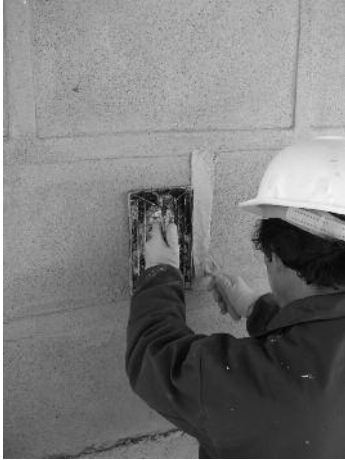
Fig. 22 Applying a thin grain size mortar in the joint area after pressing and watering the render during the drying stage to avoid the mortar being fissured.

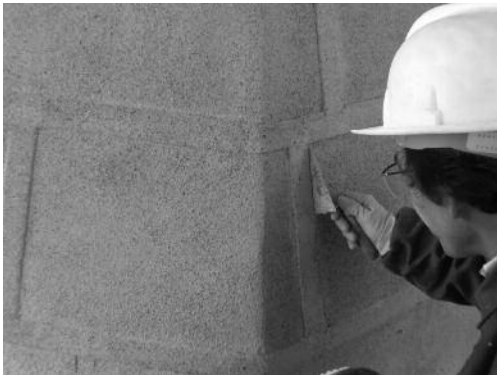
Fig. 23 Detail of the application of the final decorated layer with raised joints.

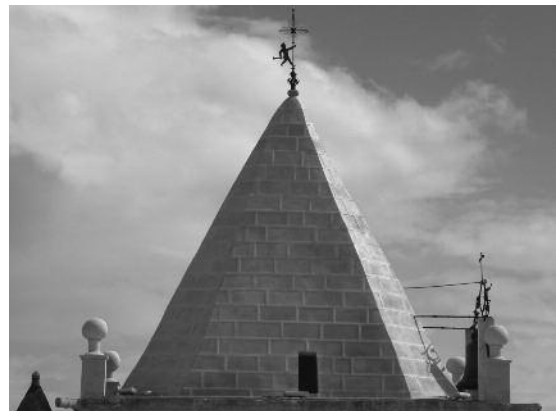
Fig. 26 The pyramidal tower after the conservation and restoration works.

The case described in this paper may be considered a remarkable example for future interventions (figs. 26-27). The methodological approach, the collaboration of the conservation team and the Project coordinator to identify problems and to find solutions, the synergies created by the trans-disciplinary team, all demonstrate that it is possible to learn about the monument, its techniques and materials during the conservation process and to have a continuous evaluation and validation of different options taken along the process. It is clear that, in cases where there are unknown, unpredictable factors, due to the specific work and value of the materials; it is possible to change the course of action and introduce new

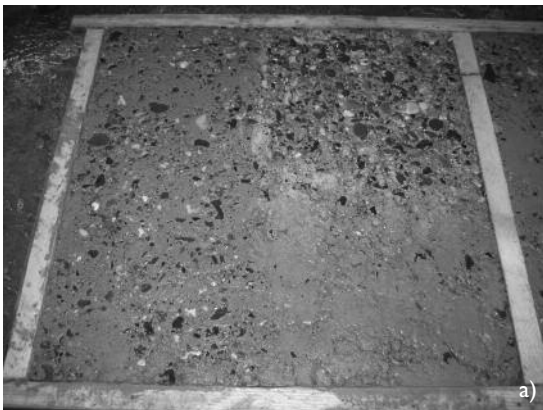
Fig. 4 To reproduce the eroded facies encountered on the ancient concrete to be restored, two deactivation products were tested, inducing 2 depths of deactivation (a) and (b).

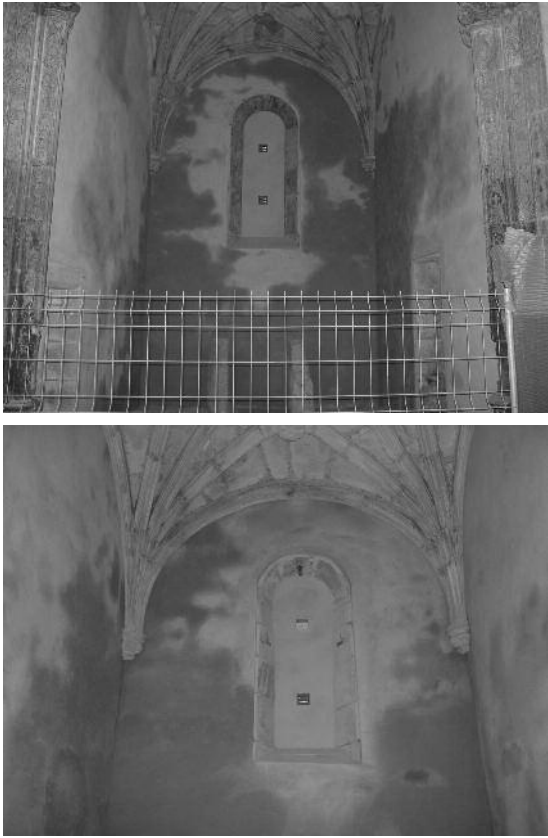
Fig. 4 Drying of a lime-base rendering inside a church in Northern Portugal (September 2004 and January 2005).
