Número *Issue* 7 | Junho *June* | 2008

# | Conservar Património |

**HMC 08 | HISTORICAL MORTARS CONFERENCE**  
24th TO 26th SEPTEMBER 2008 | LNEC | LISBON | PORTUGAL

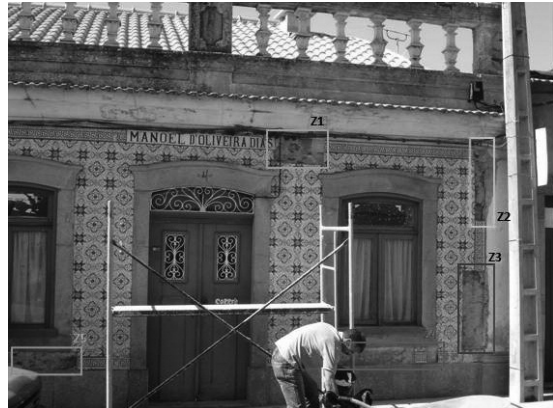
Fig. 1 Mortar sampling, showing different sampling areas

Sampling in each building was performed at various heights taking into account different conservation states of the facade tiles. Sample location is identified taking into account the building where it was collected, the area from which it was taken (Z1, Z2,...), as seen in Figure 1, and the sample number (A1, A2, A3...) in the form of : House\_Zone\_Sample.

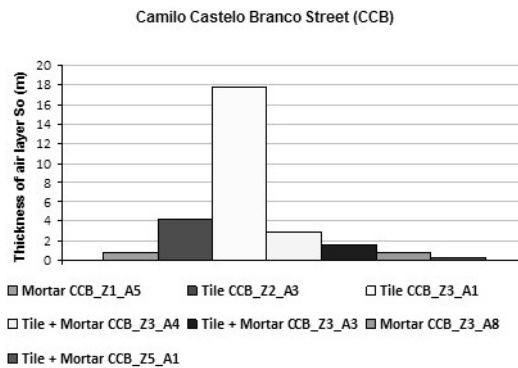
Fig. 3 Thickness of the equivalent air layers of mortar samples

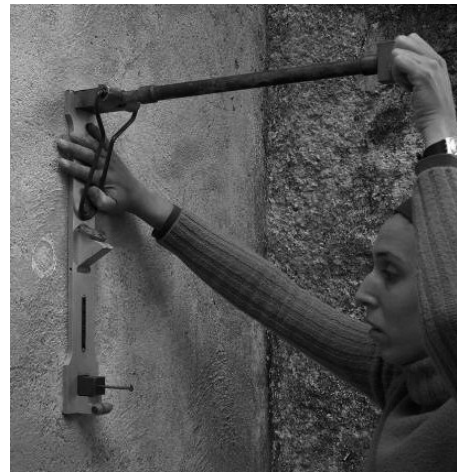
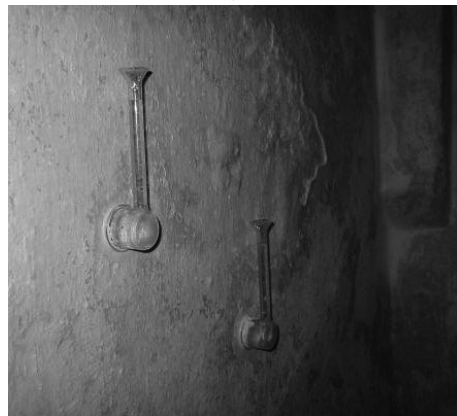
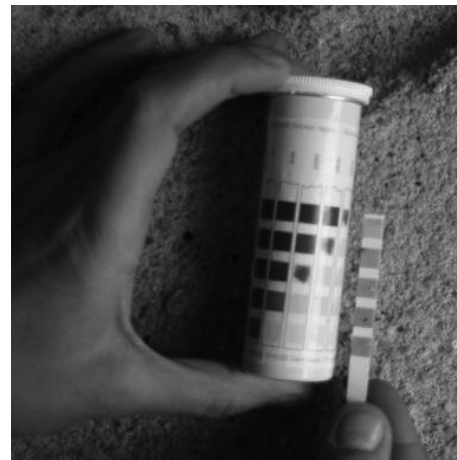
Fig. 3 a) controlled penetration; b) Karsten tubes; c) Salt identification with colorimetric identifiers.

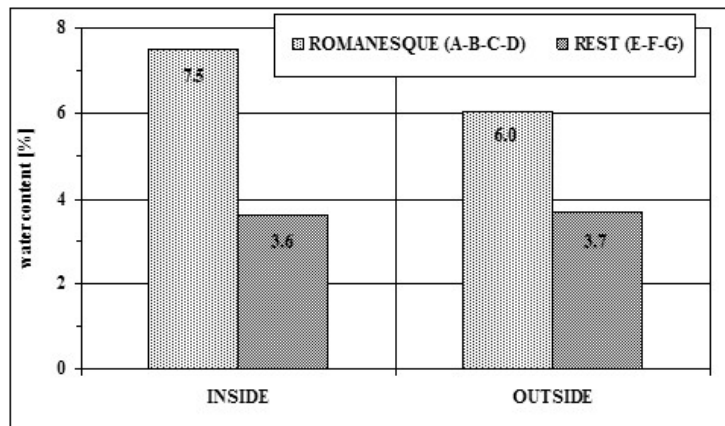
Fig. 5 Comparison between the average values of water content of masonries measured in the Romanesque part and in the rest of the building.

The Romanesque portion of the church shows the greater water contents in masonries (Figure 5) without

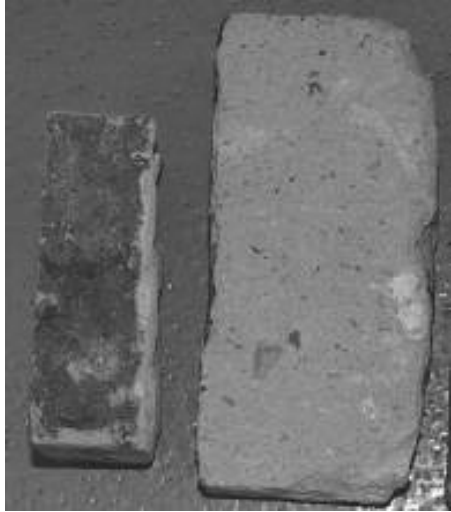
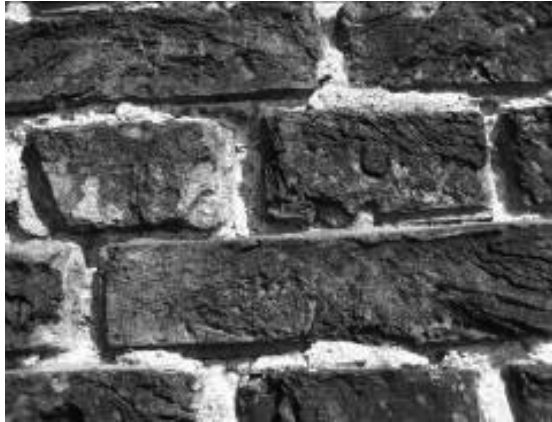
Fig. 3 Above, outside weathered side face of brick and inside (not weathered) original bed face of brick; below, outside weathered side of a wall.

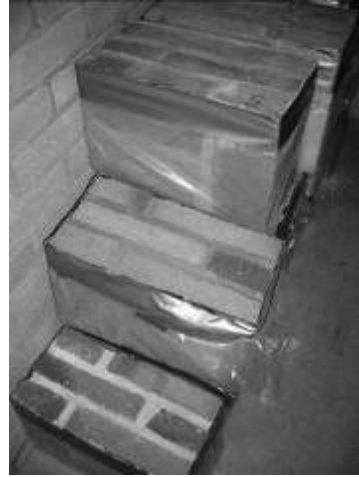
Fig. 5 View of test specimens. During the test, the uncovered face (the outer side of the wall) is exposed to absorption of water ("rain") or drying; the other 5 sides are protected by plastic to allow drying from the uncovered face only (unidirectional drying as in a wall). Tests were performed by TNO-Built Environment and Geosciences, the Netherlands.

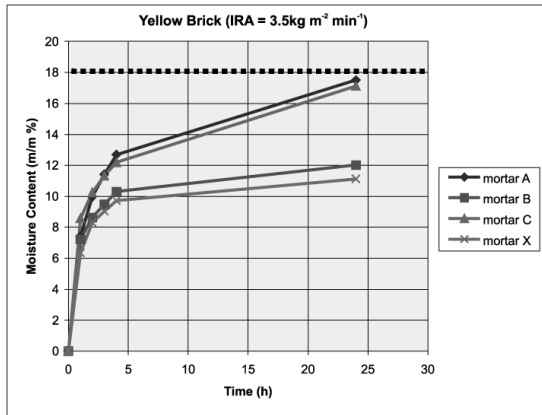
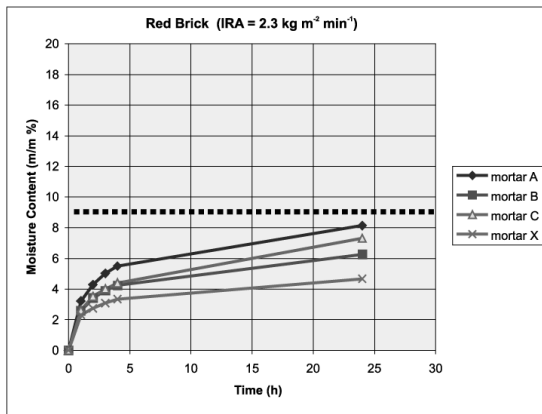
Fig. 6 Water absorption tests on various brick-mortar combinations tested; mortar A and C are lime mortars, mortar B and X are hydraulic mortars; the horizontal dotted lines in the figures indicate the values of the free water absorption by weight of the bricks (by capillary absorption from one face, over a 24 hour period) for the yellow bricks ~18 (m/m %); for the red bricks 9 (m/m %).
