# A preliminary approach for blooming removal in polyurethane-coated fabrics

Coated fabrics with thermoplastic polyurethane (TPU) are largely found in fashion and design collections in imitation leathers and glossy-look fabrics. Unfortunately, blooming is a common damage in aged TPU, appearing as white crystalline deposits at the surface. These deposits have been generally identified as adipic acid and mainly affect ester-based aromatic TPU. The white colour of adipic acid often leads to the complete unrecognition of the cultural item, highly decreasing its values. Strategies to remove blooming are still absent in the literature, resulting in a lack of action by conservators. The Glossy Surfaces project addressed this issue through preliminary research on cleaning strategies to remove adipic acid. Dry and wet methods were tested on two fabrics showing blooming and different surface cohesion. Non-confined and confined liquids in hydrogels were included and assessed by digital microscopy, colourimetry, and infrared spectroscopy. The best results were achieved with agar-agar, but limitations were also recognized.

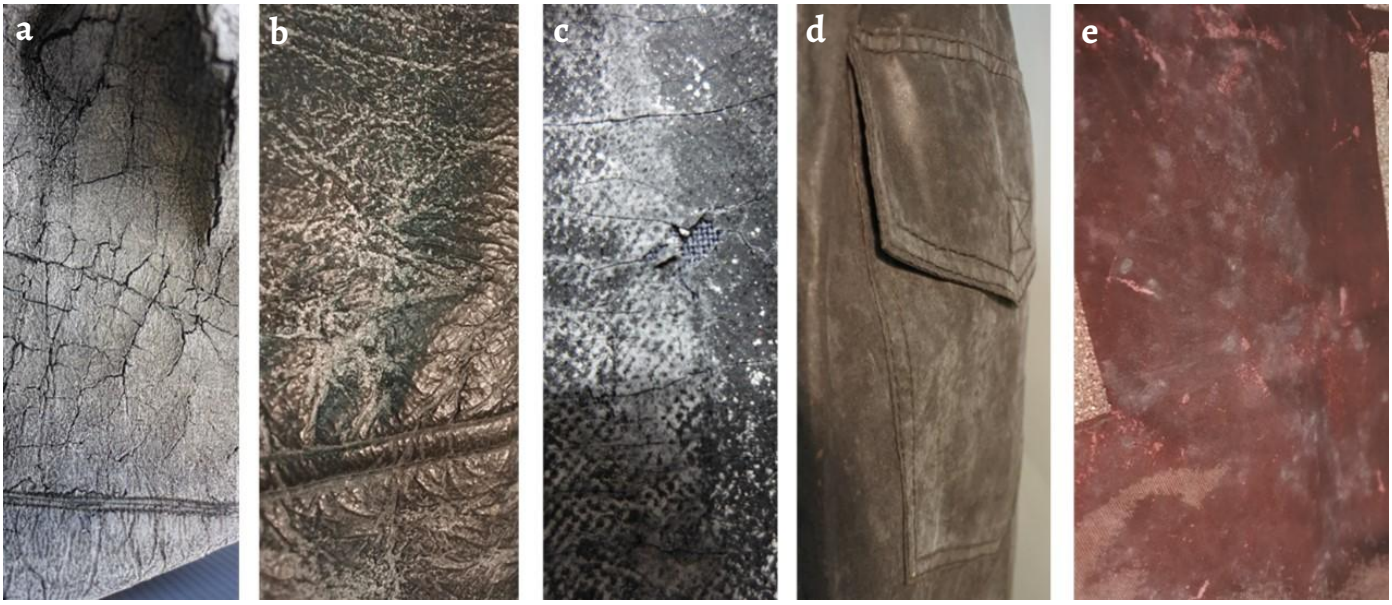
garments, shoes, and accessories [7]. Figure 2 shows examples of blooming in imitations of leather with glossy or suede-like textures assessed within the Glossy Surfaces Project.

**Figure 2**. Examples of blooming visual appearance in TPU coated fabrics from fashion case studies produced: *a)* 1960s; *b)* 1970s; *c)* 1980s; *d)* 1990s; *e)* 2000s.

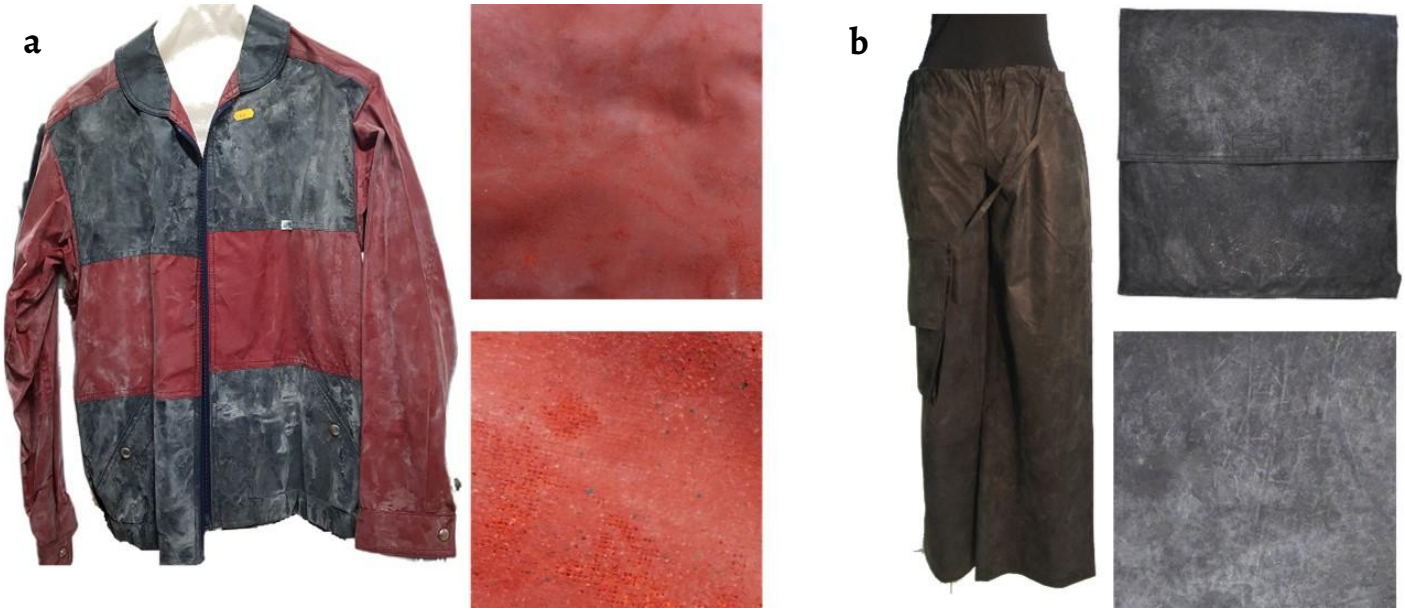
Two ester-based aromatic TPU-coatings in polyester substrates featuring blooming were selected (Figure 4). Although both exhibit blooming, one shows a more deteriorated condition with a fragile TPU coating that crumbles when handled, while the other is less deteriorated with a cohesive TPU coating. The latter is part of a fashion outfit designed by Portuguese designer Maria Gambina, consisting of a coated fabric pouch from an ensemble that also includes a pair of pants. This fashion outfit was considered a total loss by the designer due to the intensity of blooming and was donated to MUDE (The Design and Fashion Museum, Lisbon, Portugal) for research purposes. The item was left intact and 4 cm windows at the back were cleaned following the selected methods. The highly fragile TPU coating case study was purchased and consisted of a red and black jacket, of which red squares of 4 cm were cut to be cleaned following the different methods.

**Figure 4**. Selected TPU-coated fabric case studies featuring blooming for the cleaning study, with different TPU cohesion: *a)* a fragile TPU coating that crumbles when handled; *b)* a still cohesive TPU coating (pouch belonging to Maria Gambina's ensemble). Detailed images of the condition of the TPU-coated fabrics are shown close to the piece (top ones: naked eye, bottom ones with magnification ~10×).

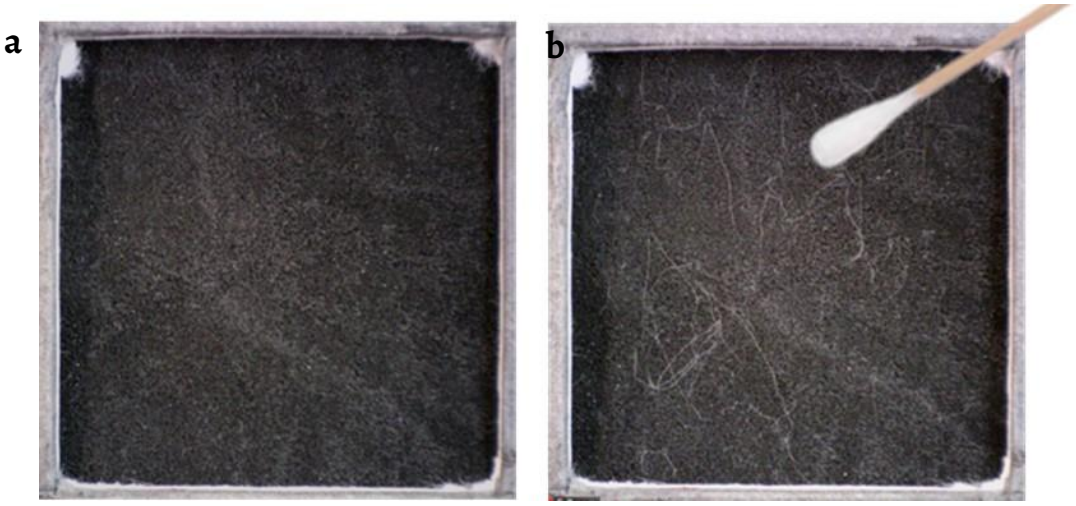
**Figure 5**. Less deteriorated TPU-coated fabric with blooming: *a)* before and *b)* after dry-cleaning with a cotton swab.

As presented in Table 1, the three dry-cleaning methods tested (cotton swab, sponge, and adhesive tape) demonstrated reduced safety as a large amount of TPU particles was removed upon cleaning. In general, the dry-cleaning methods also showed a reduced efficacy ($\Delta L^* \leq$ -2.12) when compared to the wet ones, both non-confined and confined. A small amount of adipic acid was removed, and all tools showed TPU particles after cleaning. The cotton swab was even confirmed as the worst method as a large number of fibres were detected on the TPU coating after cleaning (Figure 5), being immediately discarded for further tests. The soft sponge was selected for further testing as its reduced safety could be improved with the addition of a liquid cleaning agent.

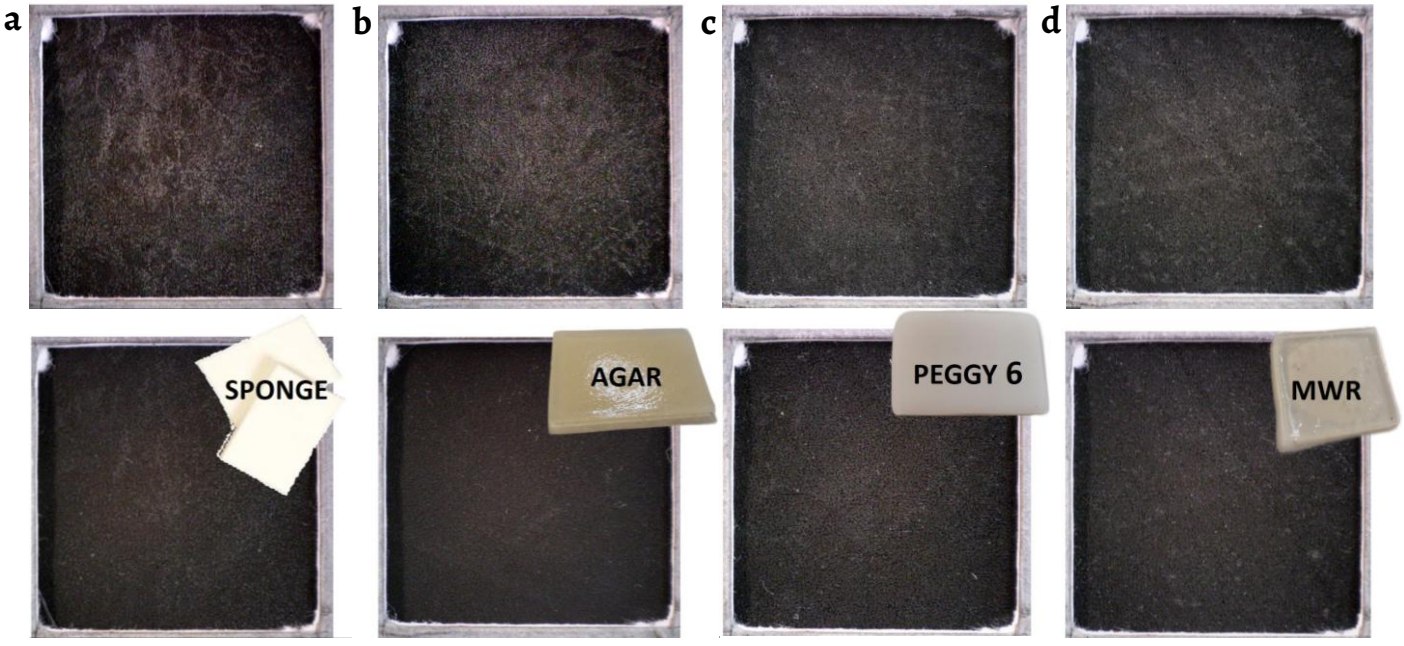
**Figure 6**. Less deteriorated TPU-coated fabric with blooming, before (top) and after (bottom) wet cleaning methods: *a)* sponge with water; *b)* agar-agar; *c)* Peggy 6; *d)* MWR.

deteriorated TPU coating. The best method within this class of non-confined liquids was the sponge with water because it was able to remove a significant amount of adipic acid (ΔL*=-5.89) without causing a large loss of TPU coating (Table 1 and Figure 6).

This was also observed with the use of ethanol; contrary to expectations, loading ethanol into the Nanorestore Gels did not significantly enhance their cleaning efficacy. Once more, this was probably related to the high retentive power of these gels, especially during a short time of interaction with the substrate (5 min).

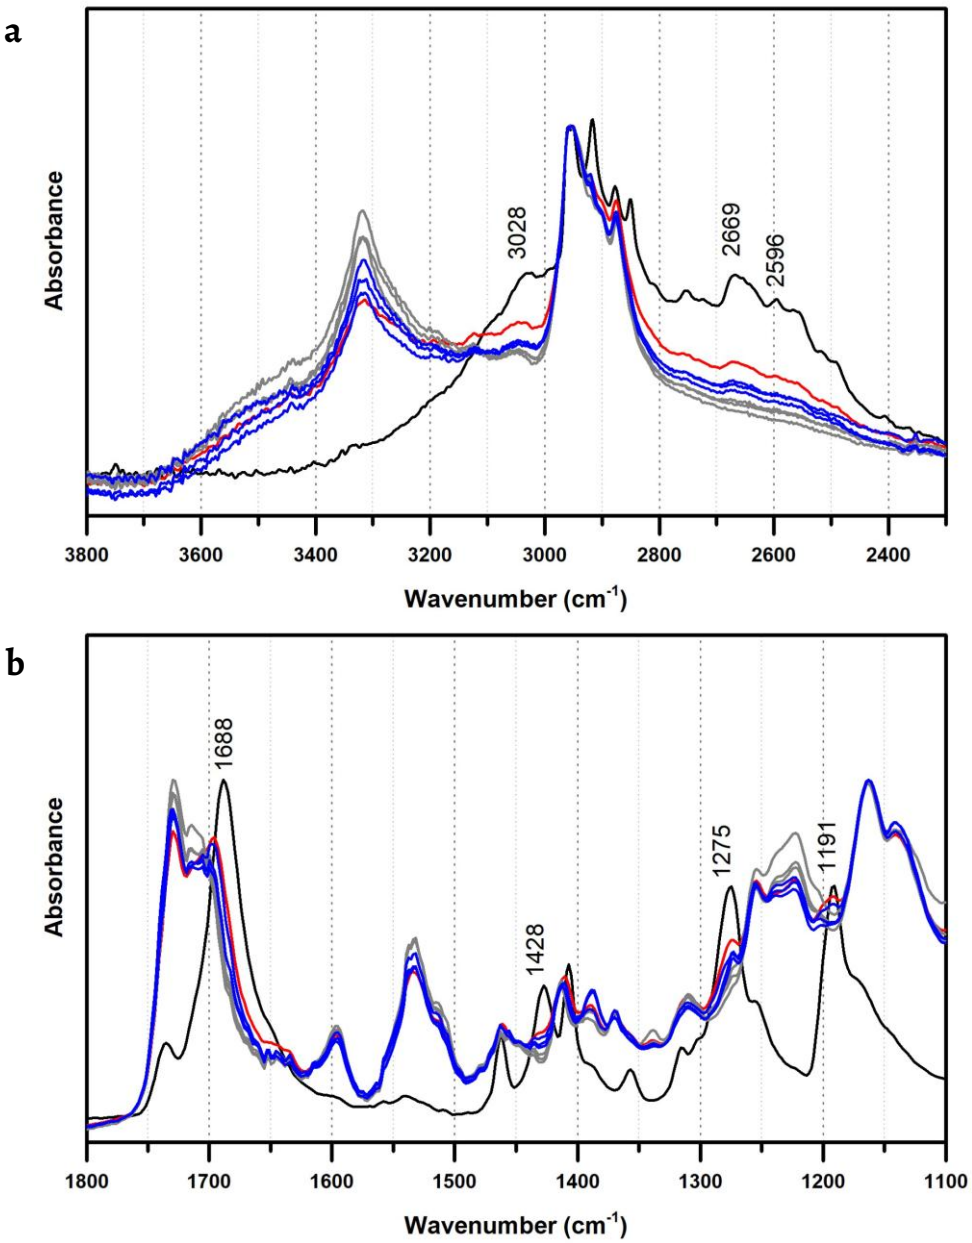
Based on infrared spectroscopy (Figure 8), it was possible to assess the homogeneity and in-depth efficacy of the two best methods, the sponge/water system and the agar-agar gel. Curiously, even though colorimetry suggested the sponge/water system as a high efficacy method in the removal of blooming, ATR-FTIR allowed the detection of spectral lines still assigned to adipic acid in the TPU-coated samples cleaned with this method: composite-profile at circa 3000 $cm^{-1}$ and bands at c. 1689, 1276 and 1192 $cm^{-1}$ (assigned to O-H, C=O, -C-O and stretching of adipic acid, respectively [32-35]) (Figure 8). On the other hand, the three spectra of the TPU-coated samples cleaned with agar-agar showed none or only small traces of these bands (Figure 8), possibly indicating a higher efficacy and homogeneity of the cleaning procedure.

**Figure 8**. Infrared spectra (ATR-FTIR) of the highly fragile TPU-coated fabric featuring blooming after cleaning with sponge/water (blue) and agar-agar gel (grey): *a)* between 3800 and 2300cm$^{-1}$; *b)* 1800 and 1100 cm$^{-1}$. Black line corresponds to adipic acid spectrum and red line to a representative spectrum of a non-cleaned sample.

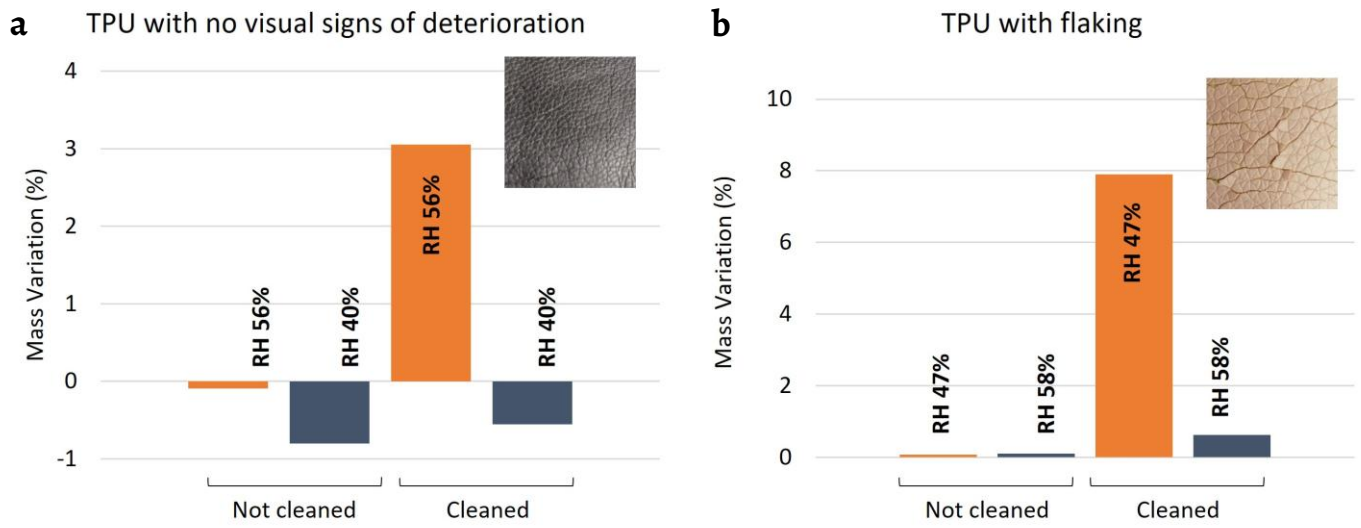
As the formation of adipic acid in ester-based TPUs is addressed in the literature as a result of the hydrolytic attack to the ester-rich segment, as previously mentioned, determining the water content in samples before and after aqueous cleaning was considered significant. The chosen strategy to follow these values was through mass measurement to assess whether water was retained in the sample after cleaning. Figure 9 shows the mass variation (%) of the two tested TPU-coated fabrics (one with no visual signs of deterioration, and another with flaking) after 1 hour and 1 day of cleaning. The relative humidity (RH) of the room was registered before all mass measurements. From the control non-cleaned samples, it was possible to observe that RH fluctuations of 15 % (between first and final measurement) were enough to cause mass variations of 1 % in the samples, which can be related to the hydrophilic nature of these TPU-coated fabrics. Also, as expected, the most deteriorated samples showed a higher mass variation right after cleaning, as surface contact with more layers of the coated fabric increases drastically, but after 1 day the original weight was almost totally recovered.

**Figure 9**. Mass variation (%) measurements of TPU-coated samples (cleaned and not cleaned) after 1 h (orange bars) and 1 day (grey bars): *a)* TPU with no signs of deterioration; *b)* TPU with flaking Inset: images of the TPU-coated samples submitted to this assessment.
