# Conservation of a WWII Supermarine Spitfire section wing

This study focuses on a WWII Supermarine Spitfire aircraft section wing conservation, salvaged from the seabed in 1988 and stored in a private garden. The object was in poor condition so decisions on the conservation, preservation or removal of parts of the original elements were needed. Firstly, the wing fragment was studied to determine its heritage interest and to assess its historical, industrial, technical and scientific values. This object will become a memorial to the pilot who died during the mission, in his hometown. The conservation project aims to find the best solution to both conservation priorities and exhibition needs. Based on cleaning tests on corroded, painted aluminium alloys carried out within the PROCRAFT Project, a treatment was determined. This case serves as an example of how the results of a European project can be implemented in a conservation-restoration process and how industrial conservation theory can be applied to archaeological artefacts.

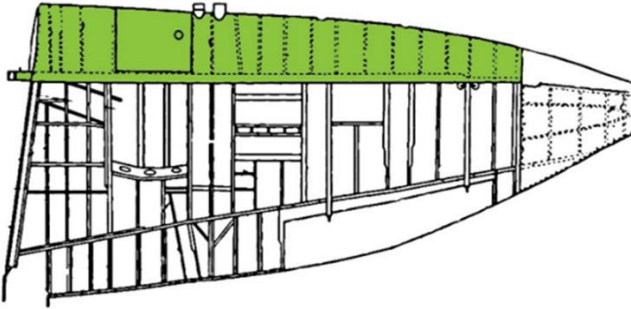
Description	Scheme
<p><b>Fragment location scheme</b></p> <p>The recovered fragment is colored in green on this diagram which shows a Spitfire wing in its entirety</p>

The most severe mechanical degradation of the aircraft probably dates from the time of the crash. The fisherman recovered only the front part of the starboard wing which accounts for no more than 30 % of the total area of a Spitfire wing. Significant degradation also took place during the period it was in the sea and stored outdoors. The internal structure had undergone extensive damage. There are major differences of state between the interior and exterior parts. The internal wing structure was in poor condition; the front spar, stringers and ribs no longer provided adequate mechanical strength due to major exfoliation and pitting corrosion. The corrosion had buckled and lifted the Al sheet (Figure 5). The ribs near the tank were in good condition, while others were in very heterogeneous condition (poor to very poor). All of the ribs displayed localized corrosion, some of which had deteriorated into exfoliation. The location of the different degradations, which were classified into four categories: localized corrosion with pitting, original paint residues, rust stains and missing rivets (Figure 6). The skin (top and bottom) was in good condition overall with traces of paint still visible (Figure 3). Paint remains were abraded and poorly preserved. Localized mechanical surface alterations were visible but did not impact overall legibility.
