# Balancing artist's intent and durability: conserving a corroded outdoor painted iron sculpture

### George Lappas and his monochrome *Tree* sculpture

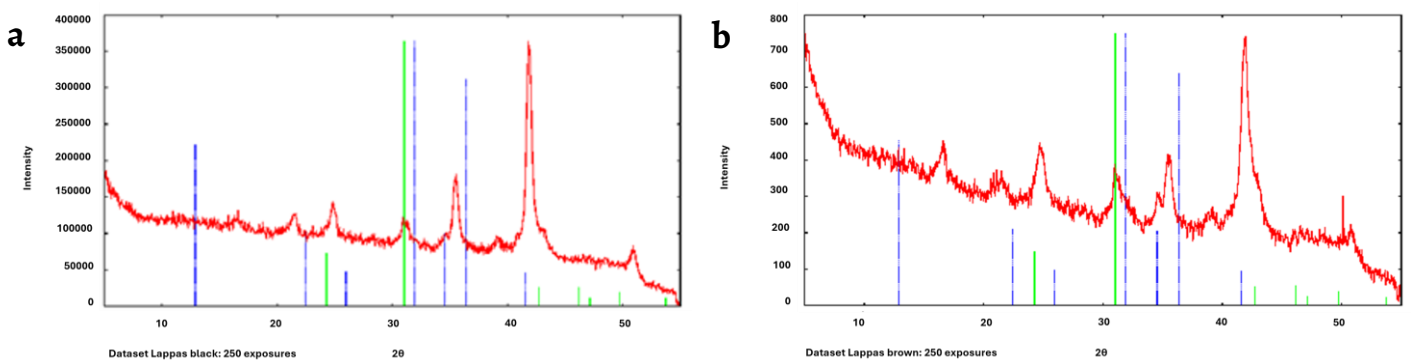
Observation and processing of the spectra documented the presence of iron oxide-hydroxides (magnetite, goethite and lepidocrocite). The spectra present a lot of background 'noise' and regions of many small peaks due to the amorphous and semi-crystalline nature of the hydrated iron products. Although characteristic peaks of magnetite and lepidocrocite (Figure 5a) and goethite and magnetite (Figure 5b) can be identified.

**Figure 5.** XRD results: *a*) characteristic peaks of magnetite (35,5°) and lepidocrocite (~14° and 23°); *b*) characteristic peaks of goethite (~21.5° and 36°) and magnetite (35,5°).

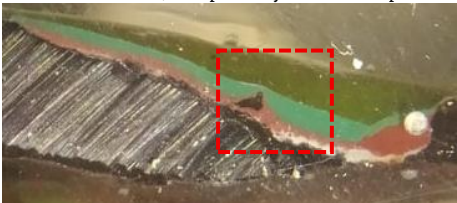
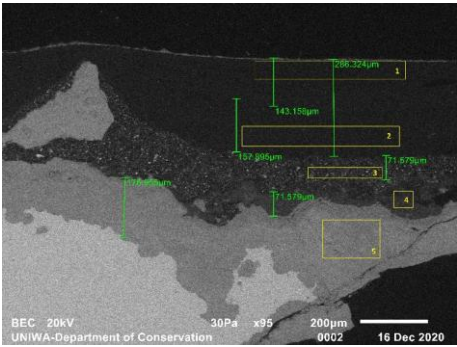
| Samples | Layer characterization | Elemental analysis |
|---|---|---|
| | 1 - Outer green paint layer<br>2 - Inner green paint layer<br>3 - Red primer<br>4 - Off-white / grey primer<br>5 - Metal substrate | <b>O, C, Si, Fe, (Ti, Cl, Al, P, Mg)</b><br><b>O, C, Fe, Si, (Ti, Cl, Al, Ca, P, Mg, K)</b><br><b>O, C, Fe, Si, Ba, (Cr, Zn, S, Cl, K, Ca, Ti, Al)</b><br><b>O, C, Ti, Si, Fe, Ca, Mg, (Al, Cl, Na, K)</b><br><b>Fe, O, (Ca, Cl, Si, Mn)</b> |

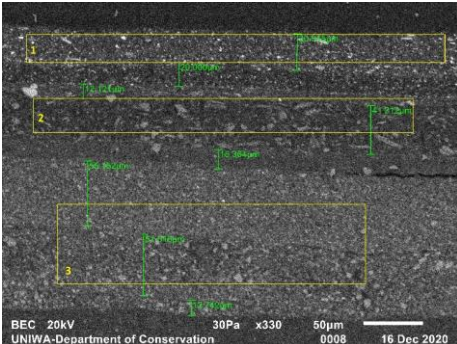
| Samples | Layer characterization | Elemental analysis |
|---|---|---|
| | 1 - First layer of green paint (possibly the artist's paint)<br>2 - Second layer of green paint<br>3 - Third layer of green paint (the top layer before conservation procedure) | <b>O, C, Ba (S, Fe, Ca, Zn, Cl, Si, P, Cr, Al, Mg, K)</b><br><b>O, C, Si, Mg, Ca, (Cl, Fe, Al, Ti, Na, K)</b><br><b>O, C, Ca, Si, (Cl, Mg, Al, Fe, Na, K, Ti)</b> |
