# Balancing artist's intent and durability: conserving a corroded outdoor painted iron sculpture

MARIA GIANNOULAKI \*

University of West Attica, Dept. of  
Conservation of Antiquities &  
Works of Art, Ag. Spyridonos,  
Aigaleo, 12 210, Greece

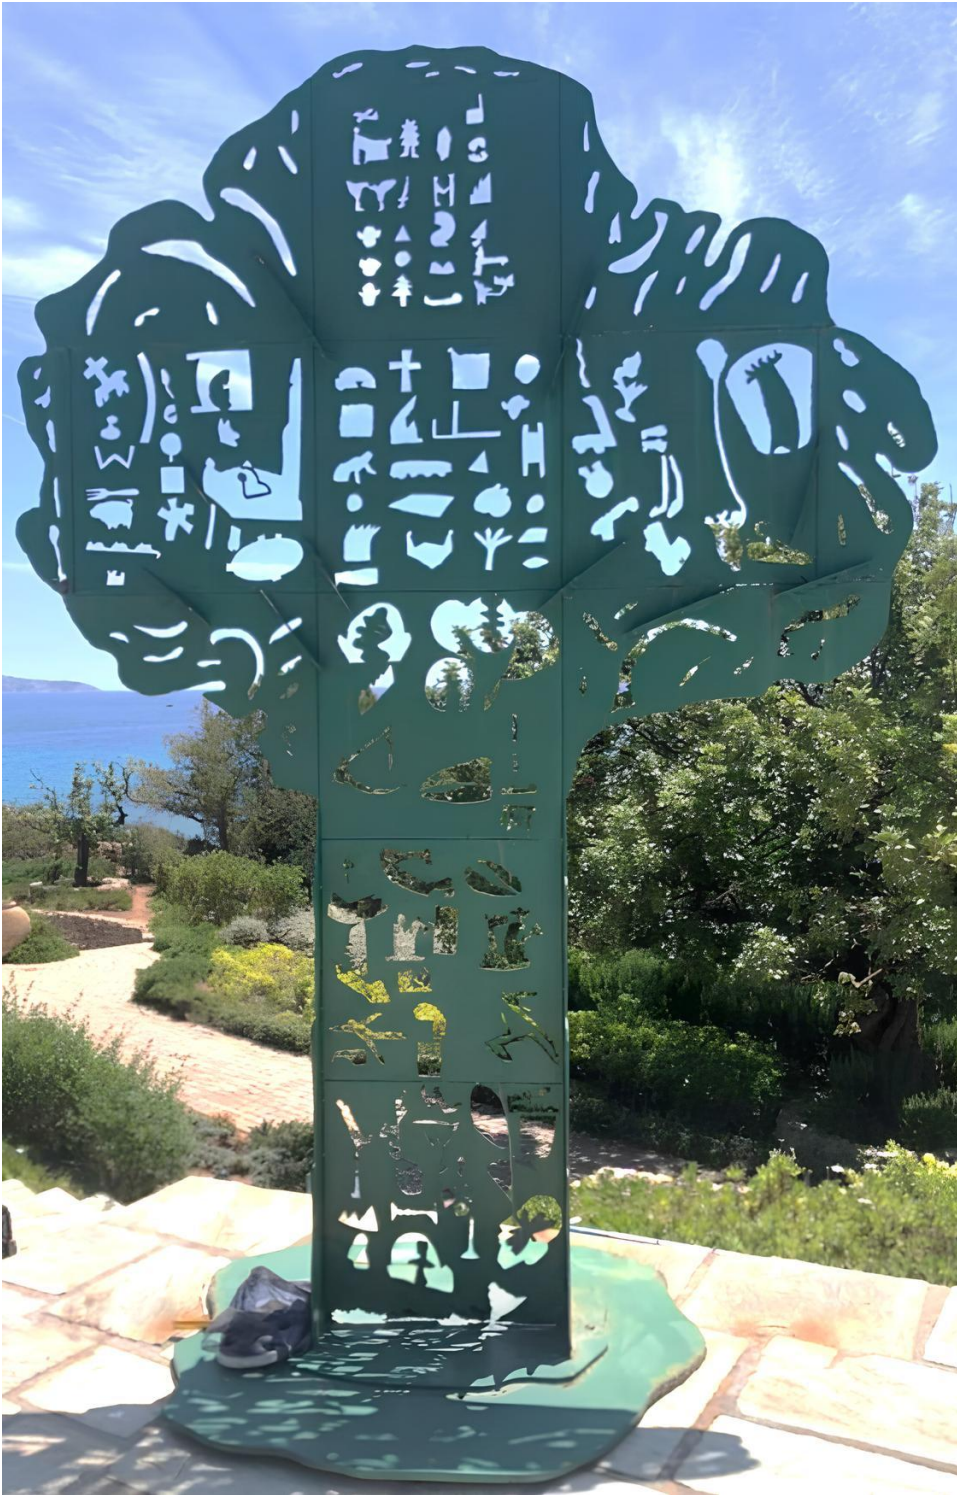
The *Tree* is part of a private collection and its manufacture was commissioned to Lappas in the beginning of the 1990's. It is permanently exposed in the garden of a residence (Figure 1) with close proximity to the sea in a coastal town in the Argolis region of the Peloponnese, Greece. The exposition environment is characterized as non-urban and coastal with transposition and deposition of salts (chlorides and sulphates). By evaluating climate and weather data graphs from 1955 until 2025 [17], it can be determined that the local climate is humid, with wet autumns and winters and mild summers, and is characterised by intense sunlight. The marine environment, rich in air transferred corrosive salts, enhances electrochemical corrosion through surface moisture condensation and temperature fluctuations [18]. The exposure in direct sunlight during the day affects the paint layer.

The effects of the exposure environment were documented, including localised paint loss and extended paint detachment, as well as uniform and localised iron corrosion, accompanied by stress corrosion cracking.

**Figure 1.** The *Tree* sculpture in its permanent position (photo: private collection).
