Architectural analysis of the main facade of the collegiate church of Osuna using high-density data collection

FERNANDO DÍAZ-MORENO

This study examines the collegiate church of Nuestra Señora de la Asunción in Osuna, Spain, begun in the early 16th century. It presents numerous geometric alterations and a strong material heterogeneity, making it difficult to understand the construction sequence, and thus its heritage value for possible restoration work. The study aims to determine whether these anomalies are original or the result of later interventions. We therefore analyze both the structural and geometric details of the facade panels, approaching the subject from multiple perspectives thanks to the methodological improvements on the field of heritage building survey. The analysis of mass data collection suggests that geometric deviations are due to issues that emerged in the set-out survey for the building works, and that the facade was constructed in a continuous phase during the 1530s. The study concludes that the facade likely originates from the workshop of master Diego de Riaño.

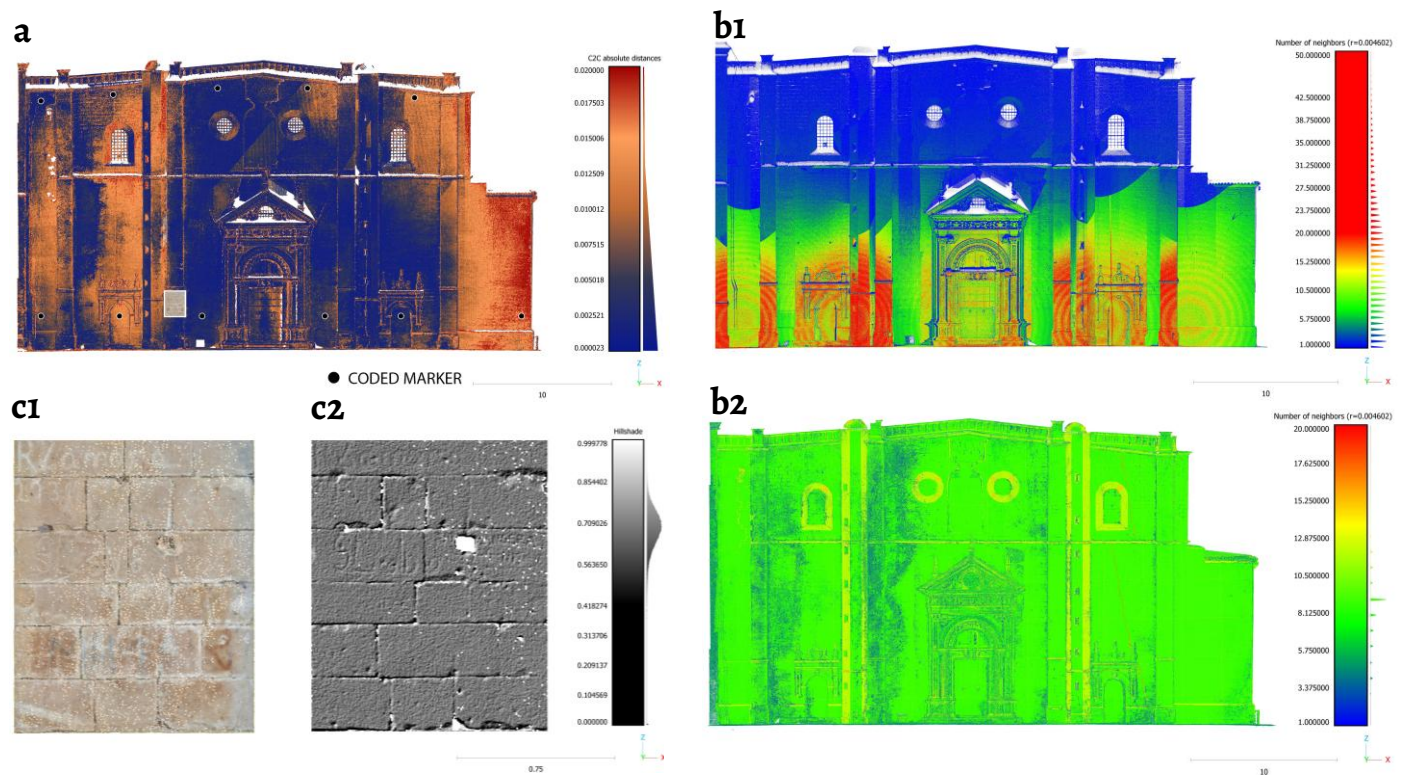
Figure 4. Hypothesis: *a*) Deviations between the cloud obtained by photogrammetry and the cloud obtained with the scanner; *b*) point density (number of neighbours) of the scanner point cloud (*b1*) and the photogrammetry point cloud (*b2*); *c*) relief surface detail: point colors view (*c1*) and Hillshade view (*c2*).

To optimize the point clouds and reduce the tie point errors, we followed the recommendations of Mayer, Gomes Pereira and Kersten [13]. We compared the two point clouds: the one from the scanner has a higher density, only in the lower areas of the facade, but greater heterogeneity in the whole (Figure 4b-1), while the photogrammetry cloud has a lower but more constant density of points (Figure 4b-2).

To check the geometric accuracy of the photogrammetry, we compared the drone cloud with the scanner cloud by aligning them in CloudCompare 2.13 with the ICP (Iterative Closest Point) procedure [14]. Next, we calculated the direct cloud-to-cloud distance using an approximation of the Hausdorff method [15]. This demonstrated that the distance variations between the two clouds are practically imperceptible, except for the right angle of the facade where more photographs would have been needed (Figure 4a).

Also in CloudCompare and for specific cases, like checking elements that were not visible in the 2D photographs (Figure 4c-1), such as incisions, depressions, etc., we generate a Hillshade view (Figure 4c-2), through the Rasterize command selecting the most favorable sun position, of the cloud with a more homogeneous density, i.e., that of the photogrammetry (Figure 4b-2). Lastly, in Agisoft Metashape we generated orthoimages of the main planes of the facade, selecting manually the photographs for better orthophoto creation [20]. This produced a combined orthophoto with a resolution approaching the gigapixel size (Figure 5) [21].

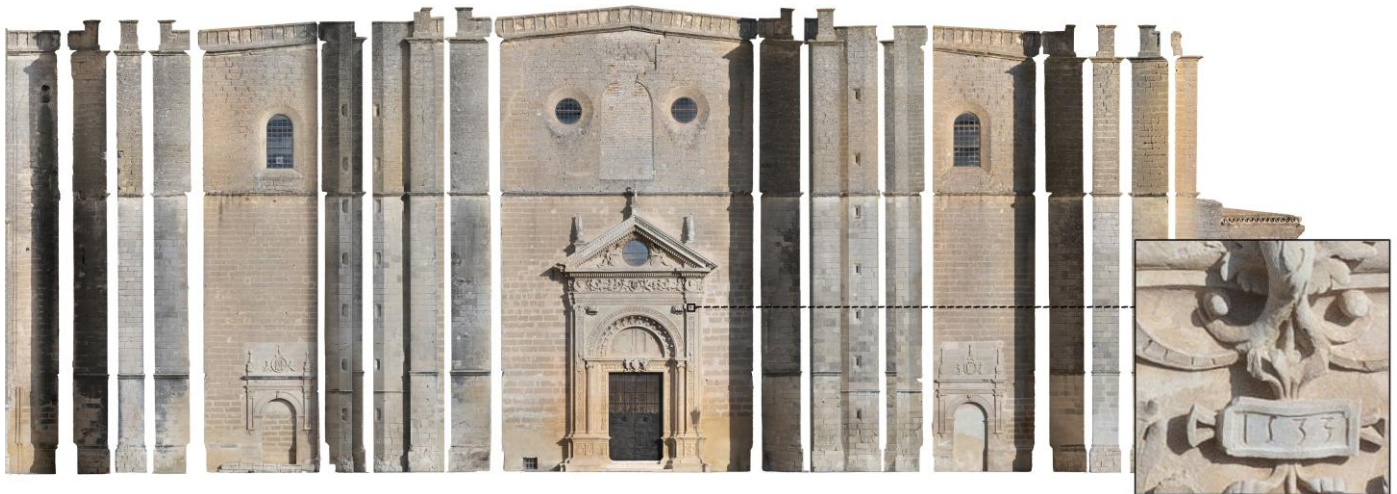
Figure 5. Exploded orthophoto of the main facade and detail of the cartouche from 1533.

same duality is discernible on the facade: the buttresses on the Gospel side present a continuity with the brick courses but this is not the case with the ones on the Epistle side. Furthermore, the openings for the stairwells are inserted at different heights and on different faces of the octagon (Figure 5). The work at different levels that we suggested above supports the existence of these two teams working simultaneously.

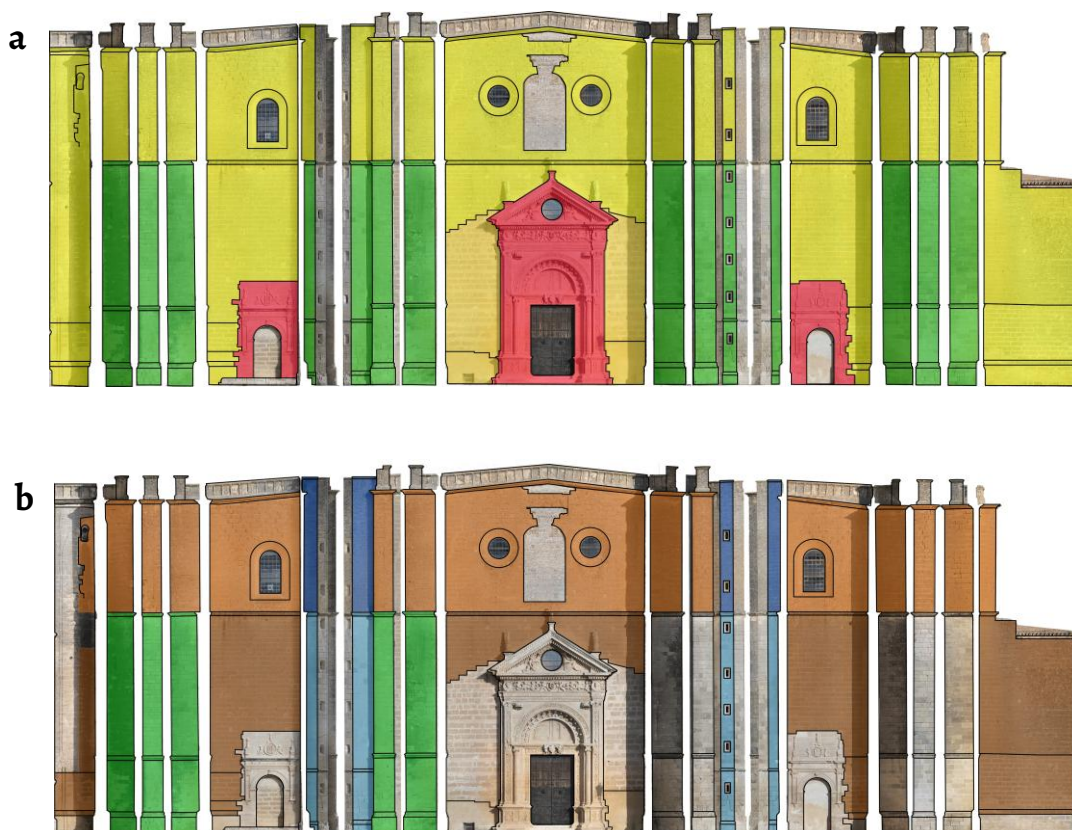
Figure 9. Facade panel analysis: a) materials; b) continuity of bed joints.

In the orthophotos, the lower section of the facade reveals a lack of material continuity between the buttresses, the stairwells of the spiral staircases and the adjacent wall surfaces (Figure 9a). The buttresses and staircases were executed with a more compact and better quality of stone, possibly brought from the nearby town of Estepa [24]. They were cut with precision and bonded with minimal joints, especially between stones, whereas the general wall surfaces were built out of a local porous stone, cut in an irregular fashion and bonded with generous joints. The position of the horizontal rows also displays significant variations between the stairwells, buttresses and general surfaces (Figure 9b).

The section above the main cornice displays a material homogeneity and greater continuity between surfaces (Figure 9a). The better quality of stone has disappeared and the rest of this entire section of the facade is executed with the stone used for the facade walls. In addition to the use of the same type of ashlar, the continuity detected in the rows of the surfaces and the buttresses suggests that they belong to the same construction unit. However, although the same material was used for the stairwells, there is a discontinuity between the rows, which are situated at a different level (Figure 9b). We therefore deduce that the buttresses and general wall surfaces were executed simultaneously, while the stairwells were built at a slightly later time, probably because these stone blocks were more complex than the rest of the facade.

Above the portal and these adjacent sections is a complete section executed with the general bond used for the facade that we mentioned earlier (Figure 9b). This same bond was used on the entire vertical deployment of the aisle and chapel elevations. All three portals that were resolved with a bioclastic limestone [9], a better quality of material more appropriate for stonework (Figure 9a). In addition to sharing the same material and type of bond, the last rows beneath the main cornice of the nave, aisles and side chapels display a clear horizontal correspondence with the central section, with coordinated bed joints, offering unequivocal evidence of the existence of a common building process (Figure 9b). Consequently, the continuity between the surfaces above the main cornice, as mentioned above, is also observed in the rows below the cornice, up to the height of the central portal.

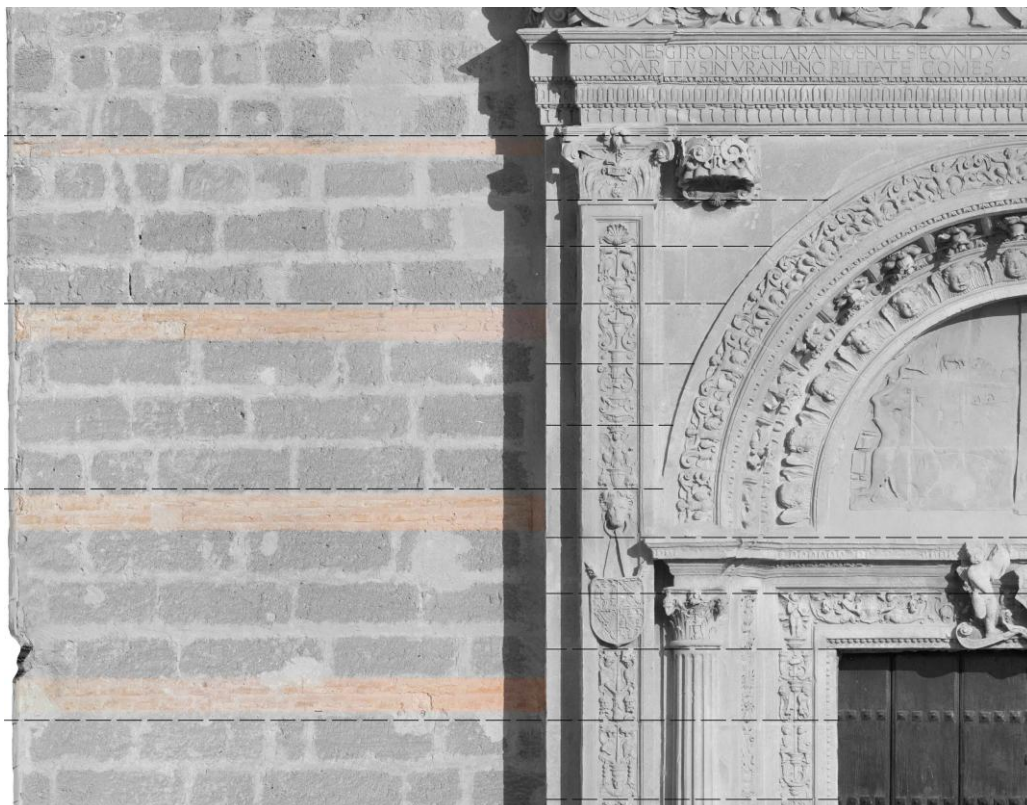
Figure 10. Detail of the main portal: continuity of stone bed joints thanks to the rows of brick.

The central section displays an inferior type of bond that is not repeated anywhere else on the facade. Its layout is related to the execution of the main portal for two reasons: i) the rows of brick in the bond serve to align the stone bed joints in the wall with the configuration of the stones in the portal; and ii) this inferior bond is delimited by the shape of the pediment (Figure 10).
