Architectural analysis of the main facade of the collegiate church of Osuna using high-density data collection

FERNANDO DÍAZ-MORENO

Abstract

This study examines the collegiate church of Nuestra Señora de la Asunción in Osuna, Spain, begun in the early 16th century. It presents numerous geometric alterations and a strong material heterogeneity, making it difficult to understand the construction sequence, and thus its heritage value for possible restoration work. The study aims to determine whether these anomalies are original or the result of later interventions. We therefore analyze both the structural and geometric details of the facade panels, approaching the subject from multiple perspectives thanks to the methodological improvements on the field of heritage building survey. The analysis of mass data collection suggests that geometric deviations are due to issues that emerged in the set-out survey for the building works, and that the facade was constructed in a continuous phase during the 1530s. The study concludes that the facade likely originates from the workshop of master Diego de Riaño.

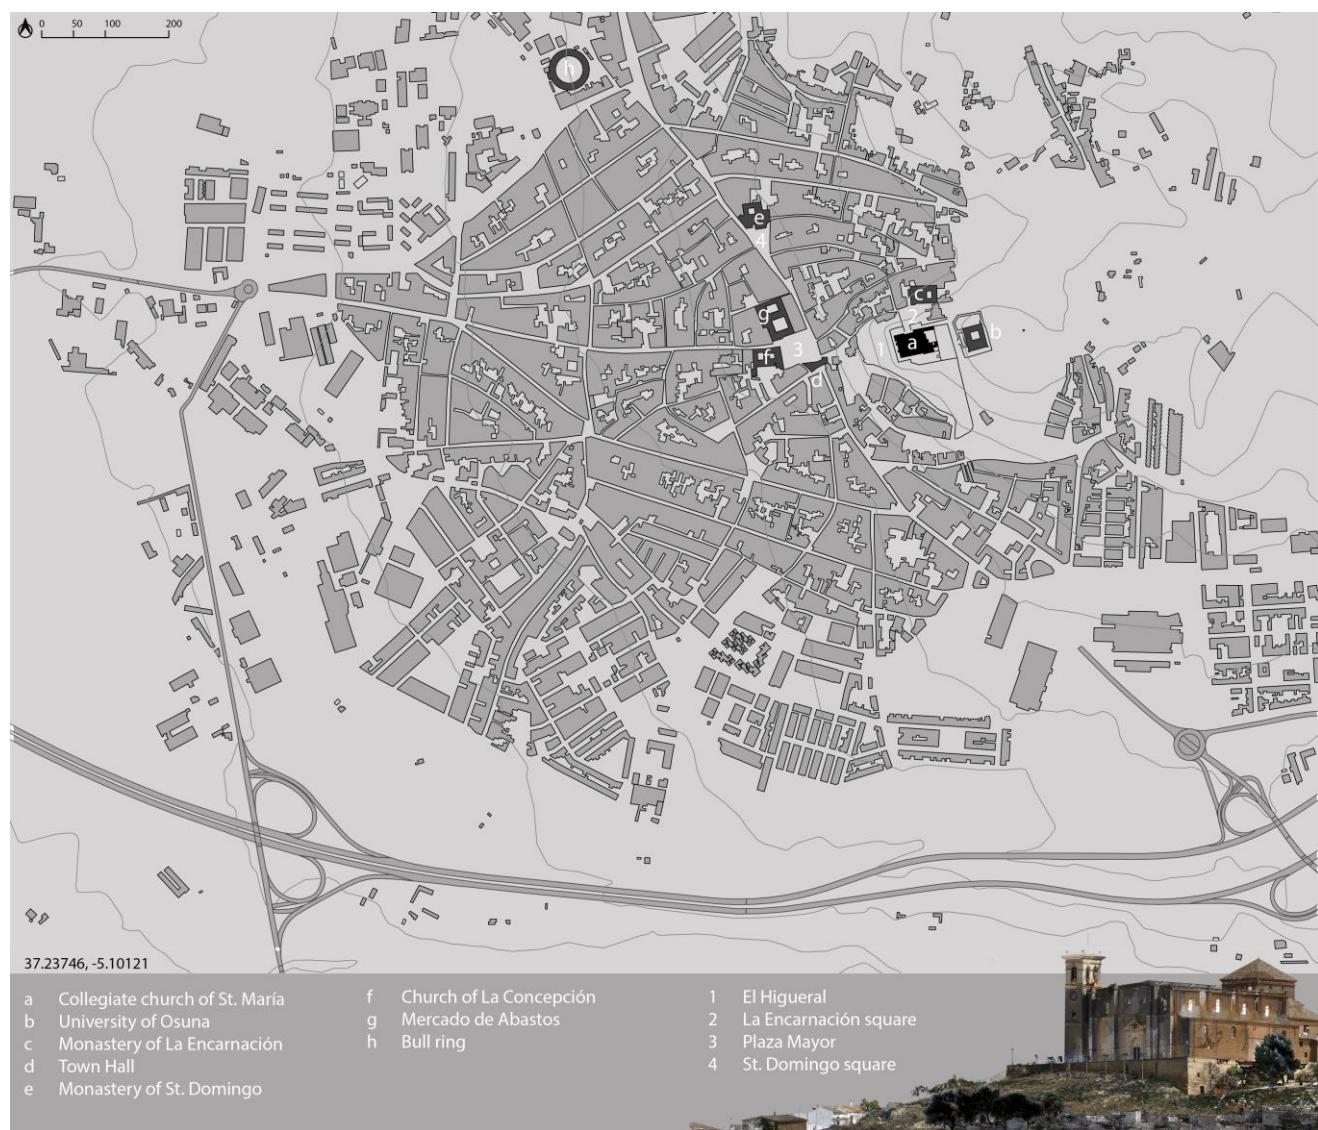
Figure 1. Plan of the town of Osuna and southwest view of the collegiate church.

The collegiate facade represents an enigma in the original design. It faces west and stands on a raised atrium that compensates for the uneven terrain (Figure 1 and Figure 2). Today, the main facade opens on to waste ground, formerly the site of medieval Osuna that was abandoned and demolished after the townsfolk gradually moved outside the walled [5]. In addition to the accesses to the atrium via the side facades, a (now lost) stairway led directly up to the main entrance [6].

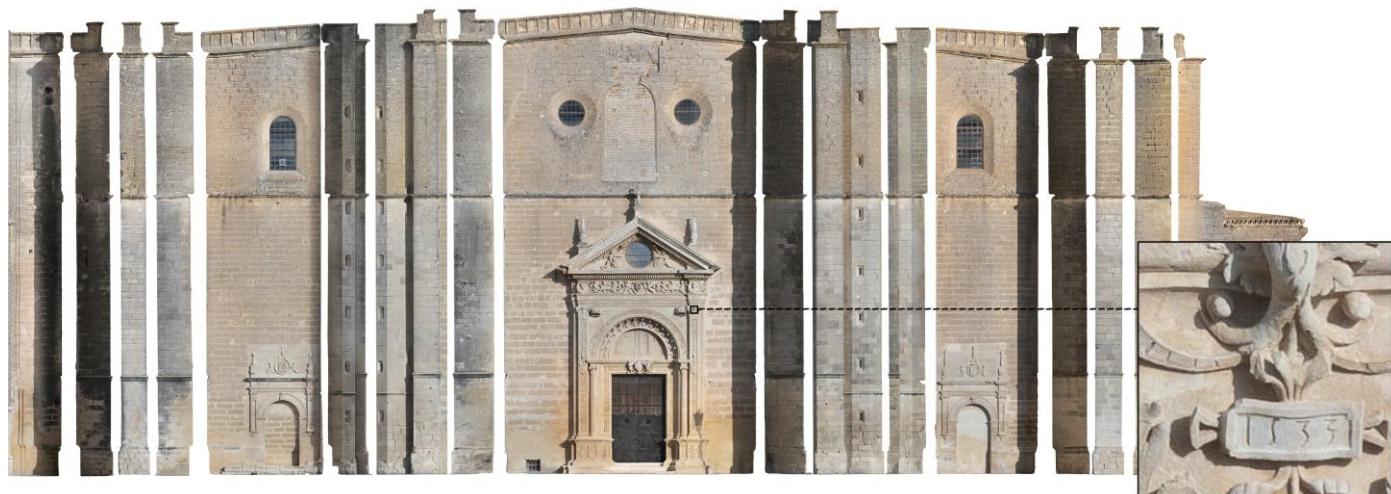
Figure 5. Exploded orthophoto of the main facade and detail of the cartouche from 1533.

Also in CloudCompare and for specific cases, like checking elements that were not visible in the 2D photographs ([Figure 4c-1](#)), such as incisions, depressions, etc., we generate a Hillshade view ([Figure 4c-2](#)), through the Rasterize command selecting the most favorable sun position, of the cloud with a more homogeneous density, i.e., that of the photogrammetry ([Figure 4b-2](#)). Lastly, in Agisoft Metashape we generated orthoimages of the main planes of the facade, selecting manually the photographs for better orthophoto creation [20]. This produced a combined orthophoto with a resolution approaching the gigapixel size ([Figure 5](#)) [21].

same duality is discernible on the facade: the buttresses on the Gospel side present a continuity with the brick courses but this is not the case with the ones on the Epistle side. Furthermore, the openings for the stairwells are inserted at different heights and on different faces of the octagon (Figure 5). The work at different levels that we suggested above supports the existence of these two teams working simultaneously.

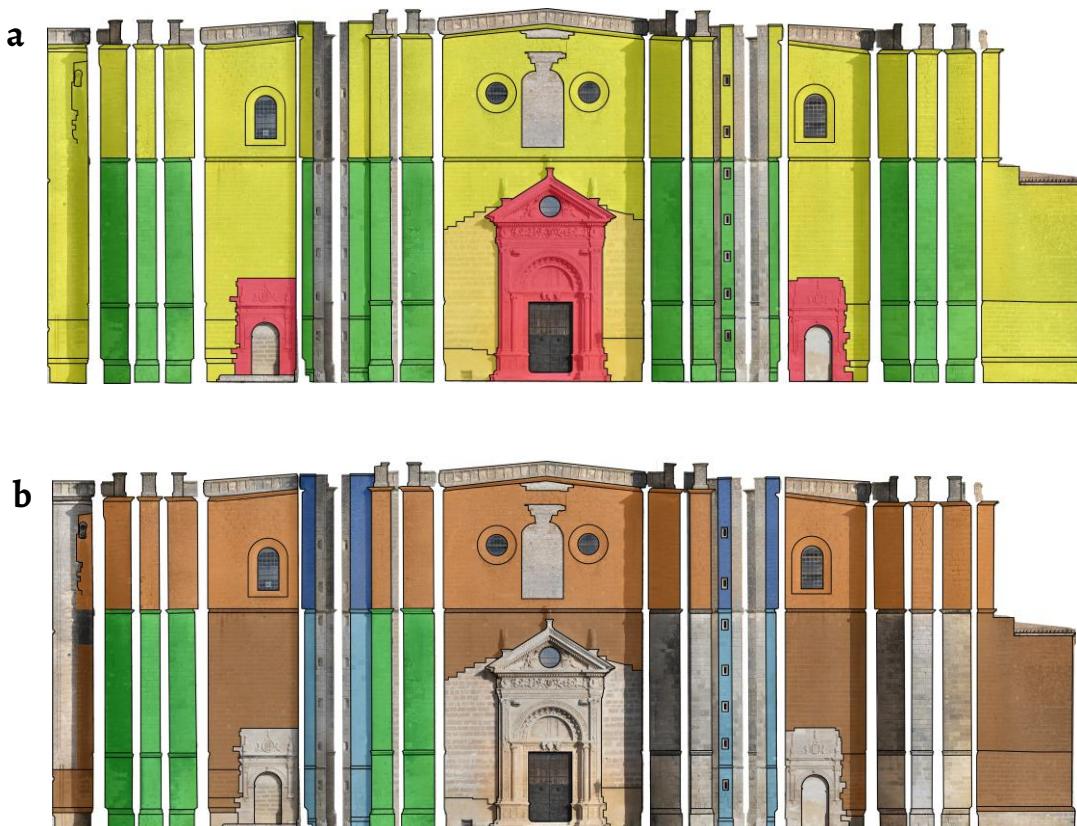
Figure 9. Facade panel analysis: a) materials; b) continuity of bed joints.

In the orthophotos, the lower section of the facade reveals a lack of material continuity between the buttresses, the stairwells of the spiral staircases and the adjacent wall surfaces (Figure 9a). The buttresses and staircases were executed with a more compact and better quality of stone, possibly brought from the nearby town of Estepa [24]. They were cut with precision and bonded with minimal joints, especially between stones, whereas the general wall surfaces were built out of a local porous stone, cut in an irregular fashion and bonded with generous joints. The position of the horizontal rows also displays significant variations between the stairwells, buttresses and general surfaces (Figure 9b).

The section above the main cornice displays a material homogeneity and greater continuity between surfaces (Figure 9a). The better quality of stone has disappeared and the rest of this entire section of the facade is executed with the stone used for the facade walls. In addition to the use of the same type of ashlar, the continuity detected in the rows of the surfaces and the buttresses suggests that they belong to the same construction unit. However, although the same material was used for the stairwells, there is a discontinuity between the rows, which are situated at a different level (Figure 9b). We therefore deduce that the buttresses and general wall surfaces were executed simultaneously, while the stairwells were built at a slightly later time, probably because these stone blocks were more complex than the rest of the facade.

Above the portal and these adjacent sections is a complete section executed with the general bond used for the facade that we mentioned earlier (Figure 9b). This same bond was used on the entire vertical deployment of the aisle and chapel elevations. All three portals that were resolved with a bioclastic limestone [9], a better quality of material more appropriate for stonework (Figure 9a). In addition to sharing the same material and type of bond, the last rows beneath the main cornice of the nave, aisles and side chapels display a clear horizontal correspondence with the central section, with coordinated bed joints, offering unequivocal evidence of the existence of a common building process (Figure 9b). Consequently, the continuity between the surfaces above the main cornice, as mentioned above, is also observed in the rows below the cornice, up to the height of the central portal.
