# The colours of deception: marble imitations in Alentejo stucco altarpieces

PATRÍCIA MONTEIRO

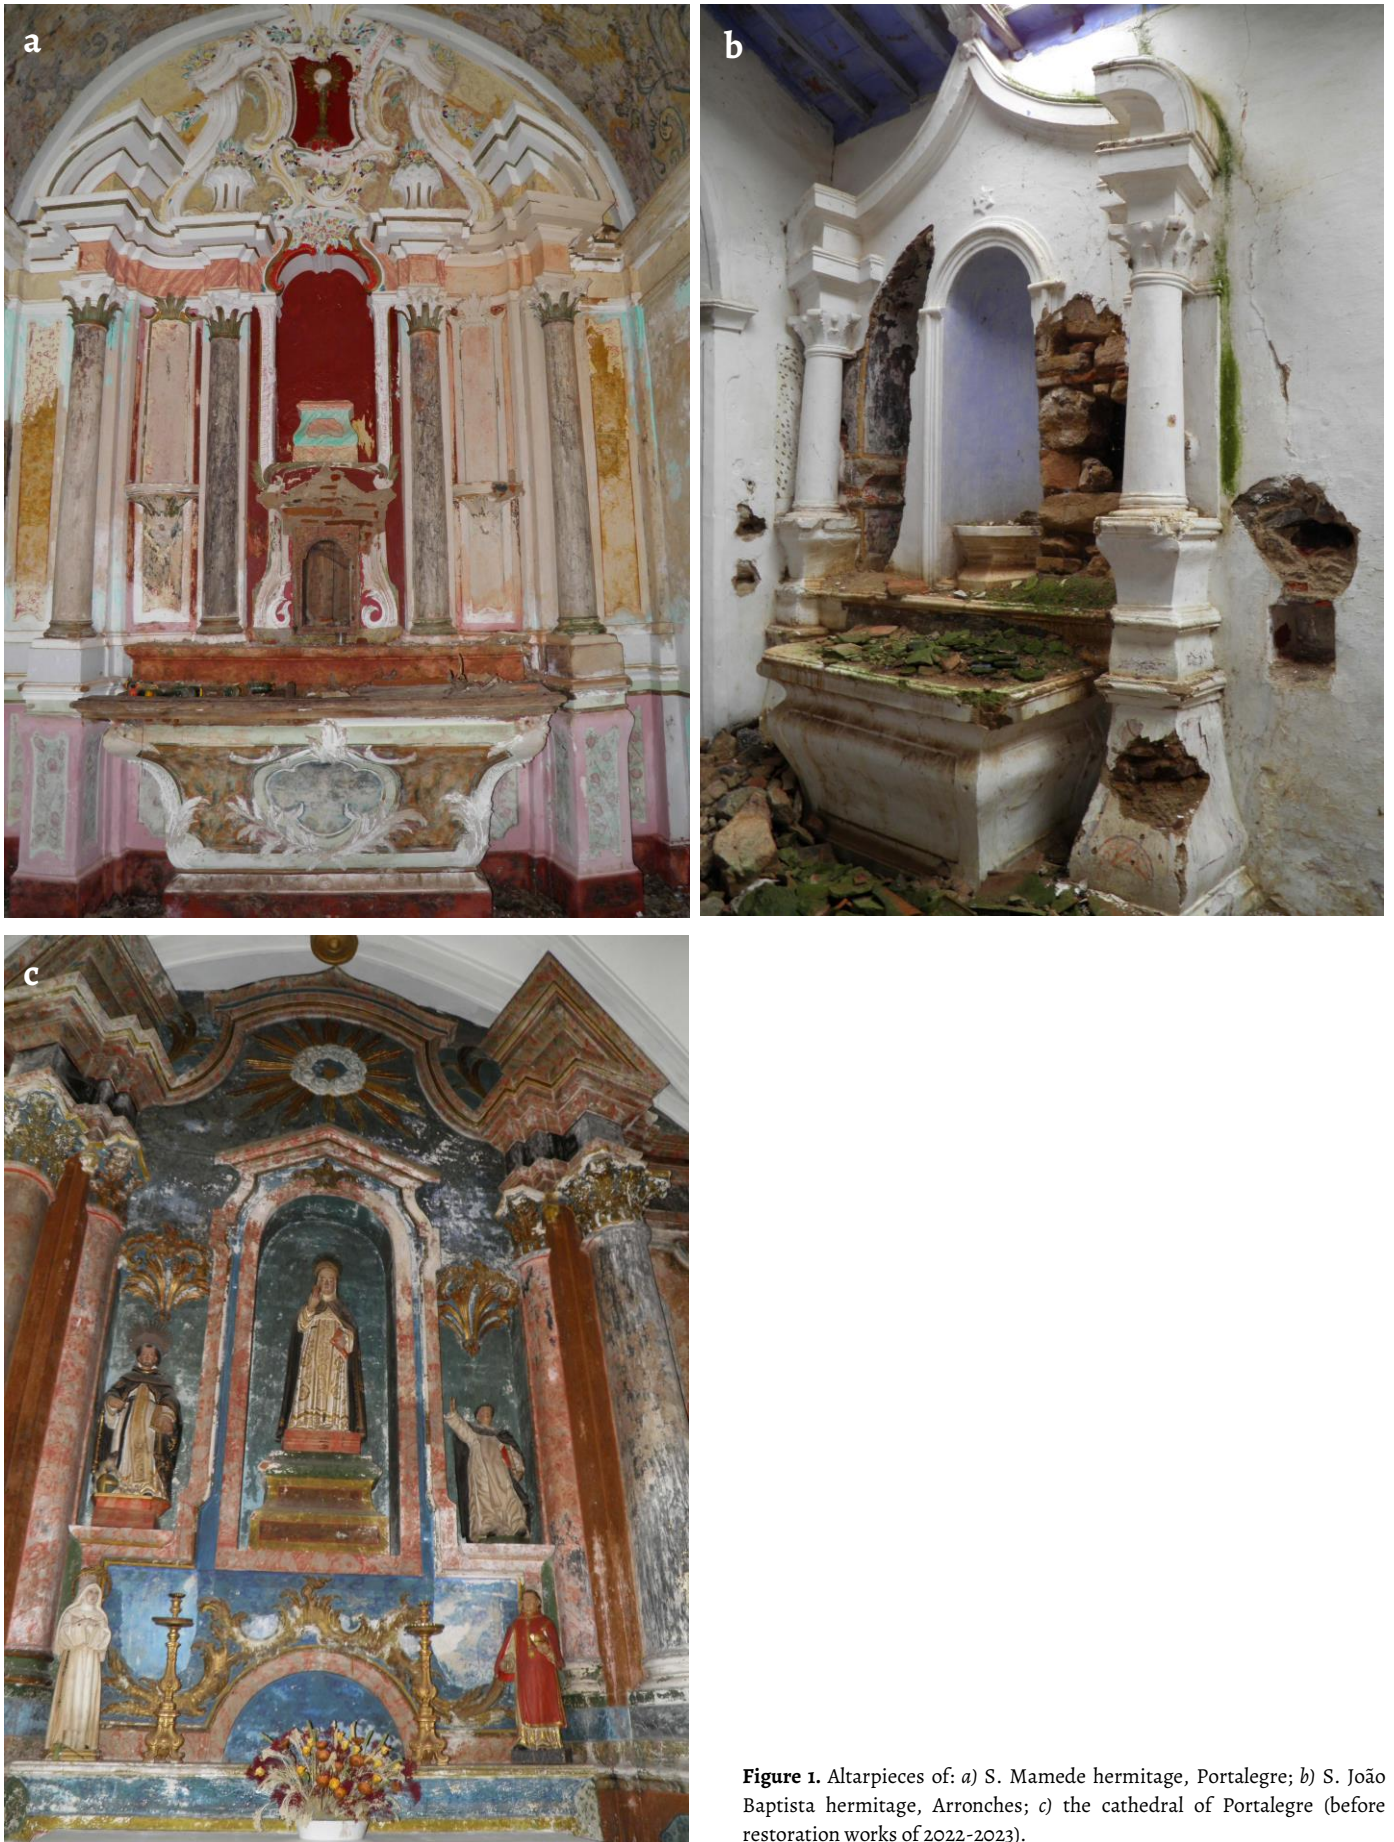
**Figure 1.** Altarpieces of: a) S. Mamede hermitage, Portalegre; b) S. João Baptista hermitage, Arronches; c) the cathedral of Portalegre (before restoration works of 2022-2023).

Starting from this premise a primary survey of Alentejo's stucco altarpieces began to proceed to their historical and artistic characterization. The vast majority of existent stucco altarpieces in Alentejo date from the late Baroque period [1]. Only six of 54 altarpieces were built before the late eighteenth century. Also, with few exceptions, they all present a poor state of conservation (Figure 1).

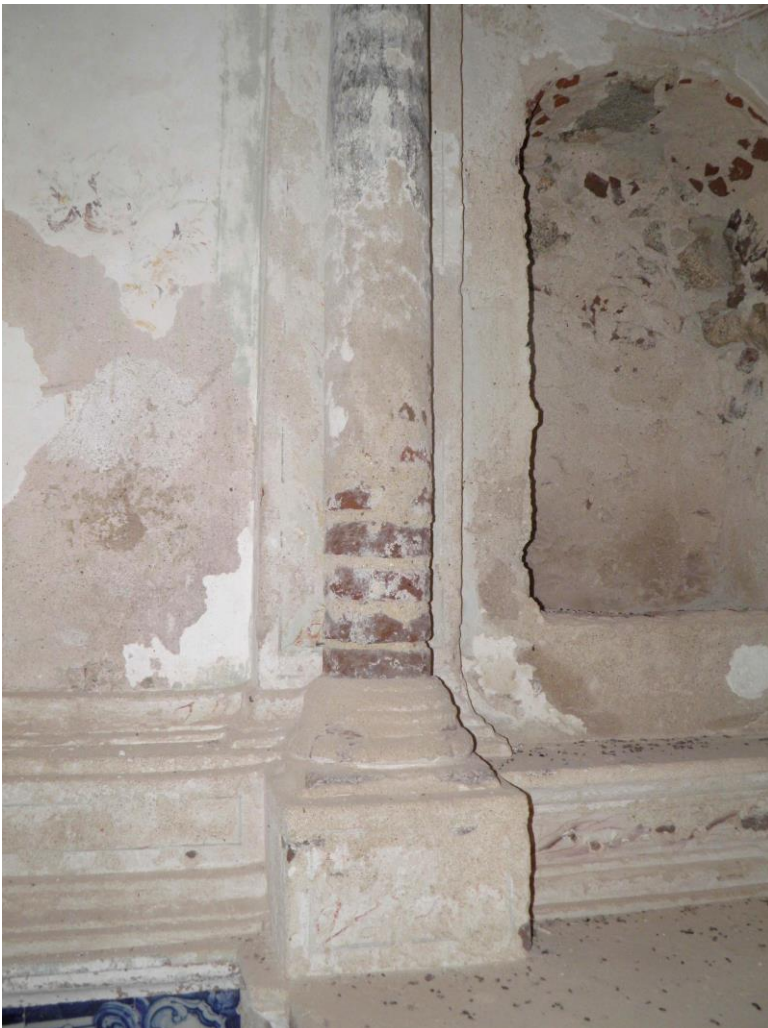
**Figure 3.** Convent of São Bento de Cástris, detail of a column in a chapel of the cloister, Évora.

Although no analyses were performed on the altarpieces presented in this paper, many of them are likely to follow Pascual Diez's basic stucco paste recipe: a mixture of gypsum, sand, and lime mixed with water over a structure made of inexpensive materials such as bricks [8]. The most common solution appears to have been the creation of an internal structure made of bricks of various shapes and sizes mixed with lime (Figure 3).

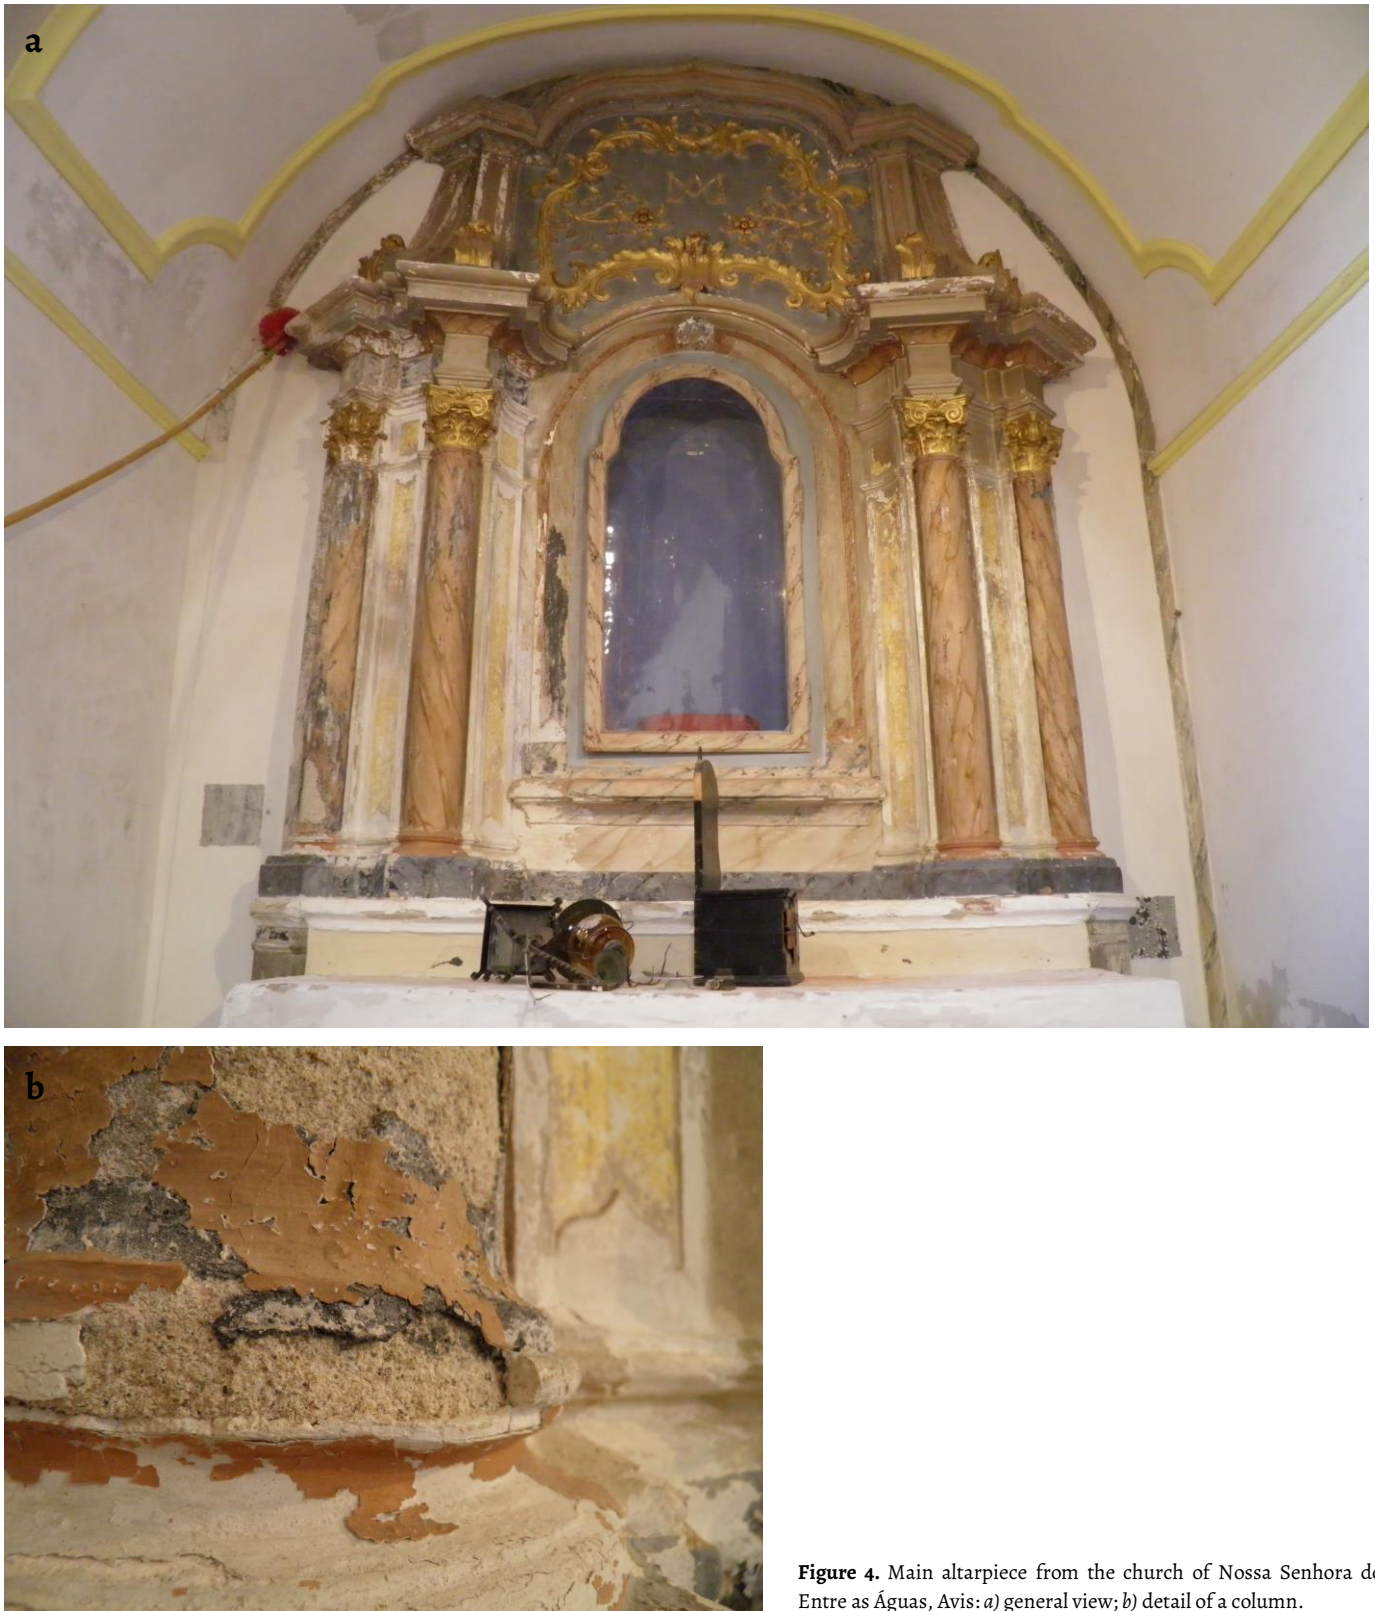
**Figure 4.** Main altarpiece from the church of Nossa Senhora de Entre as Águas, Avis: a) general view; b) detail of a column.

Repainting was indeed a very common practice in what concerns altarpieces, virtually deleting important historic elements, like their natural ageing process. Like in any other aspect of artistic heritage, the historical reality (or originality) cannot be strictly limited to a primitive state of the object in question, but also to the multiple contributions time has left on it [3]. This premise, which is elementary in any conservation project, is frequently overlooked when extensive repainting or varnishing is involved (Figure 4).

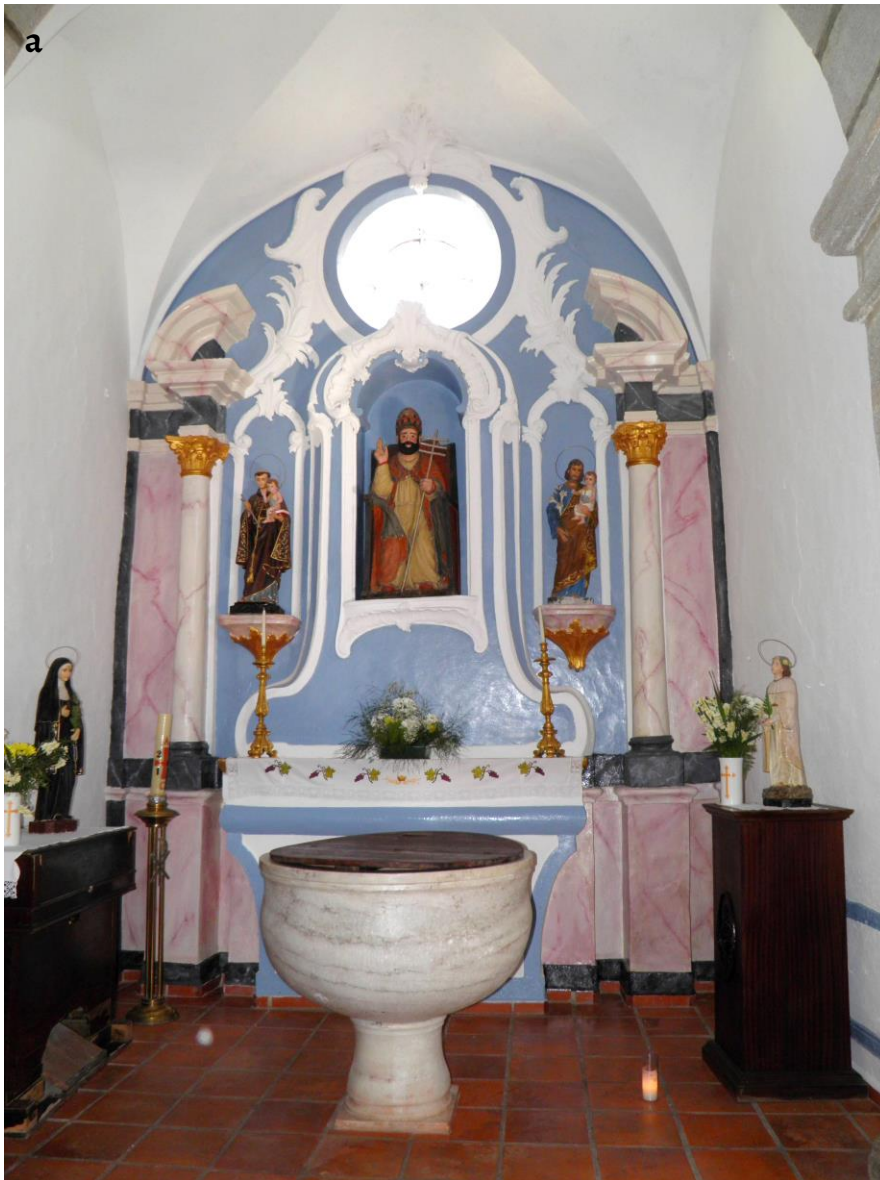
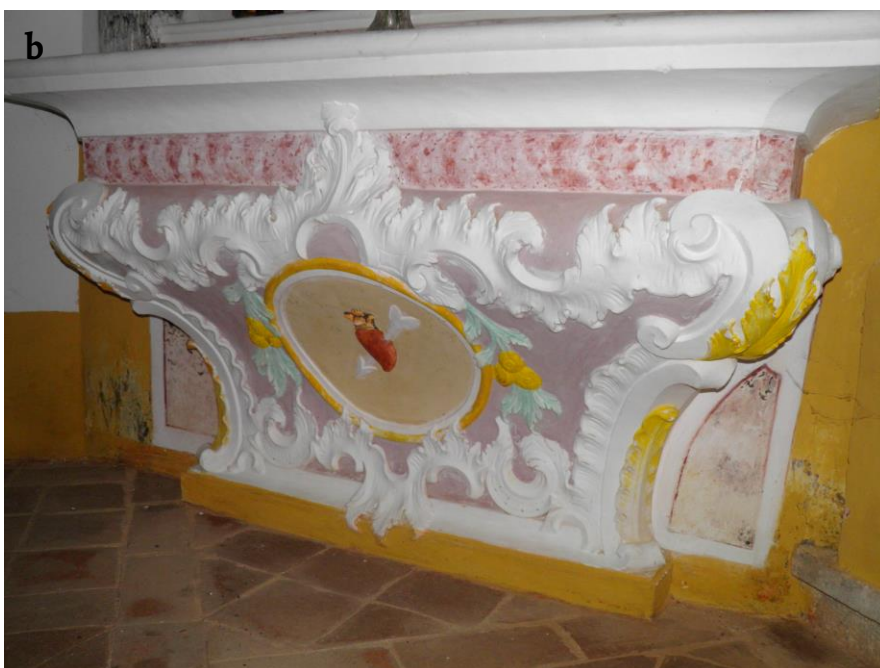
**Figure 5.** Collateral altarpieces: *a)* in the main church of Nossa Senhora da Graça in Assumar, Monforte; *b)* a detail in the hermitage of São João Baptista, Arronches.

Excessive and, in many cases, unsuitable, colour use results in the application of tones that do not exist in nature, deviating from the goal of simulating real materials. Because the outcome of these modern and more colourful interventions can be questionable and difficult to understand, Art History has labelled these works as “popular” immediately lowering their artistic value (Figure 5). Although there is no particular data on the date of these repaints, their look suggests that they are recent, most likely from the first decades of the twenty first century.

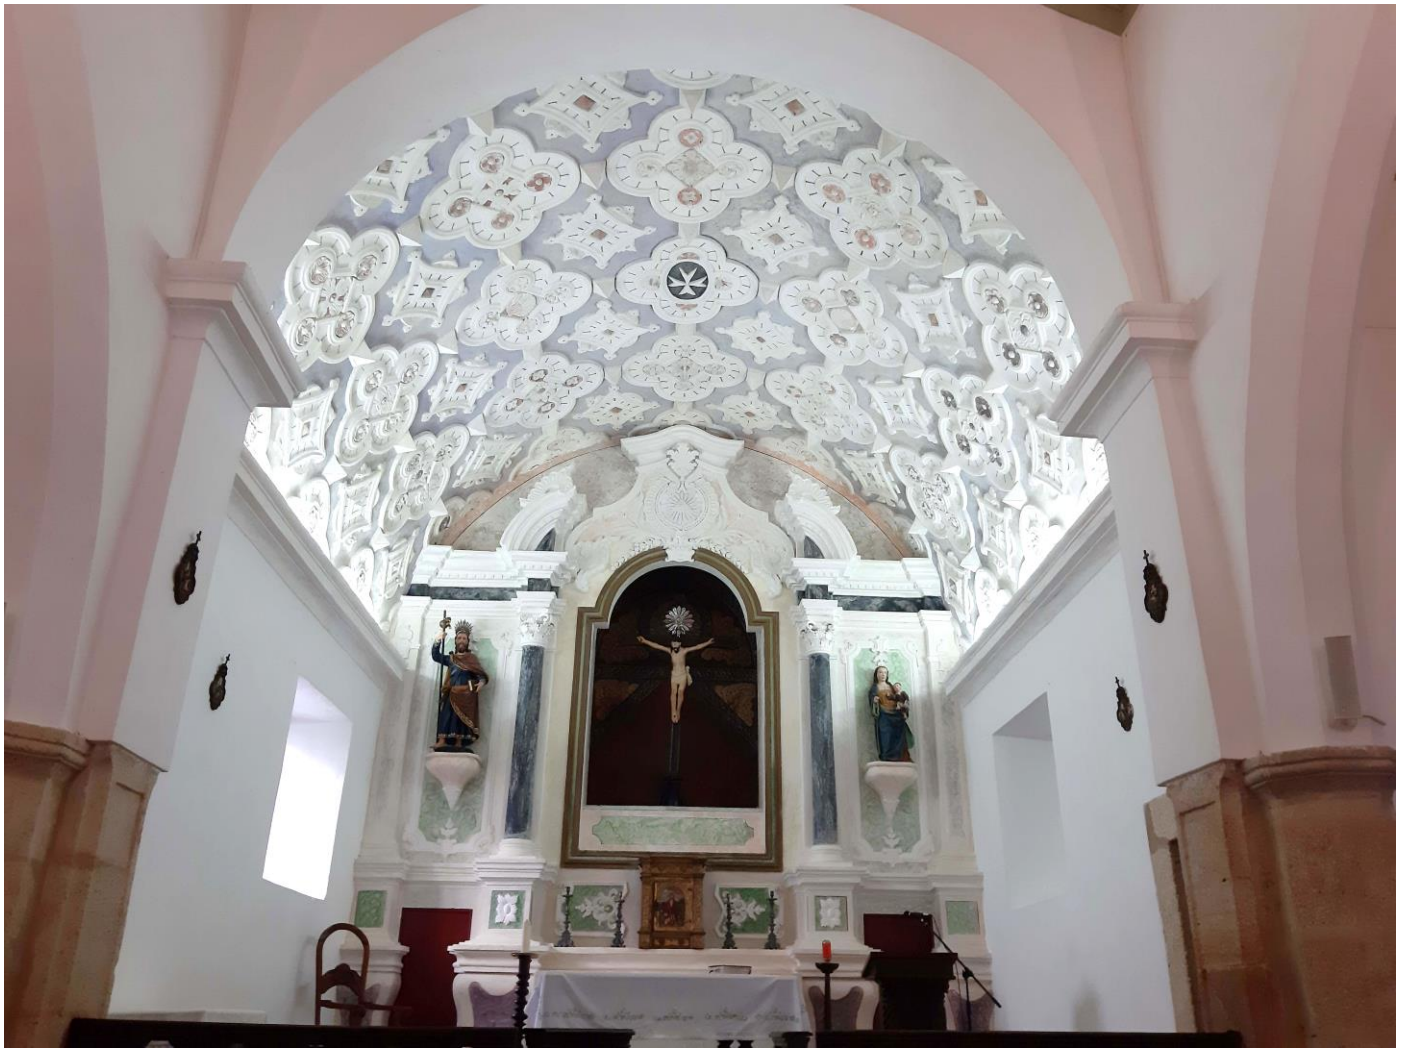
Figure 6. Main altarpiece of Santiago church, Marvão.

In another case, the original polychromies were kept, even if some were deemed less than realistic. This is the case with the main altarpiece of Santiago church (Marvão), which adhered to the tradition of an exuberant chromatic palette, a common feature of these art pieces found throughout the region [13].

Following the conservation intervention in 2018, led by the firm *Intonaco*, the local population needed some time to accept the final results, taking into account the colours that were then recovered and displayed. There were no repaints in this case to hide the original painting, but the palette used still surprised the public who frequented the church. Finally, effective communication between the owner (the parish), the conservation technician, and the general public was critical to the preservation of this large-scale stucco altarpiece (Figure 6).

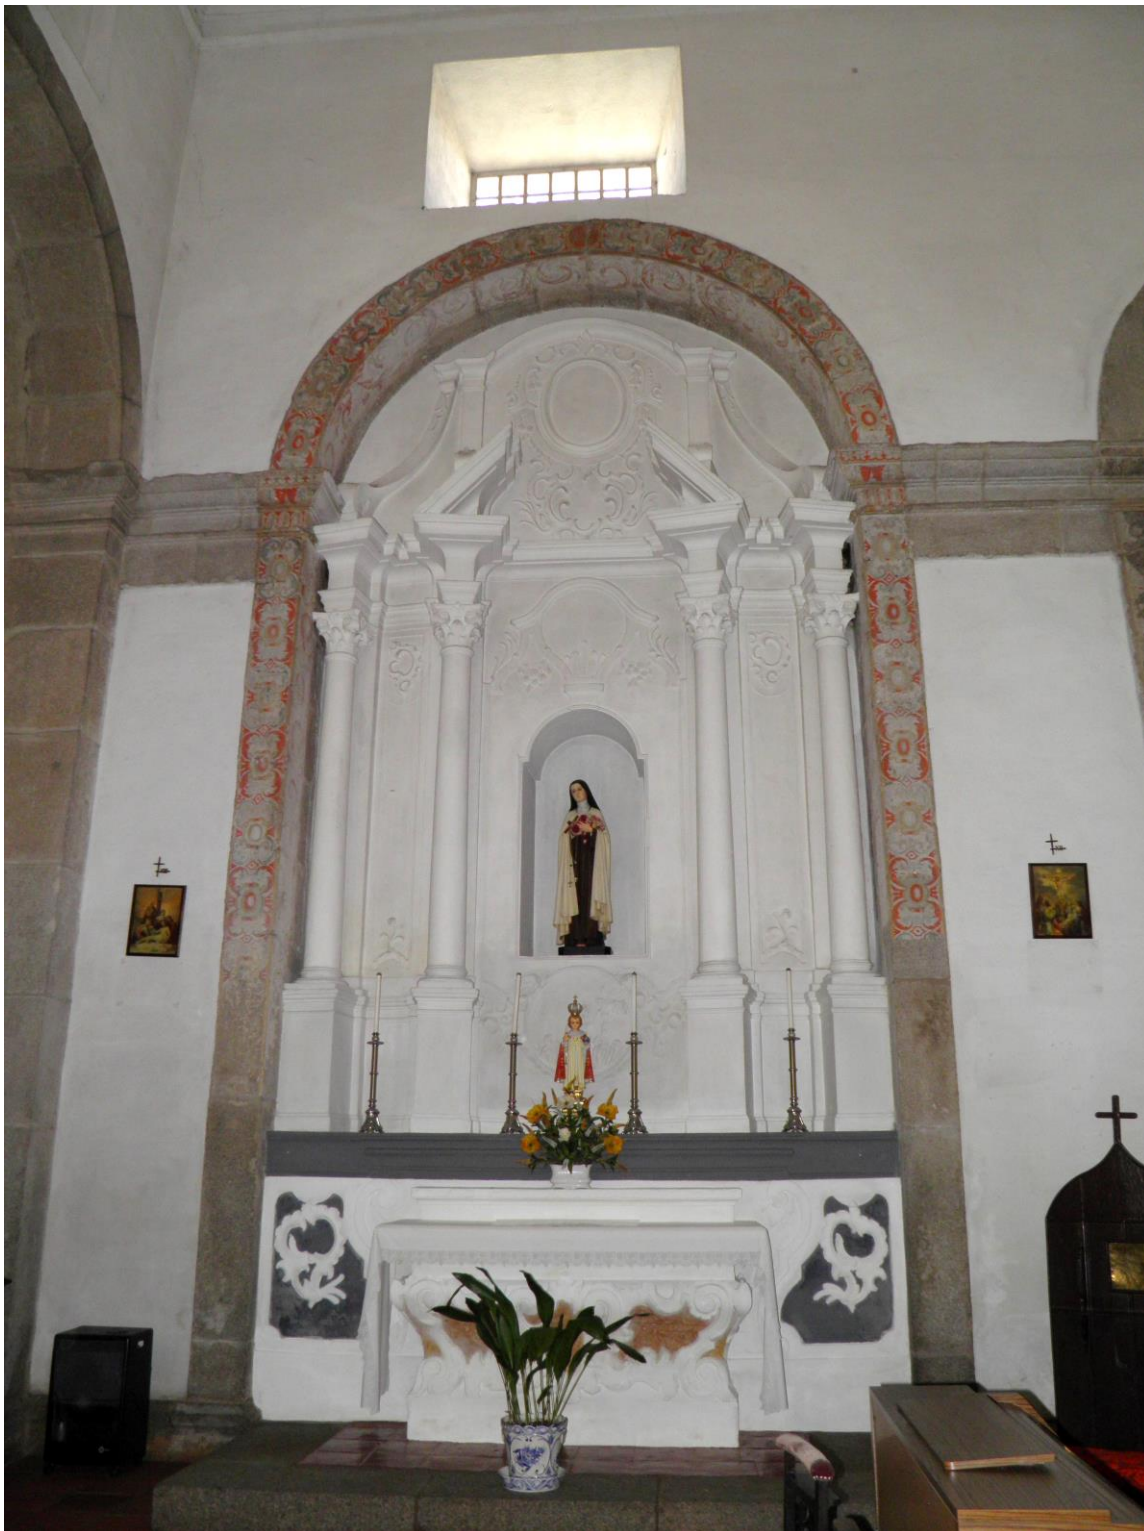
Figure 7. Collateral altarpiece of the main church of Fronteira.

The same spirit seems to have extended to some interventions in our built heritage, namely in some elements integrated into the architecture, thus creating an aseptic image and setting them apart from excessive and confusing use of colour. Whitewashing buildings' façades and their embellishments is a popular way to avoid degradation problems in this particular region of our country (Figure 7).

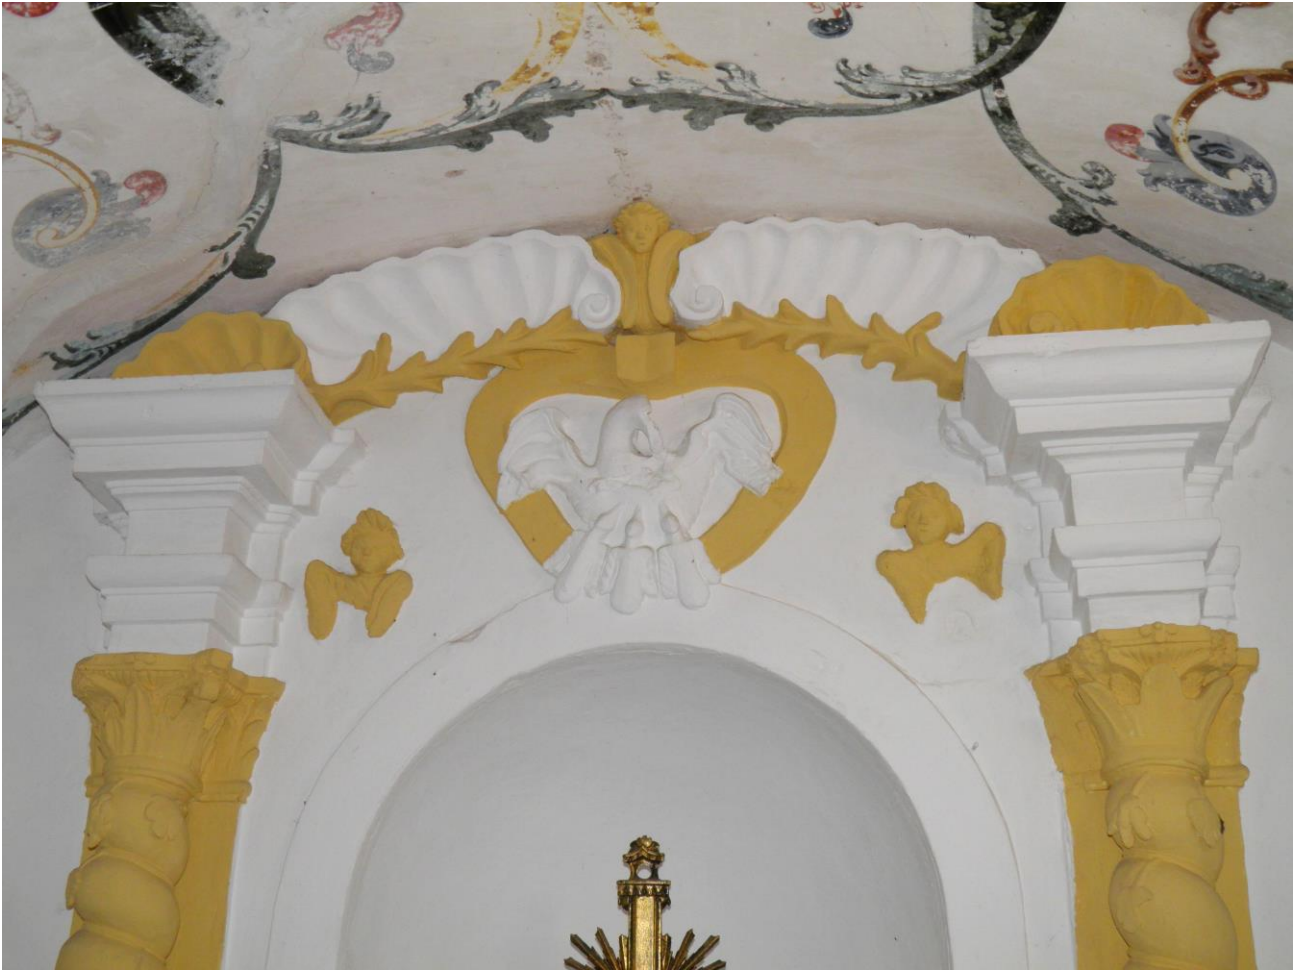
**Figure 8.** Altarpiece in the sacristy of the convent of Nossa Senhora da Esperança, Vila Viçosa.

The excessive use of lime, combined with the complete eradication of colour, resulted in an abstract image of architecture, as well as the loss of all its plastic values [18]. This was also what happened with stucco altarpieces, where an excessive amount of whitewashing created an indistinctive image, attenuating forms, volumes, and contrasts. Sometimes, to decrease the “whiteness” effect, other colours were introduced, covering specific parts of the altars (columns, ornamental details). These colours adhered to the “official” palette, which is essentially Alentejo's trademark: aside from white, ochre and blue were also used, although blue had a lesser expression in the case of altarpieces (Figure 8 and Figure 9).

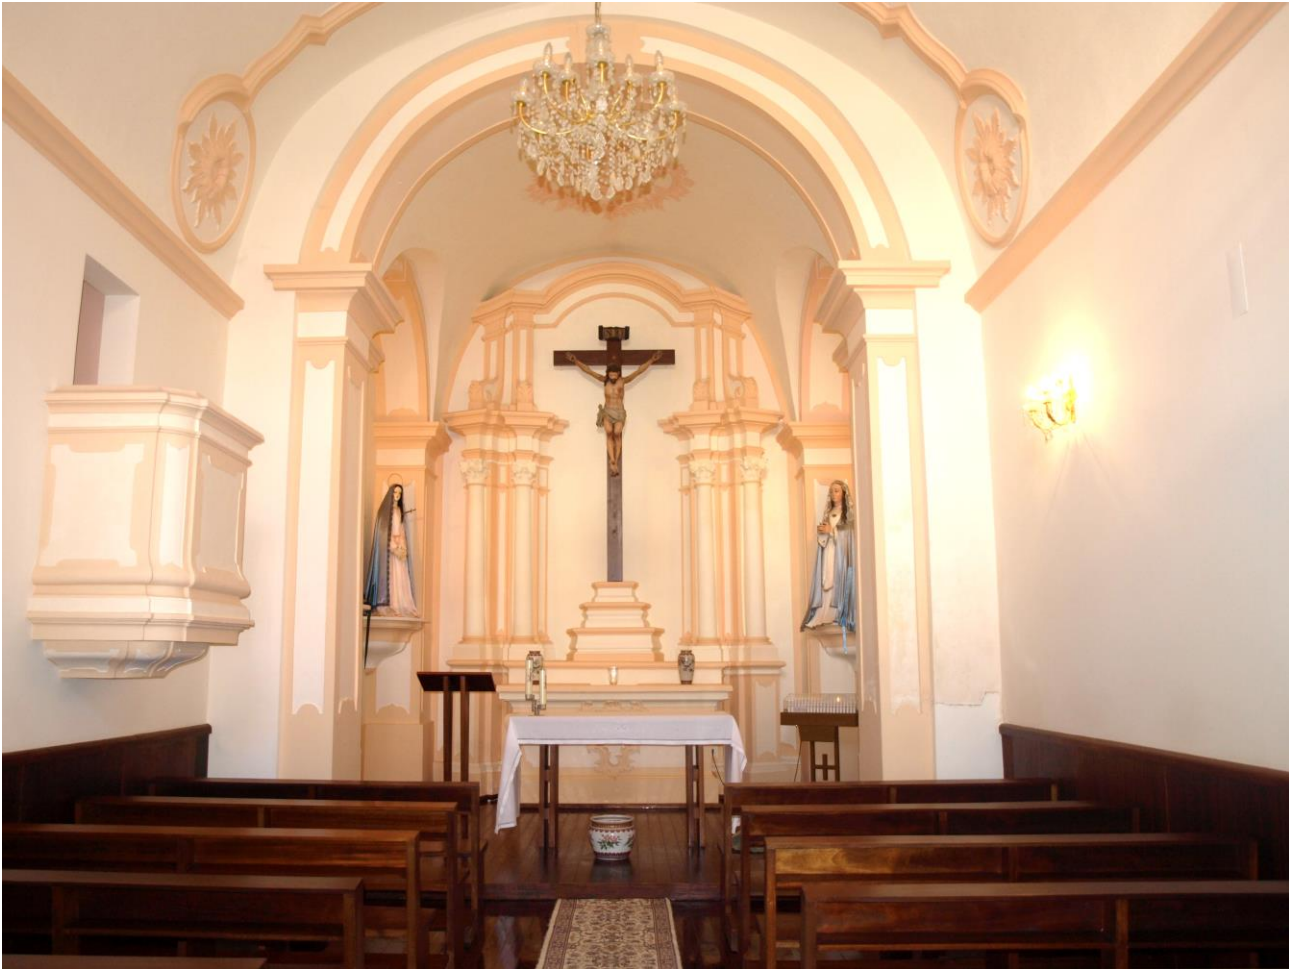
**Figure 9.** Main altarpiece of the church of Misericórdia of Montargil.
